## CAA112(r) INSPECTION REPORT

| <b>Name:</b> Glycerin Traders | |
| <b>Process:</b> NAICS 325611-03, Glycerin Manufacturing | |

### SUMMARY OF OBSERVATIONS

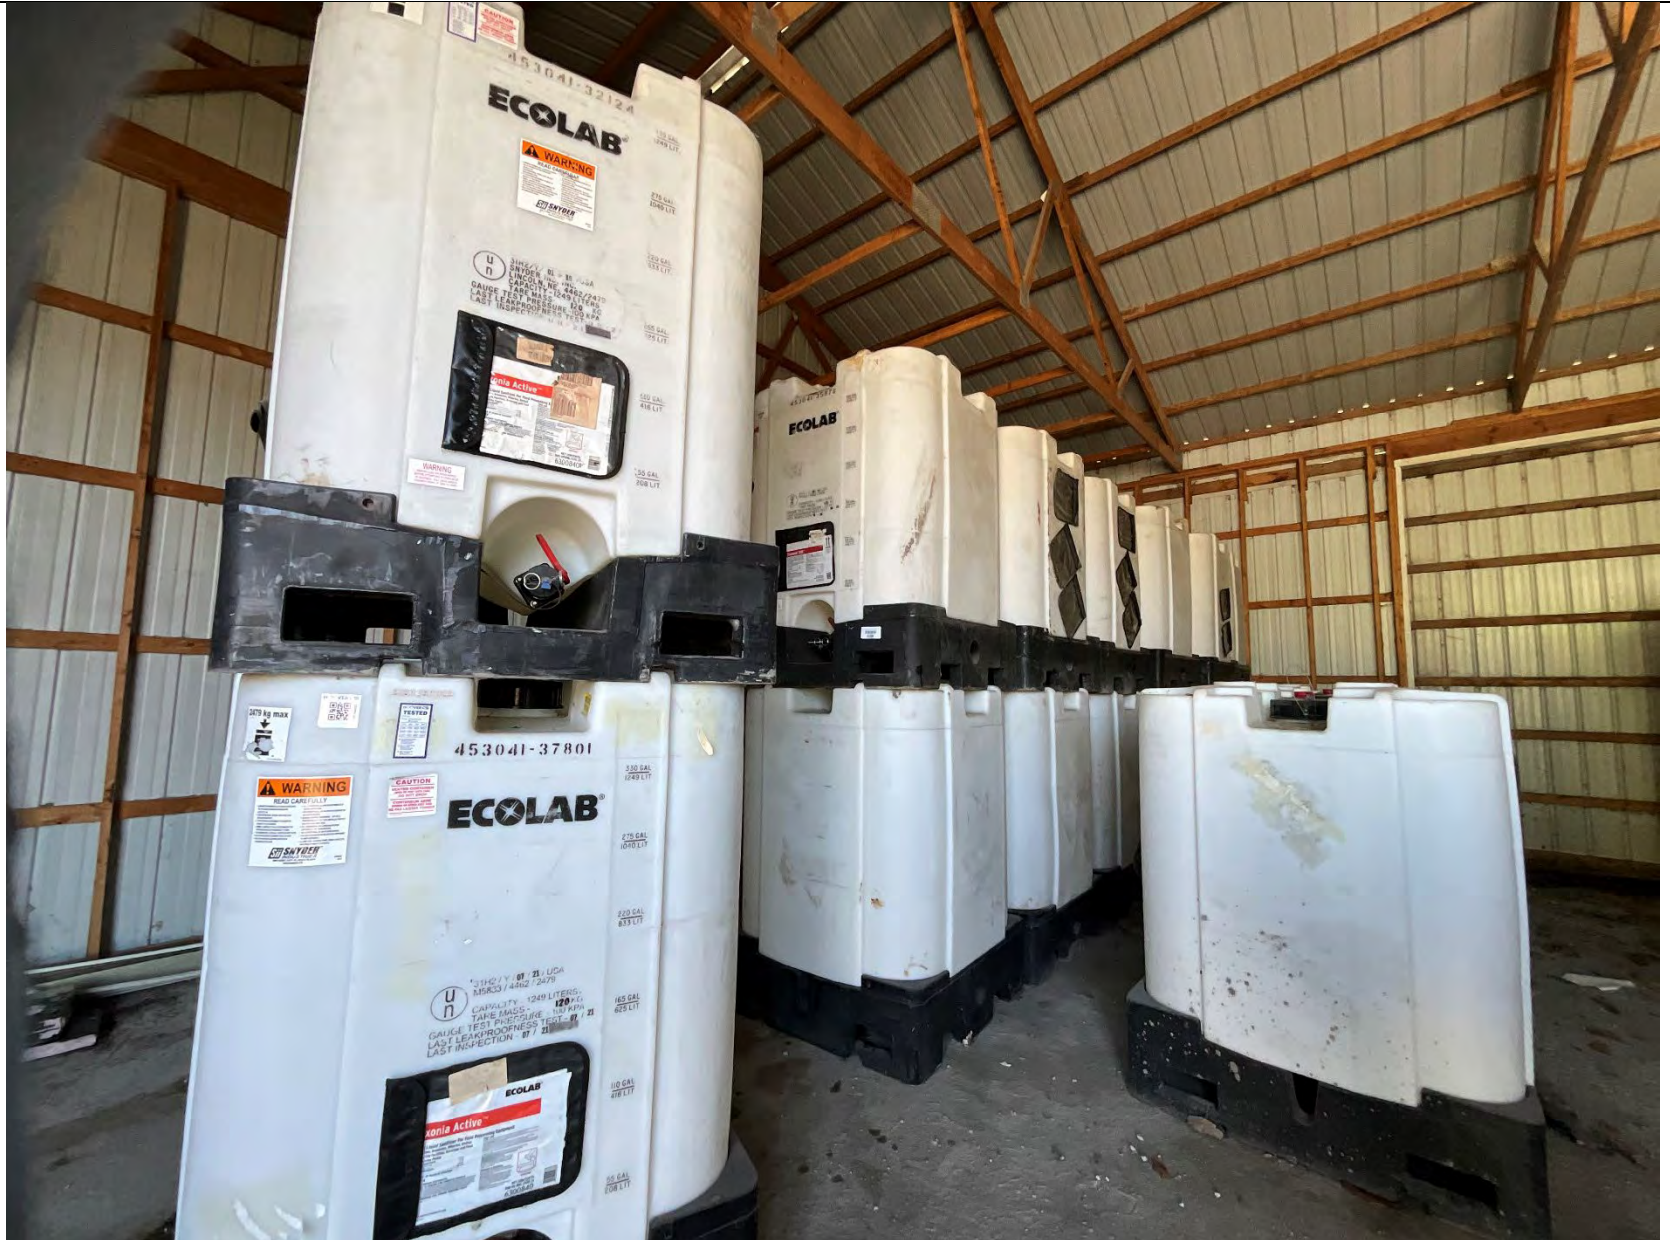
4

Empty totes – East Pole Building

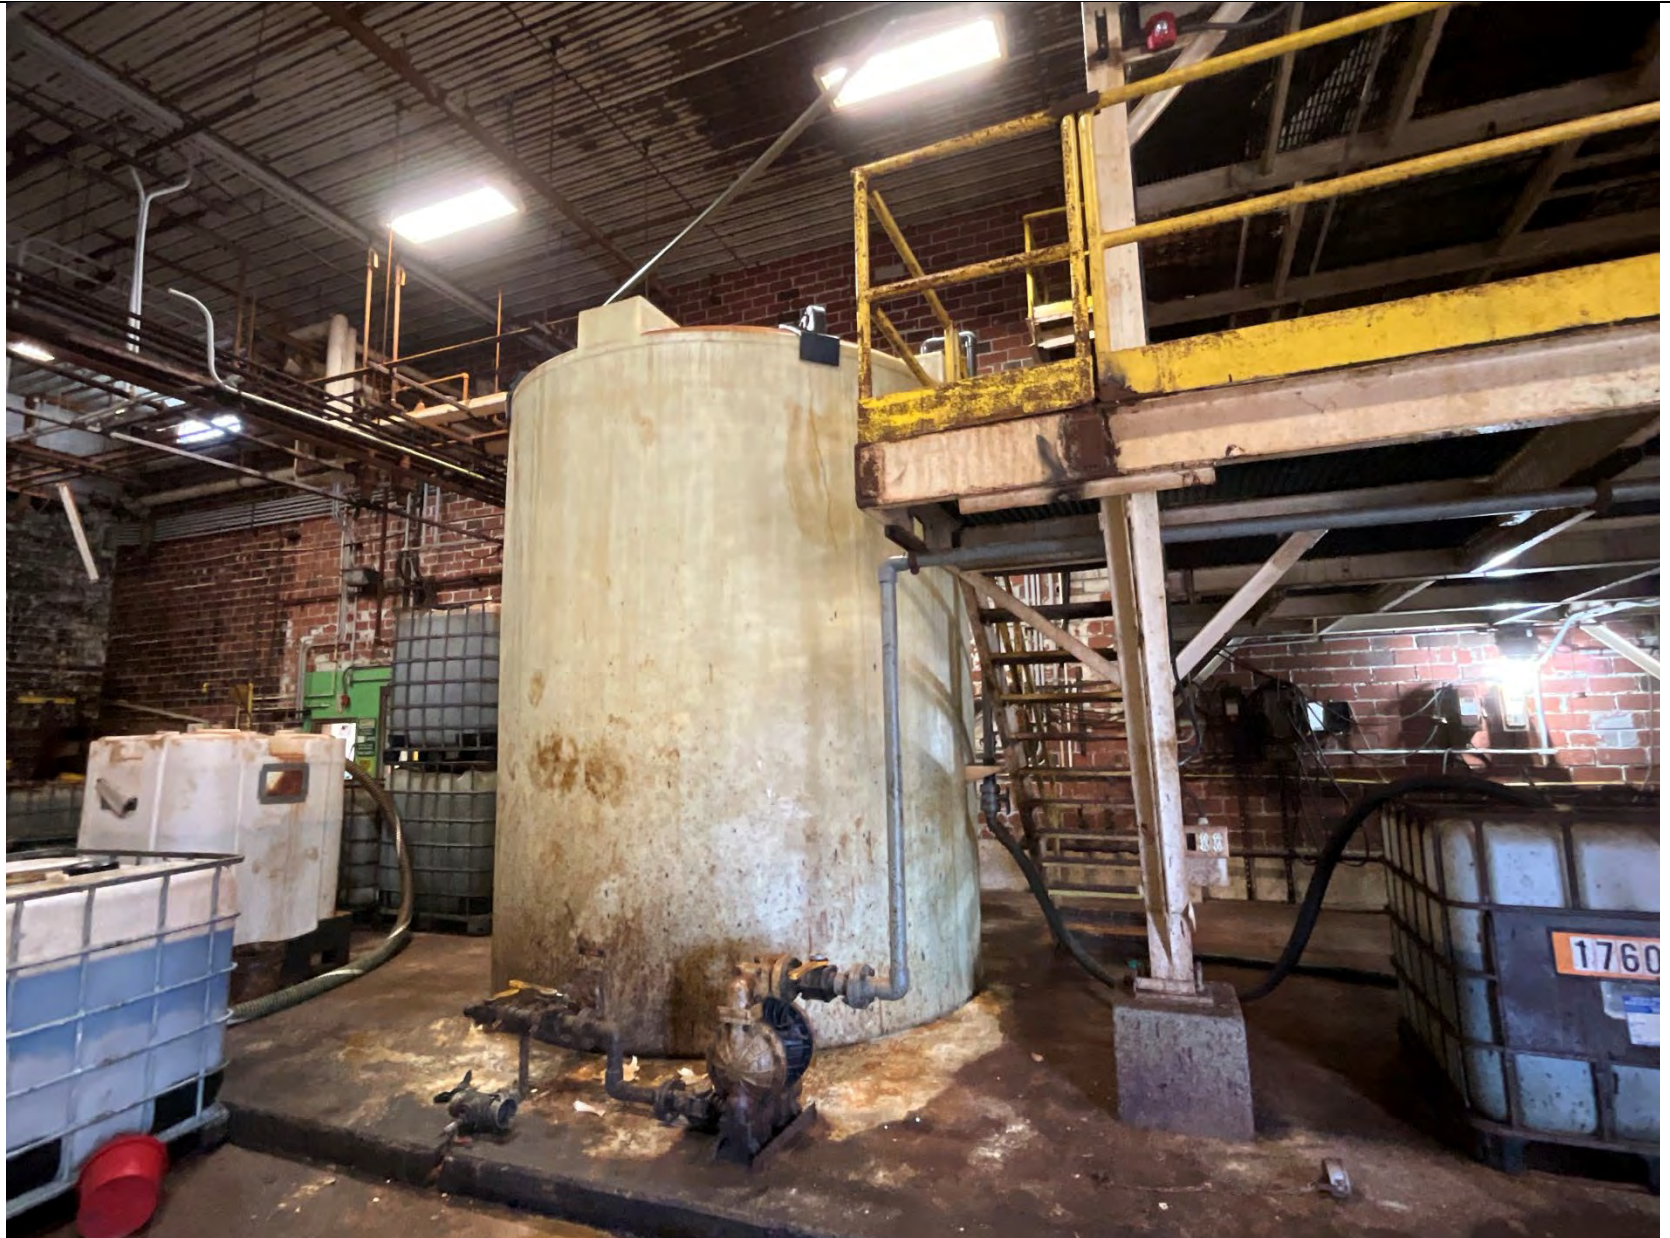
10

Poly tank contains HCl. Various totes around the area are said to contain “clean ups from spilled raw glycerin”. Pump is said to be “unused”. Previous operations, the HCl was mixed with the raw glycerin as it was unloaded from trucks to transfer to storage tanks.

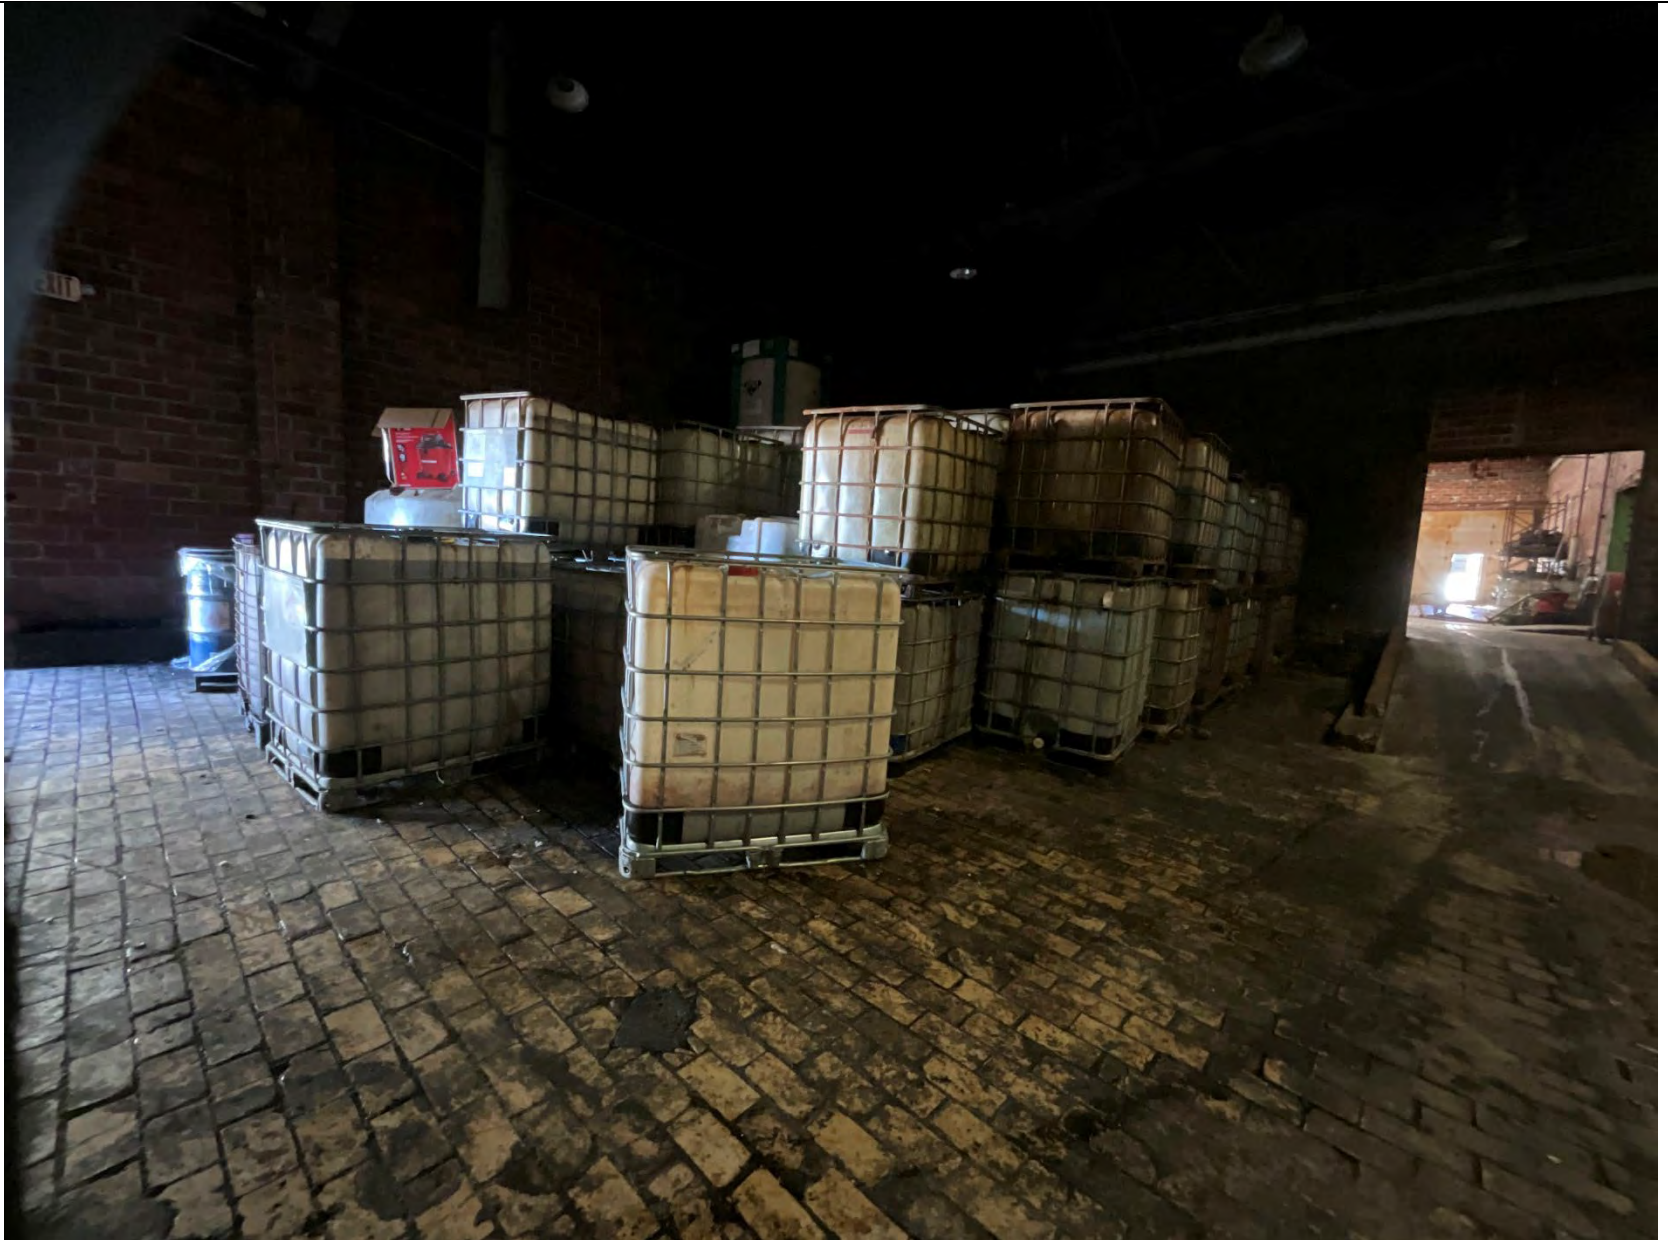
16

Warehouse and additional totes containing raw glycerin that had been spilled and cleaned up.

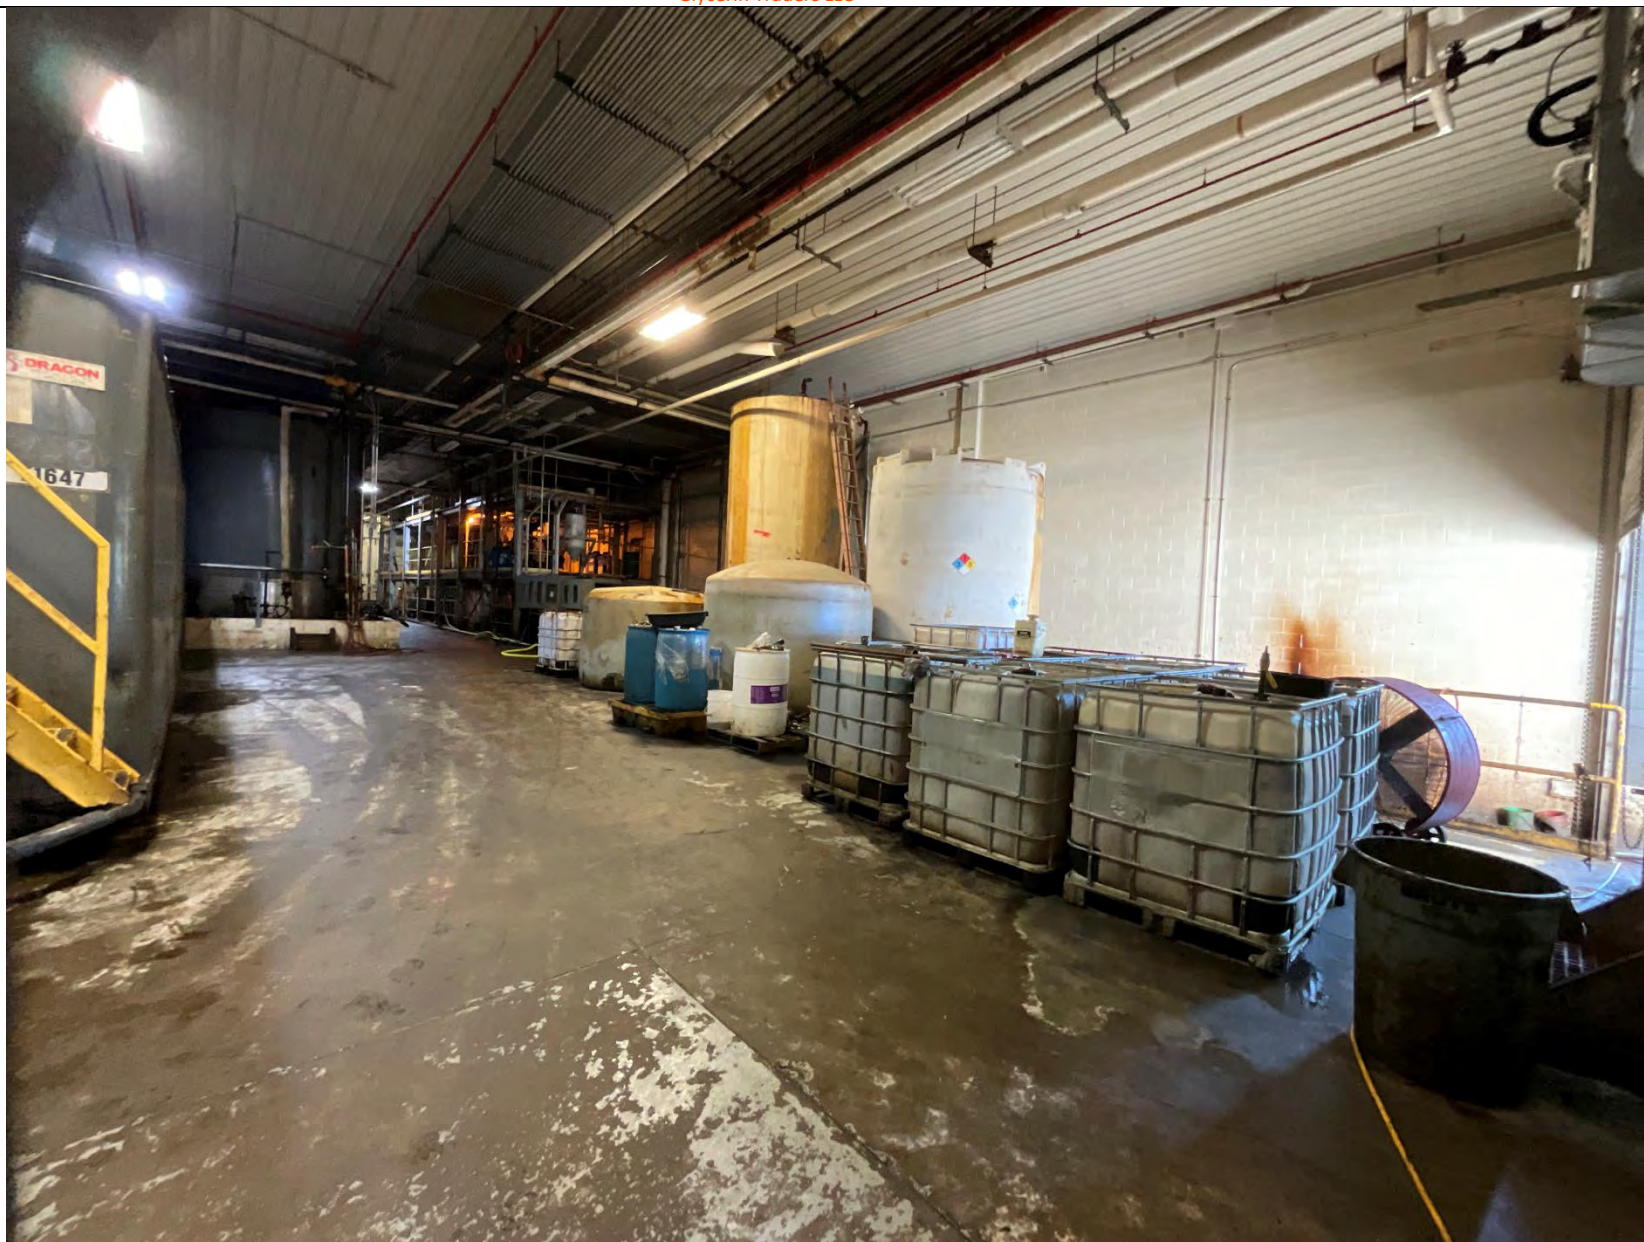
| 26 | IMG_0484.JPG | Directly outside of operations control room/quality lab. To the right: totes filled with raw glycerin recovered from spills. Tanks contain water extracted during raw glycerin processing. NFPA diamond is incorrect on poly tank of wastewater. To the left is a frac tank which contains glycerin for the process. Open buckets containing glycerin were observed in front of the frac tank and near the wastewater tanks. | 2024:11:19 14:46:24 |

Directly outside of operations control room/quality lab. To the right: totes filled with raw glycerin recovered from spills. Tanks contain water extracted during raw glycerin processing. NFPA diamond is incorrect on poly tank of wastewater. To the left is a frac tank which contains glycerin for the process. Open buckets containing glycerin were observed in front of the frac tank and near the wastewater tanks.

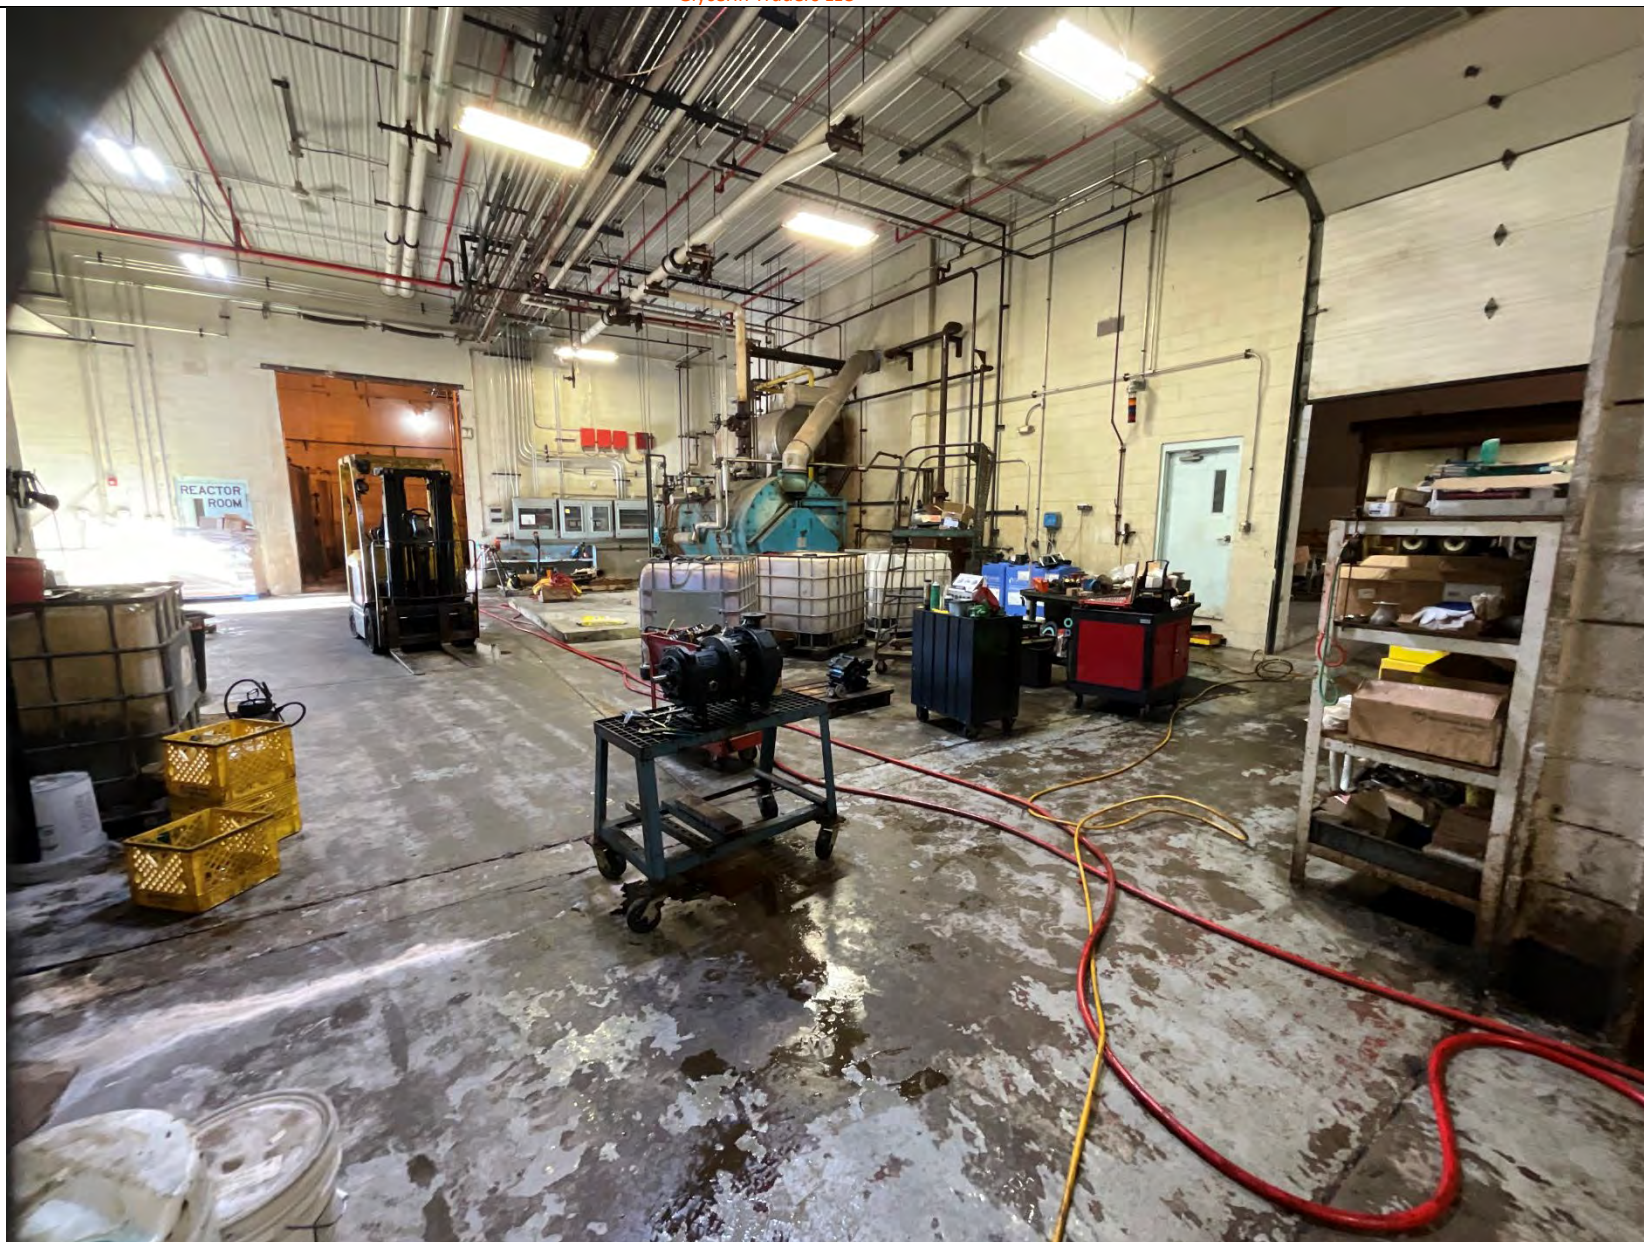
| 28 | IMG_0486.JPG | View to the north and west of the operations control room/quality lab. The current natural gas boiler that will be replaced with a larger boiler in the future. A boiler was sitting outside but it had been dropped from the delivery truck, sustaining damage. It was reported that it would not be used to replace the current boiler. More totes containing spill cleanup materials. Air hoses and chemical hoses were running throughout the area. | 2024:11:19 14:46:34 |

View to the north and west of the operations control room/quality lab. The current natural gas boiler that will be replaced with a larger boiler in the future. A boiler was sitting outside but it had been dropped from the delivery truck, sustaining damage. It was reported that it would not be used to replace the current boiler. More totes containing spill cleanup materials. Air hoses and chemical hoses were running throughout the area.

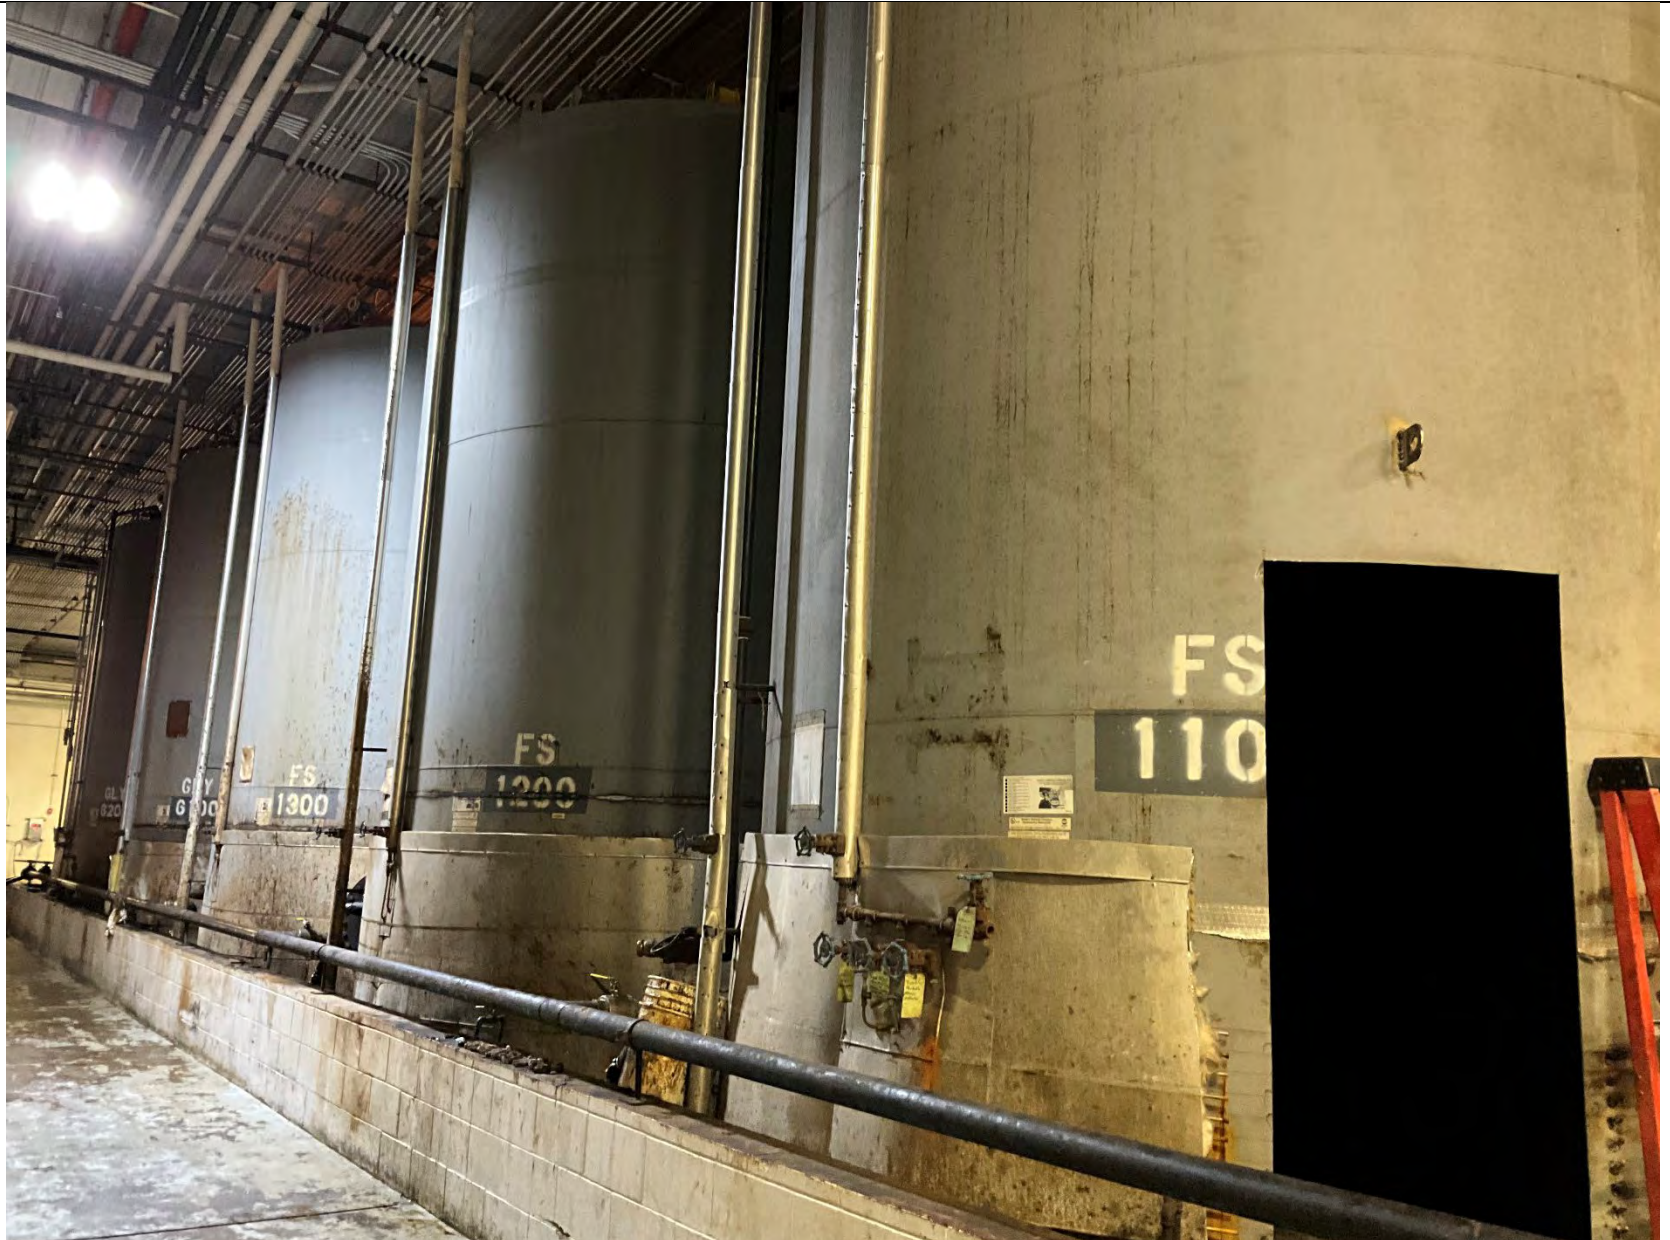
| 29 | IMG_0487.JPG | Image looking east from tank farm. Tank 11 that is out of service and was said that it was being prepared to be relined with stainless steel lining by contractors hired to reline it. | 2024:11:19 14:55:56 |

Image looking east from tank farm. Tank 11 that is out of service and was said that it was being prepared to be relined with stainless steel lining by contractors hired to reline it.

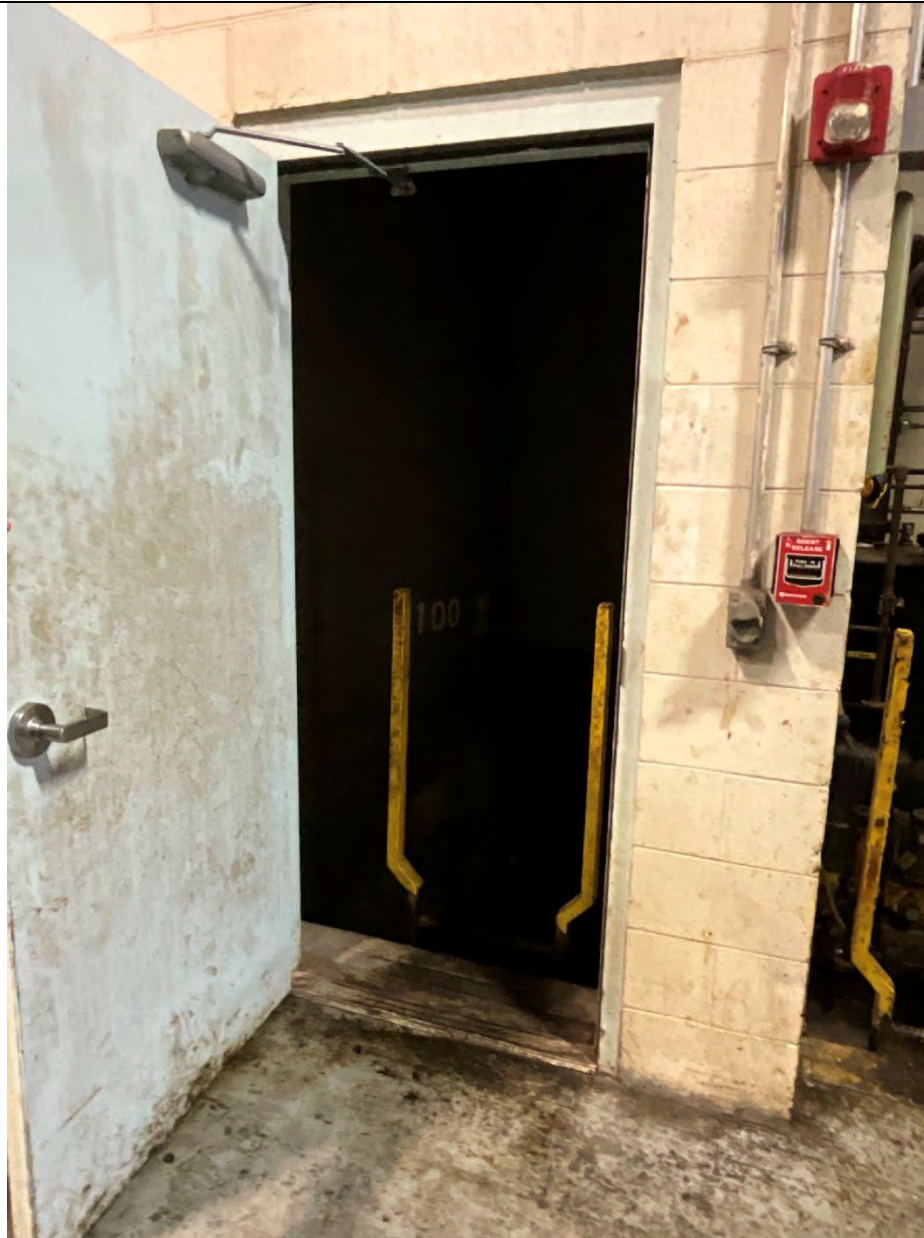
32

Tank 12 is the refined methanol stated to be 99.99% methanol that has been extracted from the glycerin. The room was described as a confined space. It was described as an explosion and fireproof room. Electrical to the room was not operational. Electrical in the area appeared to be classified. Room is a containment room that would contain a spill.

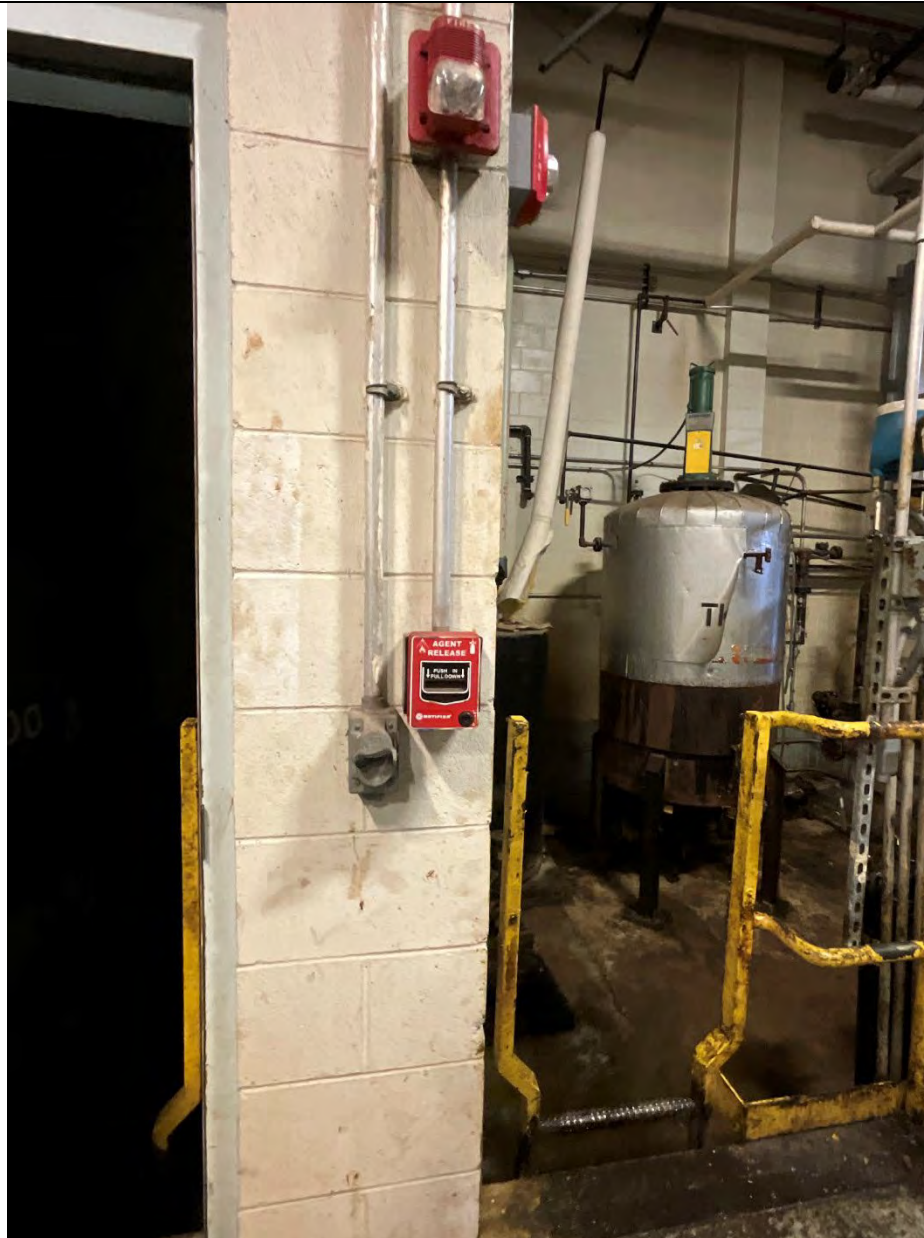
34

Image of fire alarm and nonworking light switch for the room.

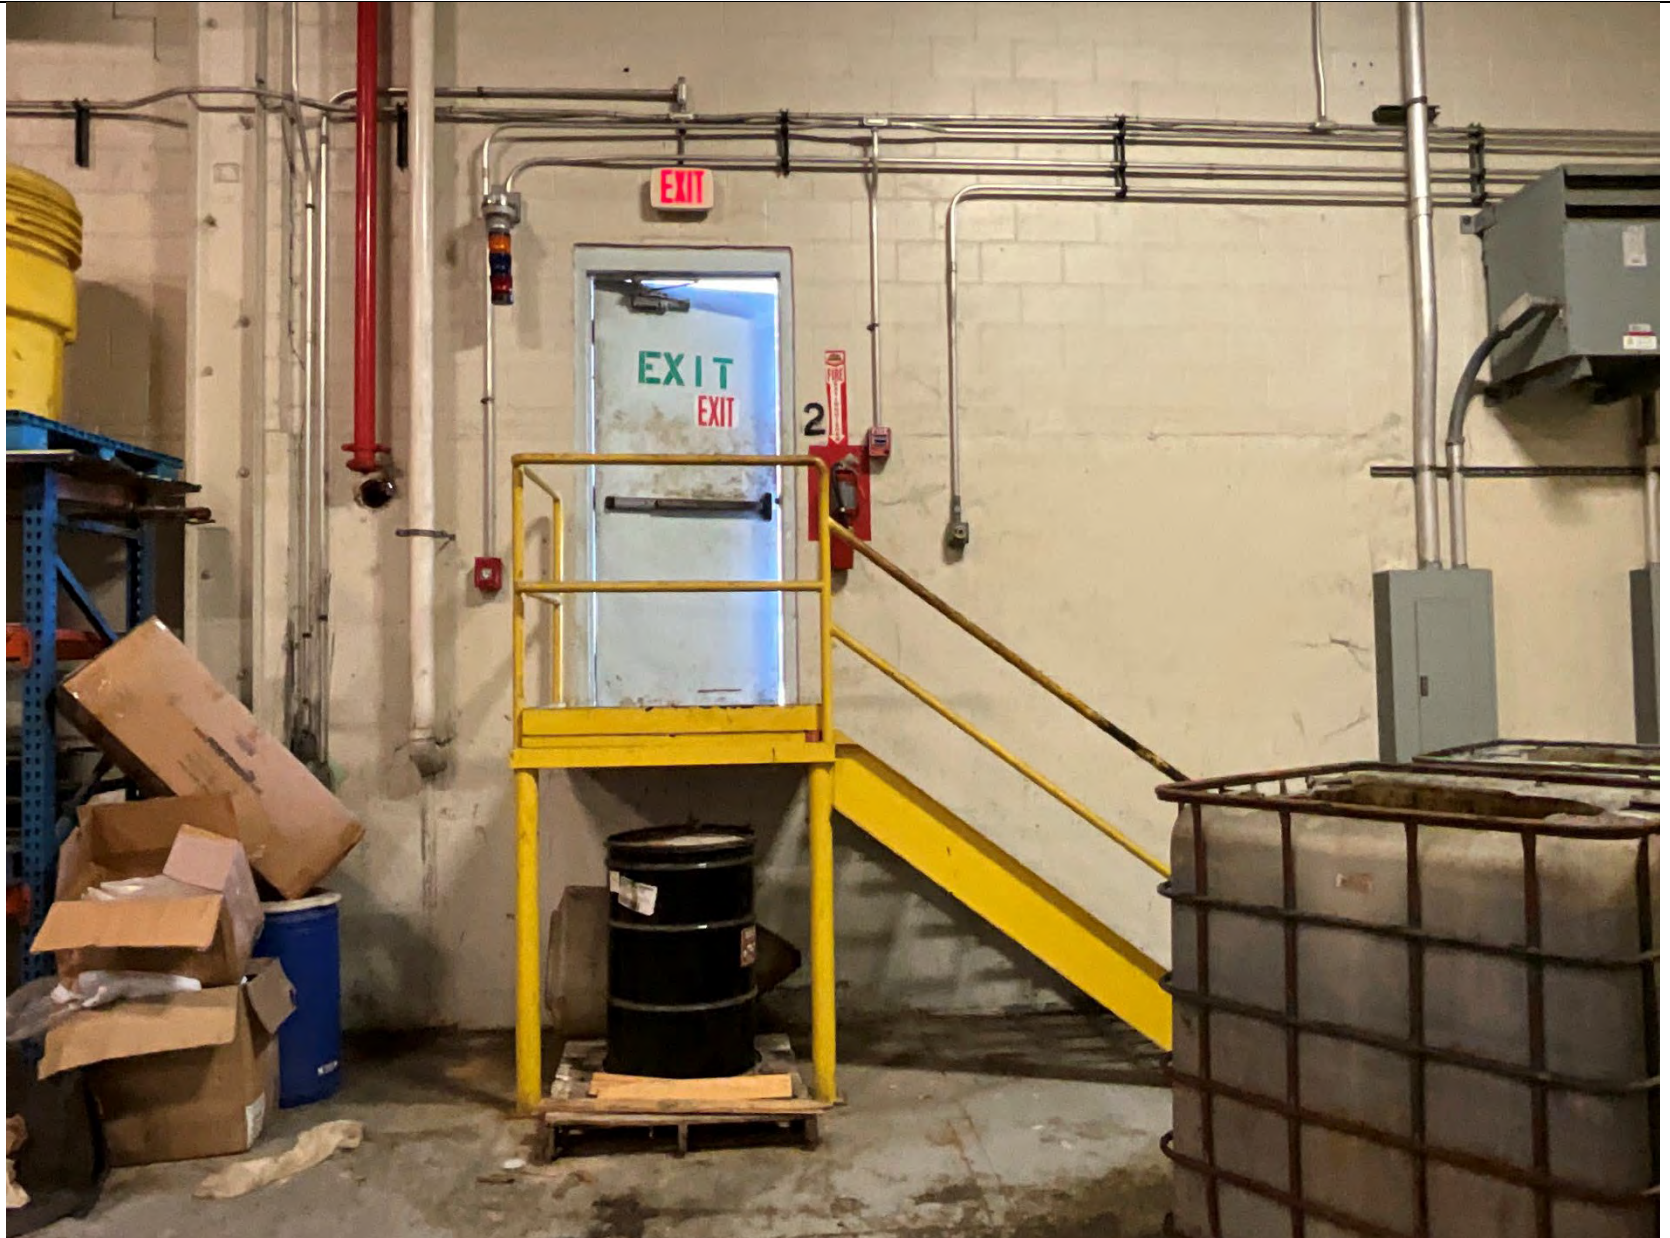
| 41 | IMG_0499.JPG | Exit door on the east side of the building near the methanol tank rook. Emergency stop button, fire alarm and fire extinguisher located by the exit door. Red pipe is a fire pipe that has no elbow joint connect. As is seen in Image 65-67, there is a connection on the outside of the facility for a fire truck to connect to the fire system, but that capability has been disabled. | 2024:11:19 15:06:16 |

Exit door on the east side of the building near the methanol tank rook. Emergency stop button, fire alarm and fire extinguisher located by the exit door. Red pipe is a fire pipe that has no elbow joint connect. As is seen in Image 65-67, there is a connection on the outside of the facility for a fire truck to connect to the fire system, but that capability has been disabled.

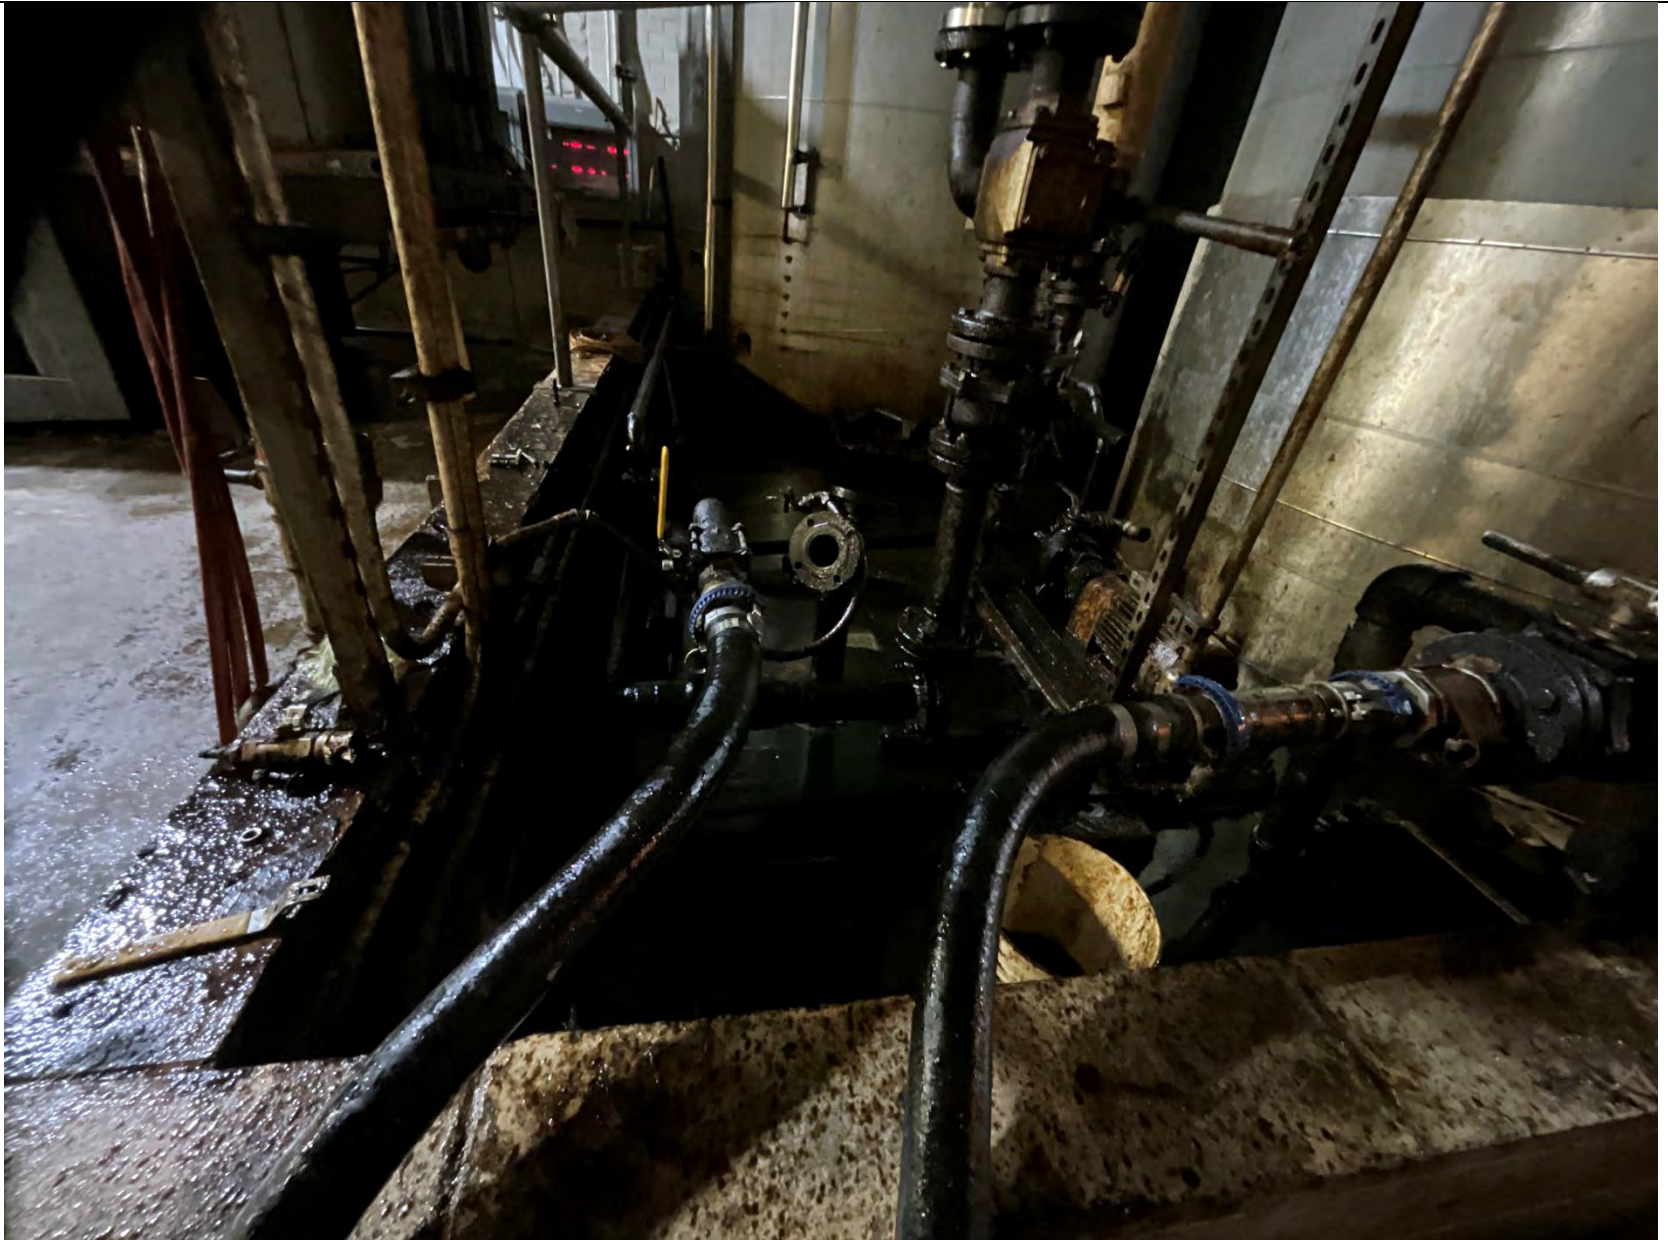
As discussed in the **Field Tour** section of this report and seen in digital images IMG\_0502.JPG and IMG\_0503.JPG, there was a release during this inspection that was contained in the tank farm containment area. Mr. Weible stated that approximately 20 – 50 gallons was released when that a sample port had been left open or was knocked open by the contractors and leaking glycerin into the tank farm containment.

| 45 | IMG_0503.JPG | Another view, like image 44. | 2024:11:19 15:10:01 |

Another view, like image 44.

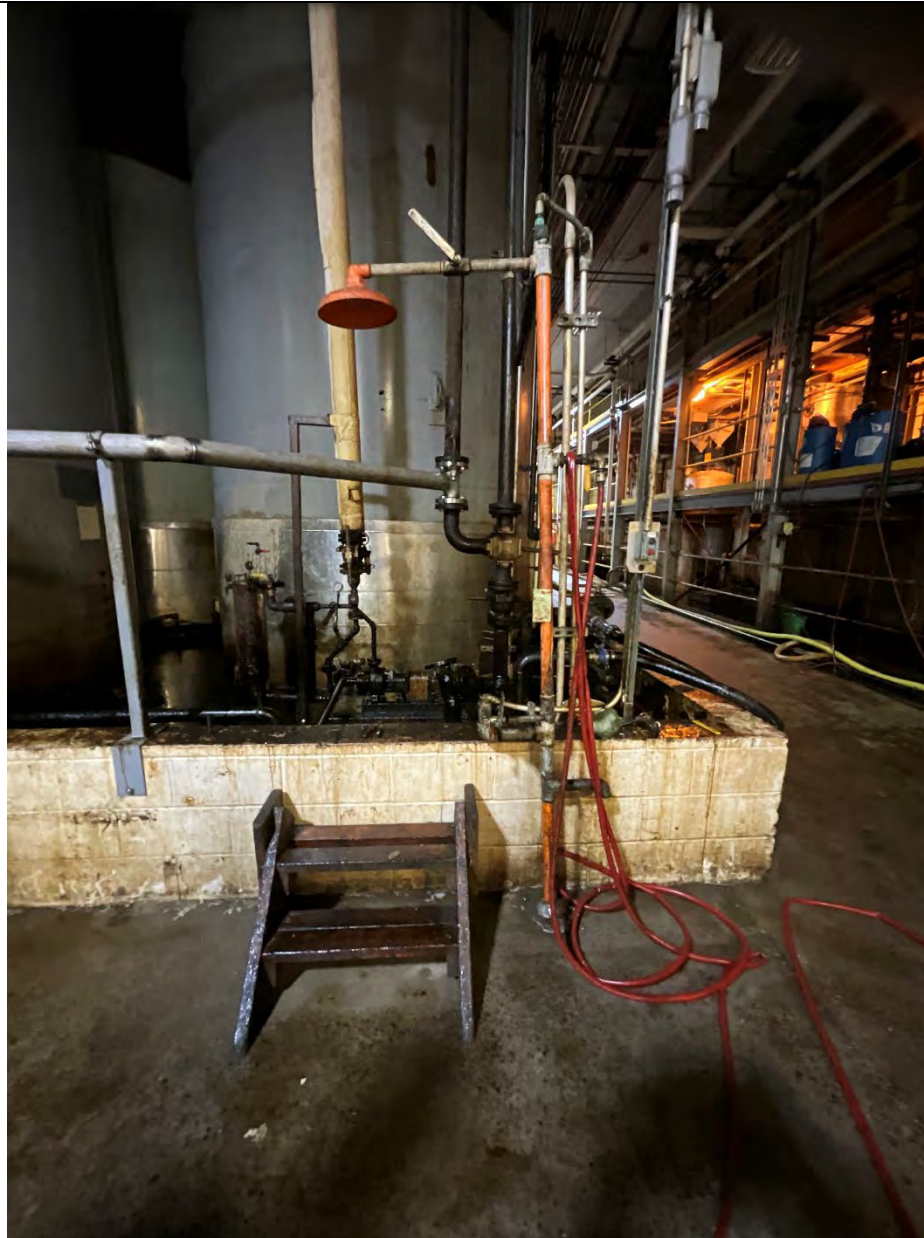
46

View looking at the front of the tank where the release had occurred.
