## CAA112(r) INSPECTION REPORT

| <b>Name:</b> Glycerin Traders | |
| <b>Process:</b> NAICS 325611-03, Glycerin Manufacturing | |

### SUMMARY OF OBSERVATIONS

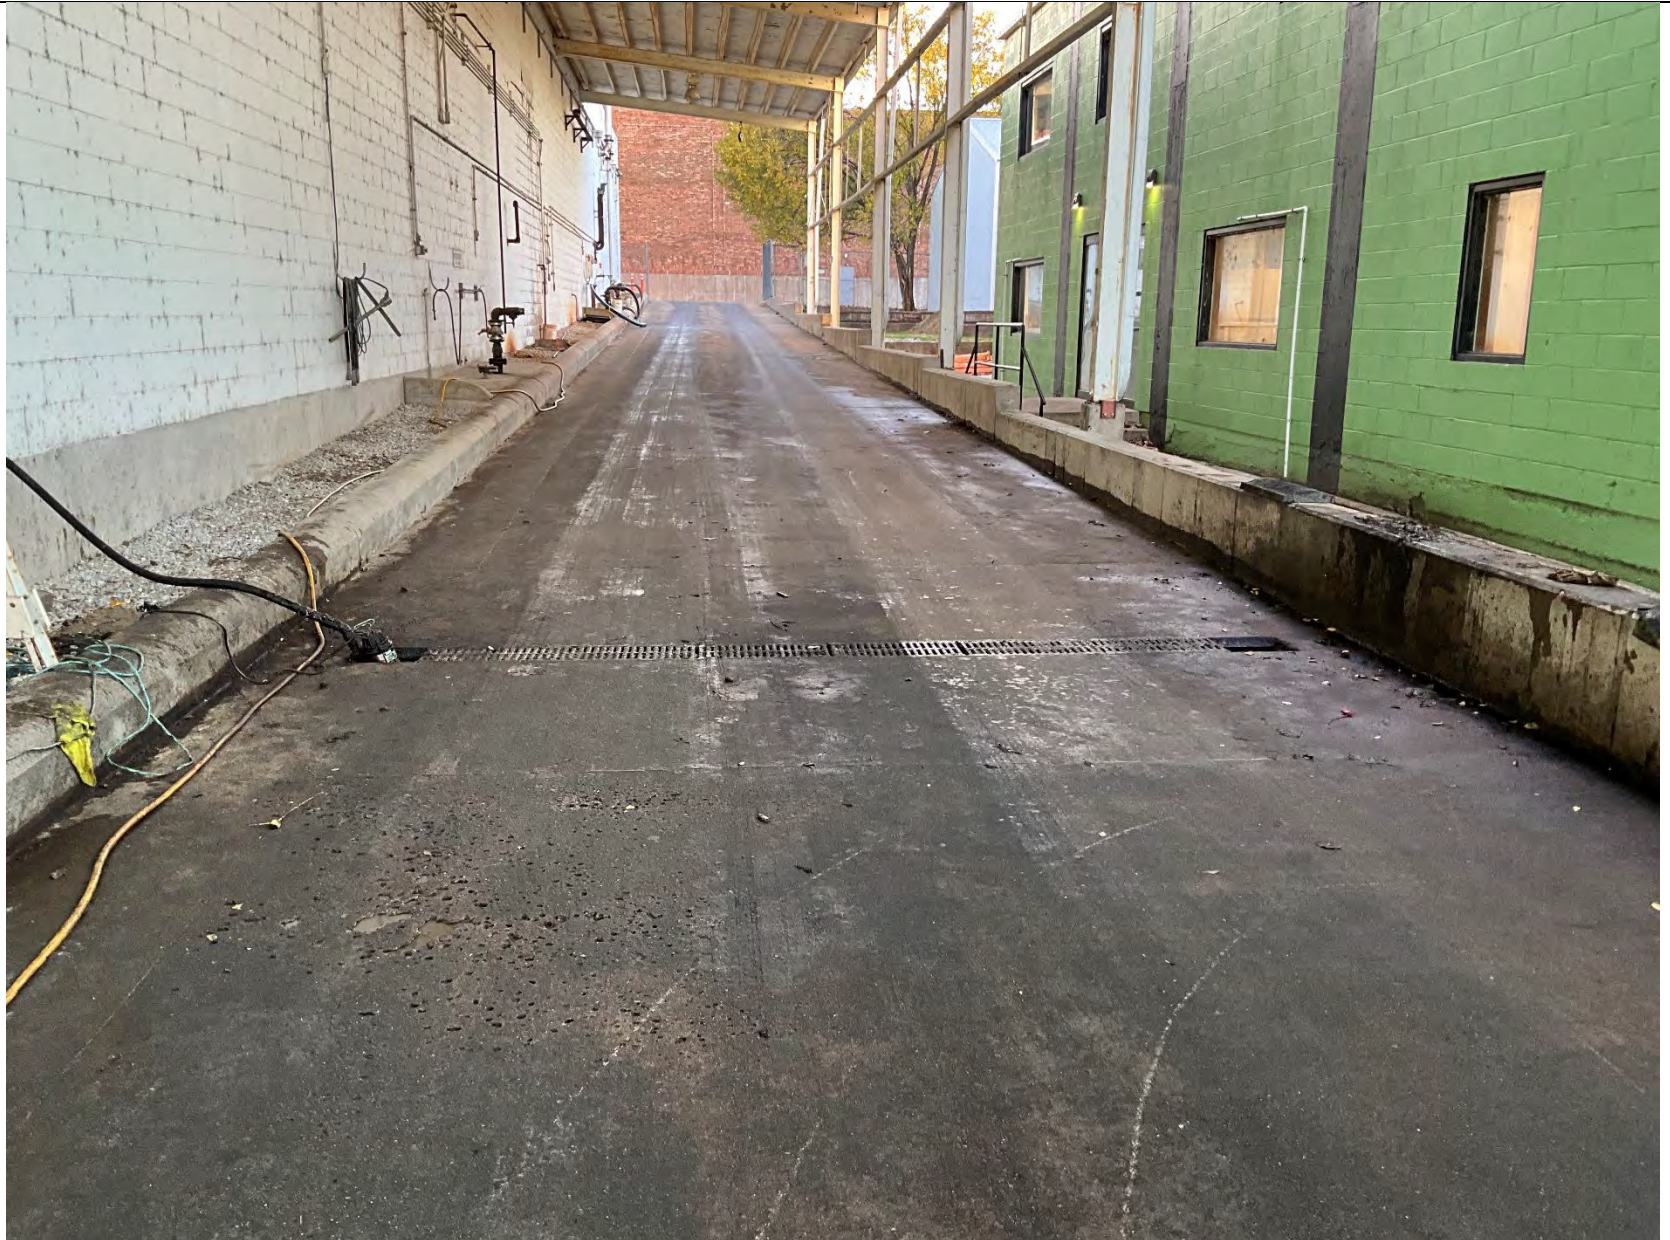
54

Trucks that will be loaded with methanol, glycerin, or recycled vegetable oil, enter from the east or from the 5th street side of the facility and pull up to the loadout areas located on the processing buildings south wall. The grate running through the driveway is where spills from truck loading are captured and then pump via sump pump into the pit as seen in Images 42 and 43.

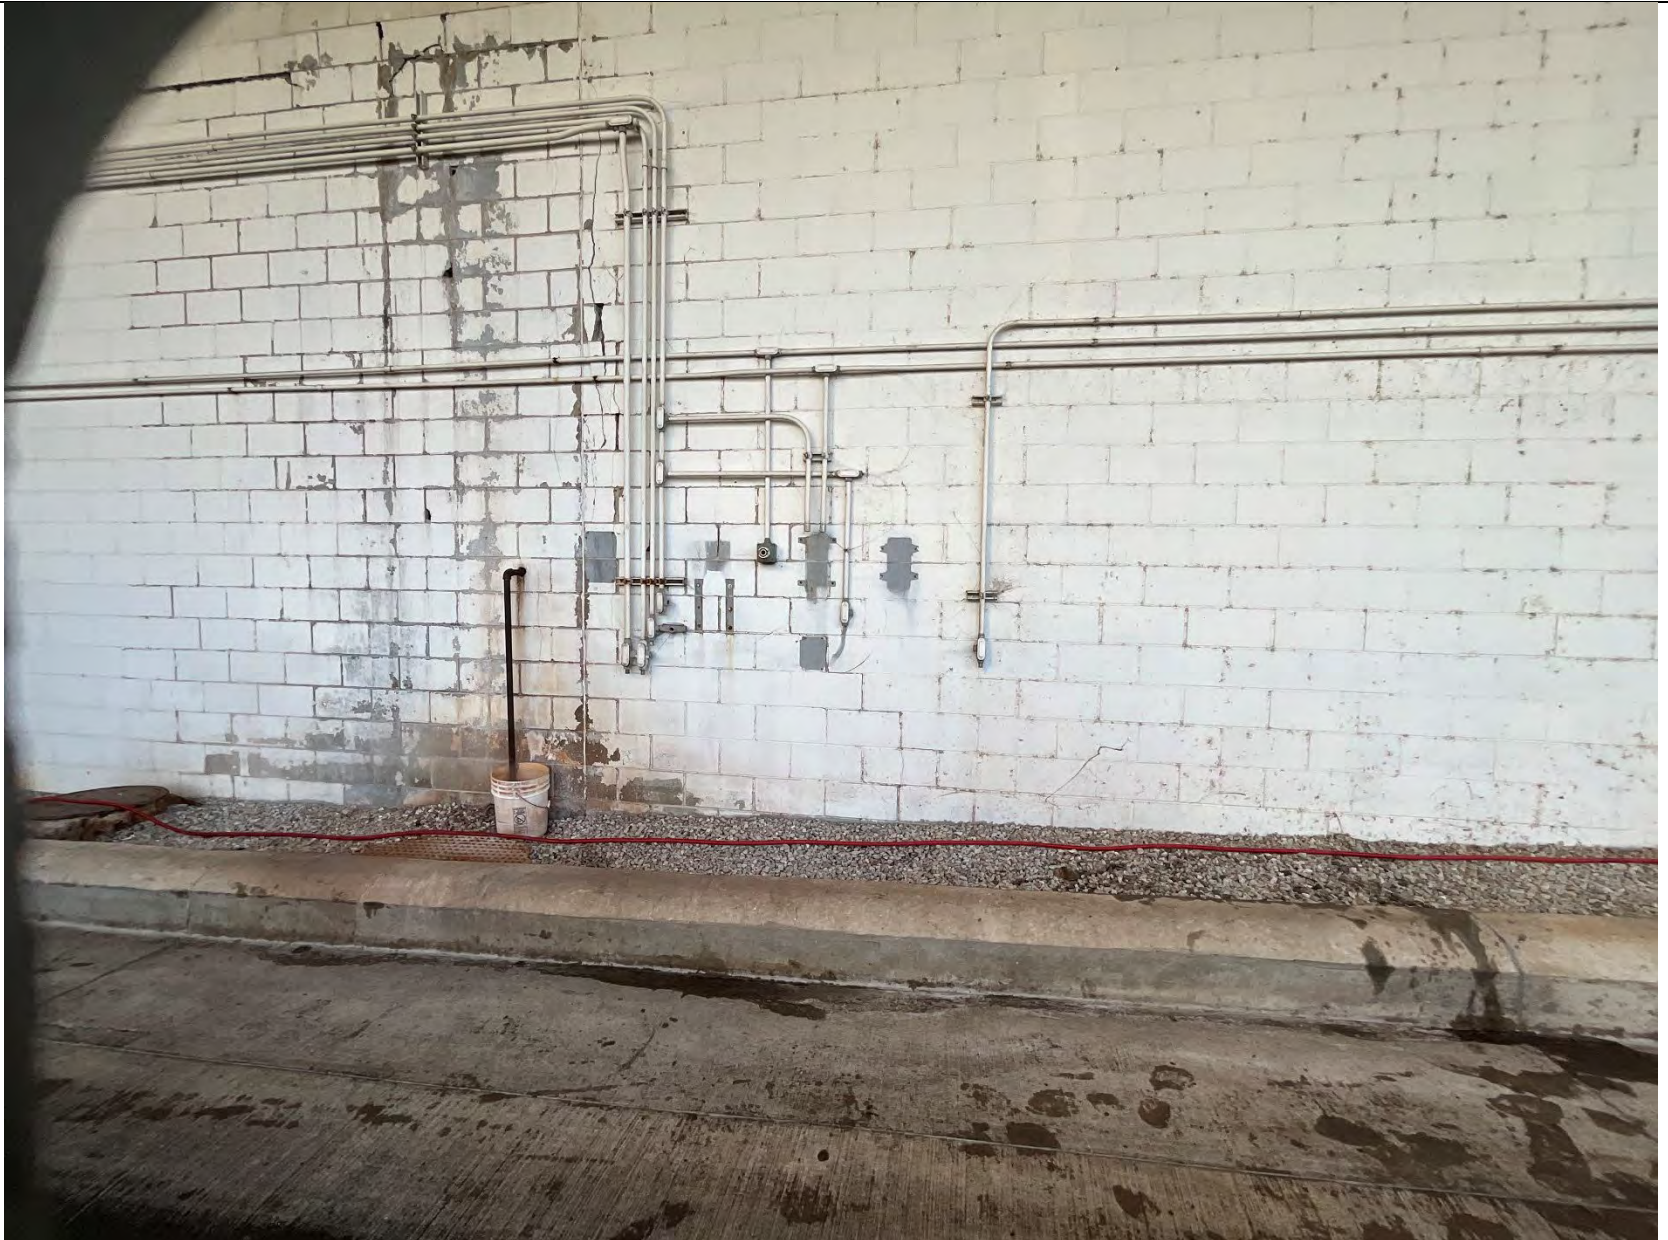
58

Steam discharge into a bucket and a Emergency Stop for the loadouts that was located between the glycerin loading and the Veg Oil Loading. A fire extinguisher and another Emergency Stop was located next the Veg Oil loadout.

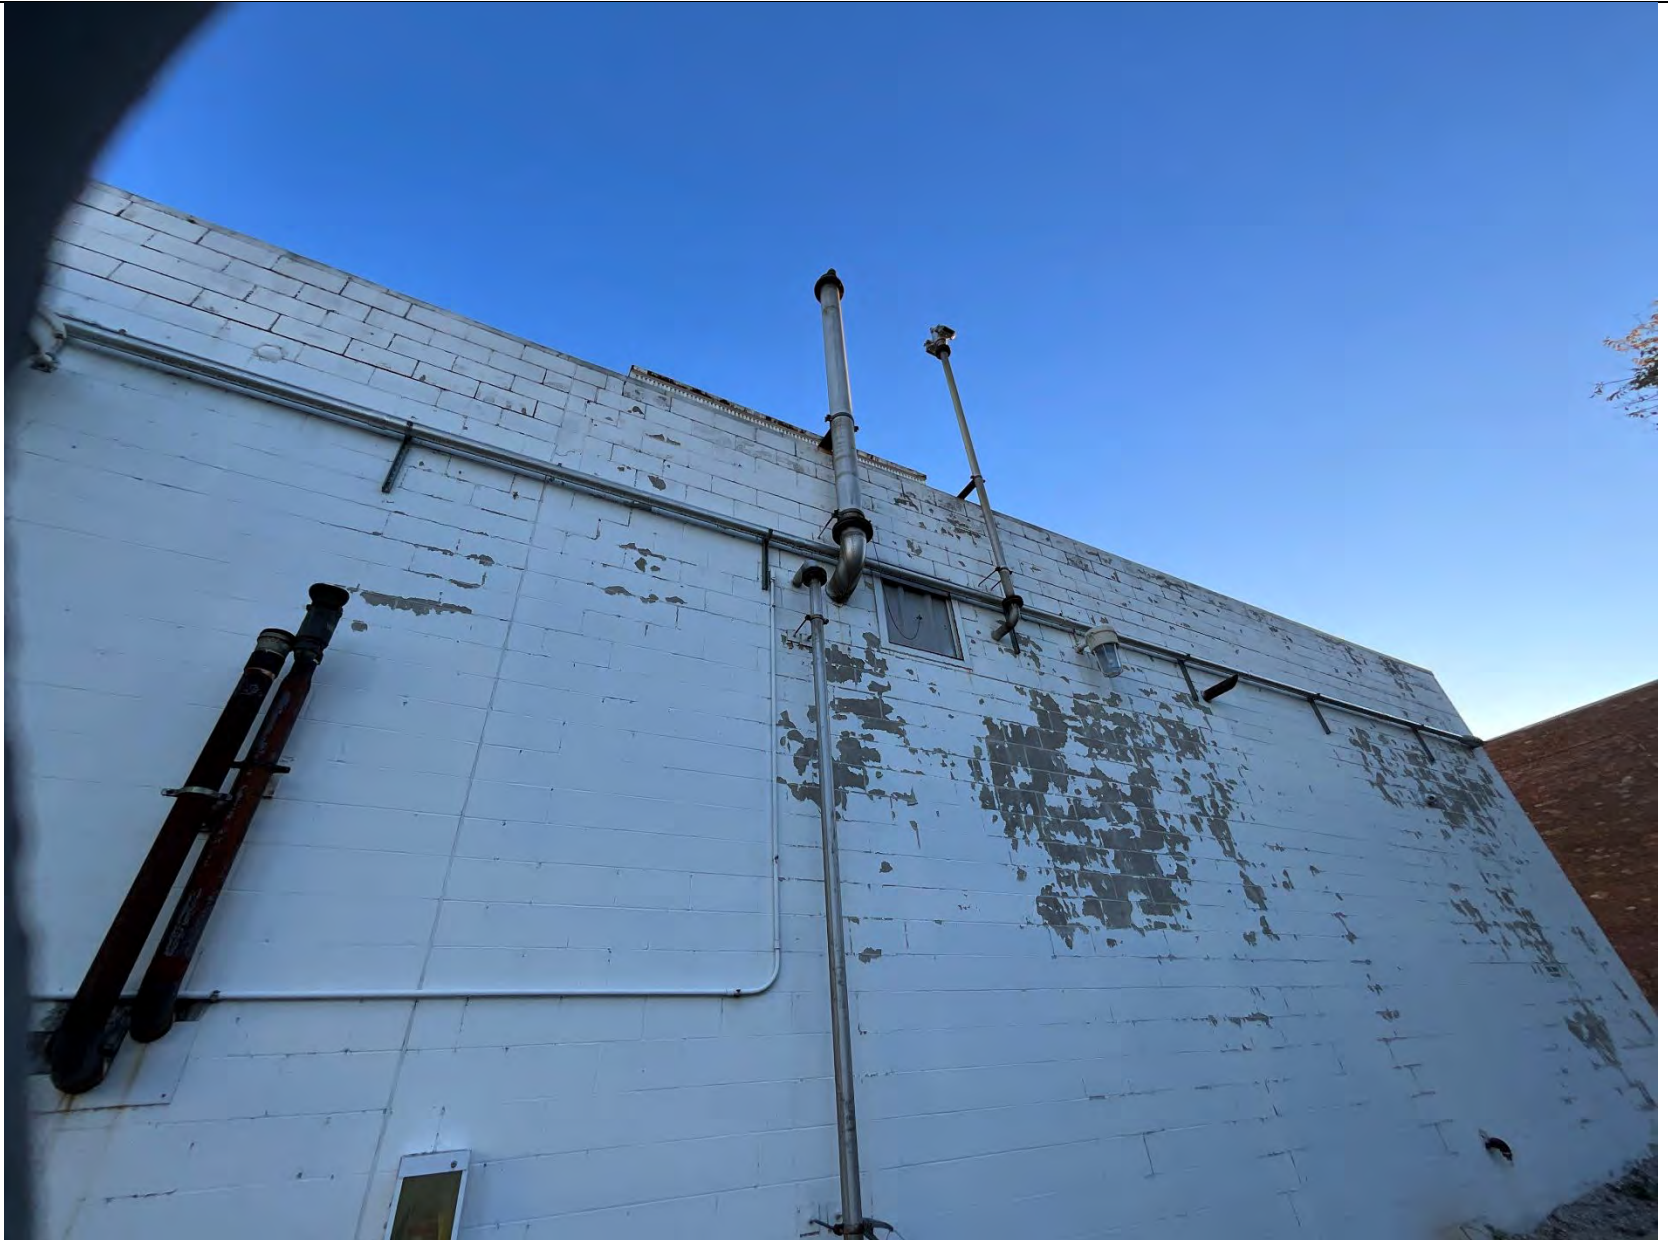
62

Image shows to methanol loadout pipe into the methanol tank room and exhaust pipes for the pressure relief devices on the methanol tank and room ventilation.

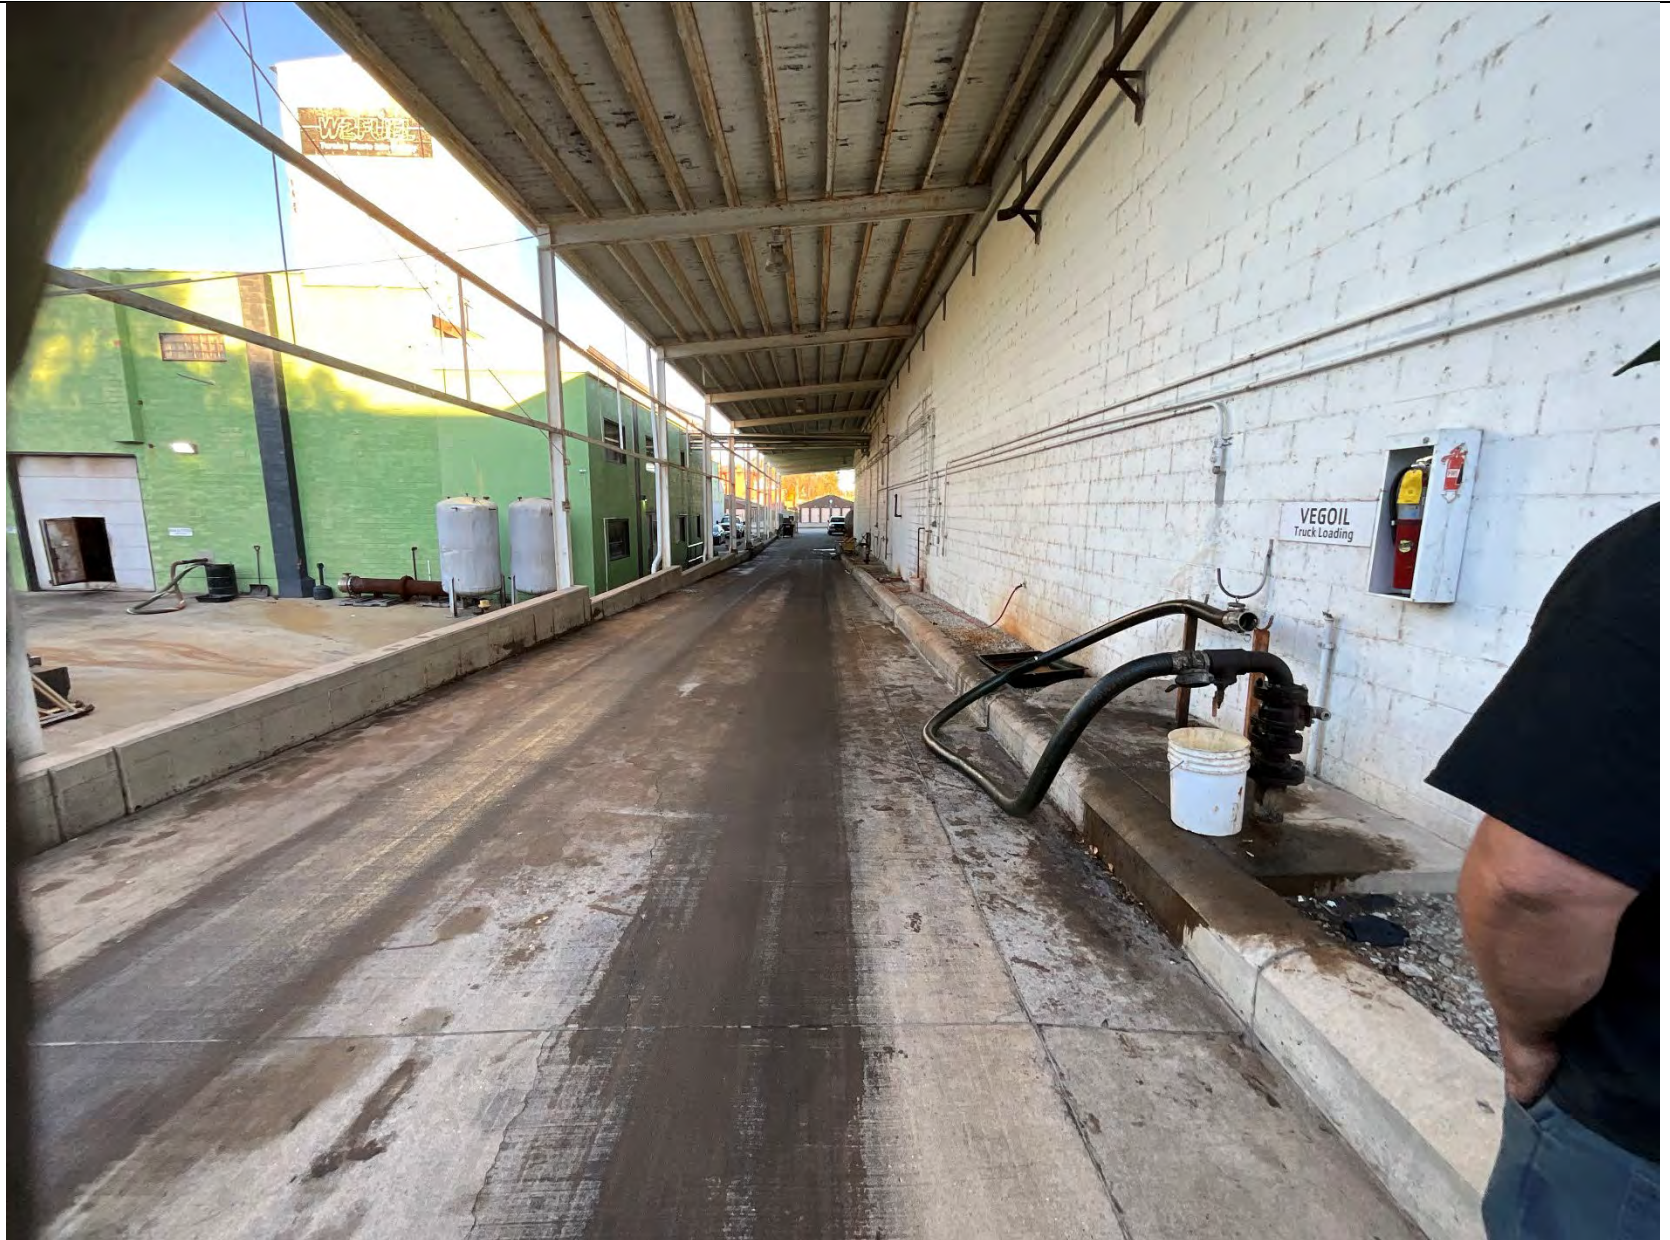
63

View looking west from the methanol loadout at the truck loading driveway. The green building on the left is the warehouse and raw glycerin tank farm location.

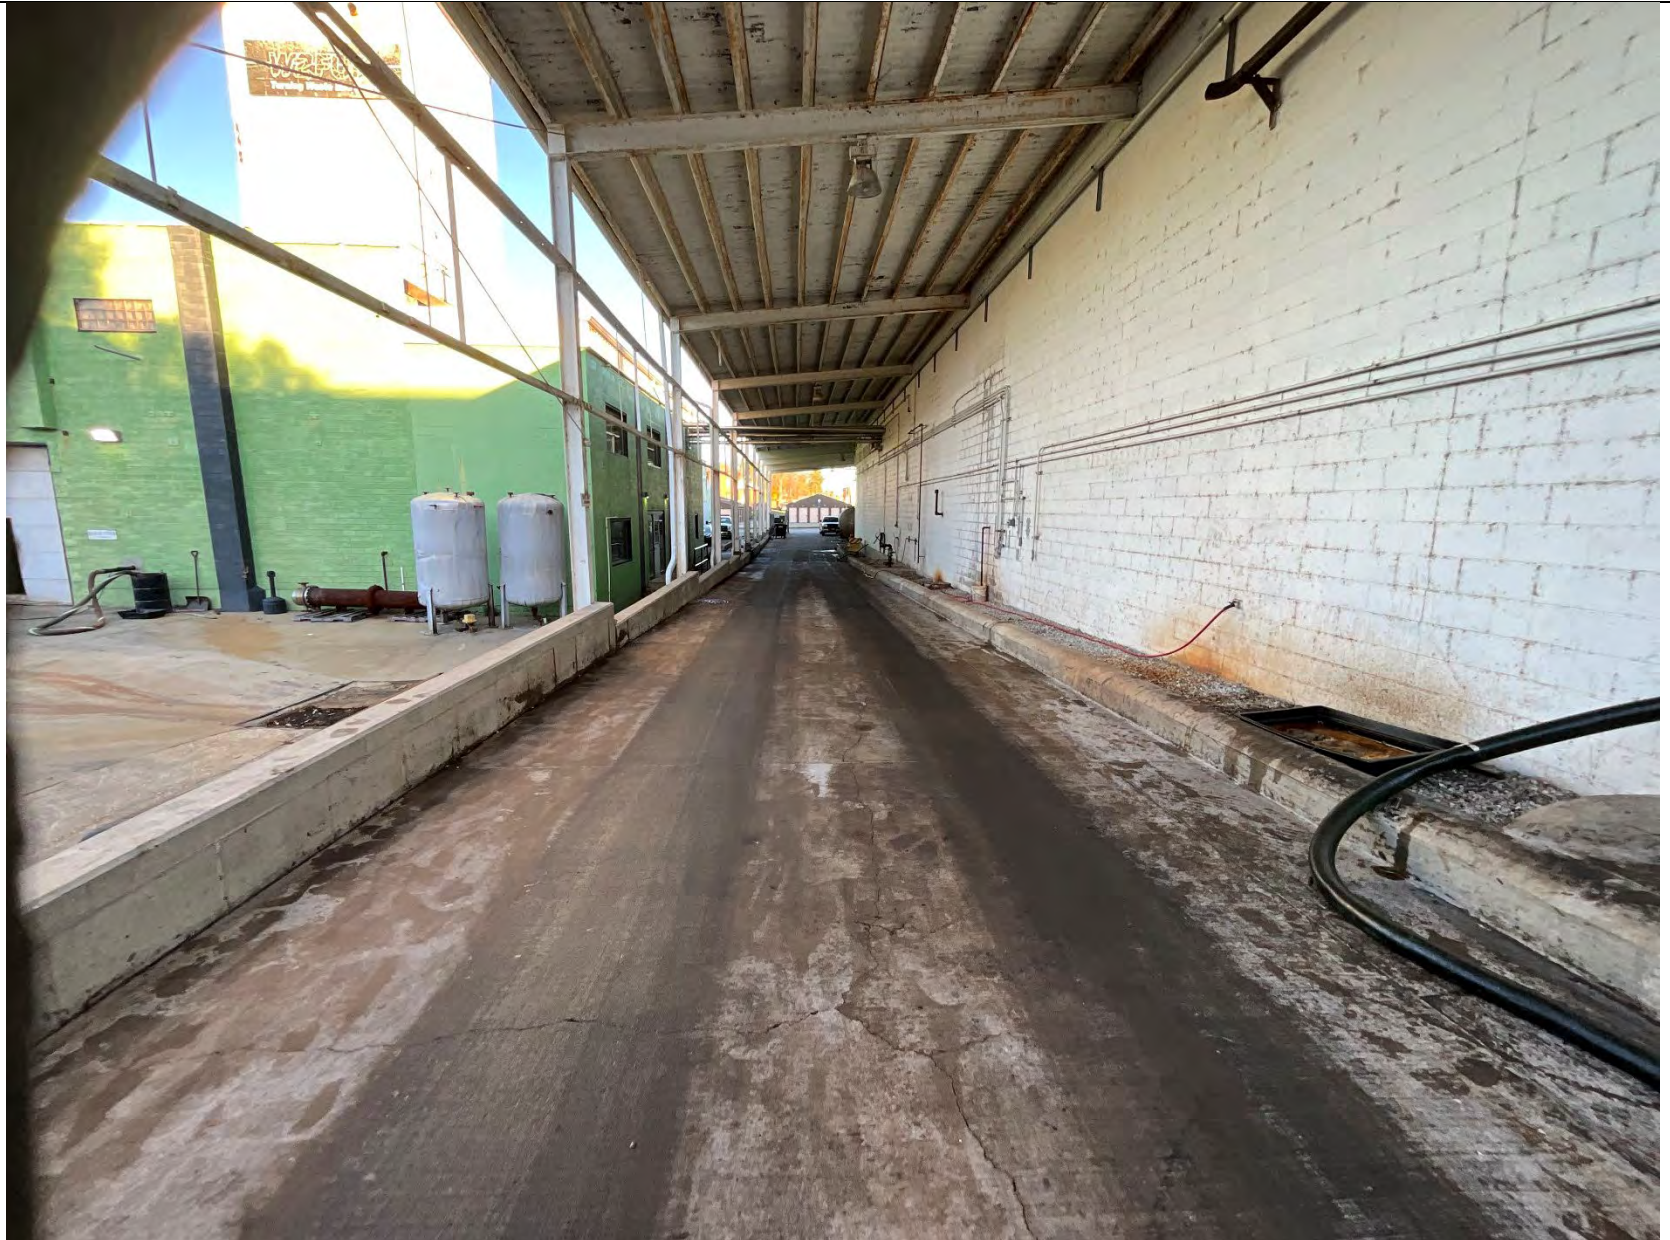
64

| 63 | IMG_0522.JPG | Similar view as Image 21. The vessels are unused from the previous biodiesel operation. | 2024:11:20 07:46:56 |

Similar view as Image 21. The vessels are unused from the previous biodiesel operation.

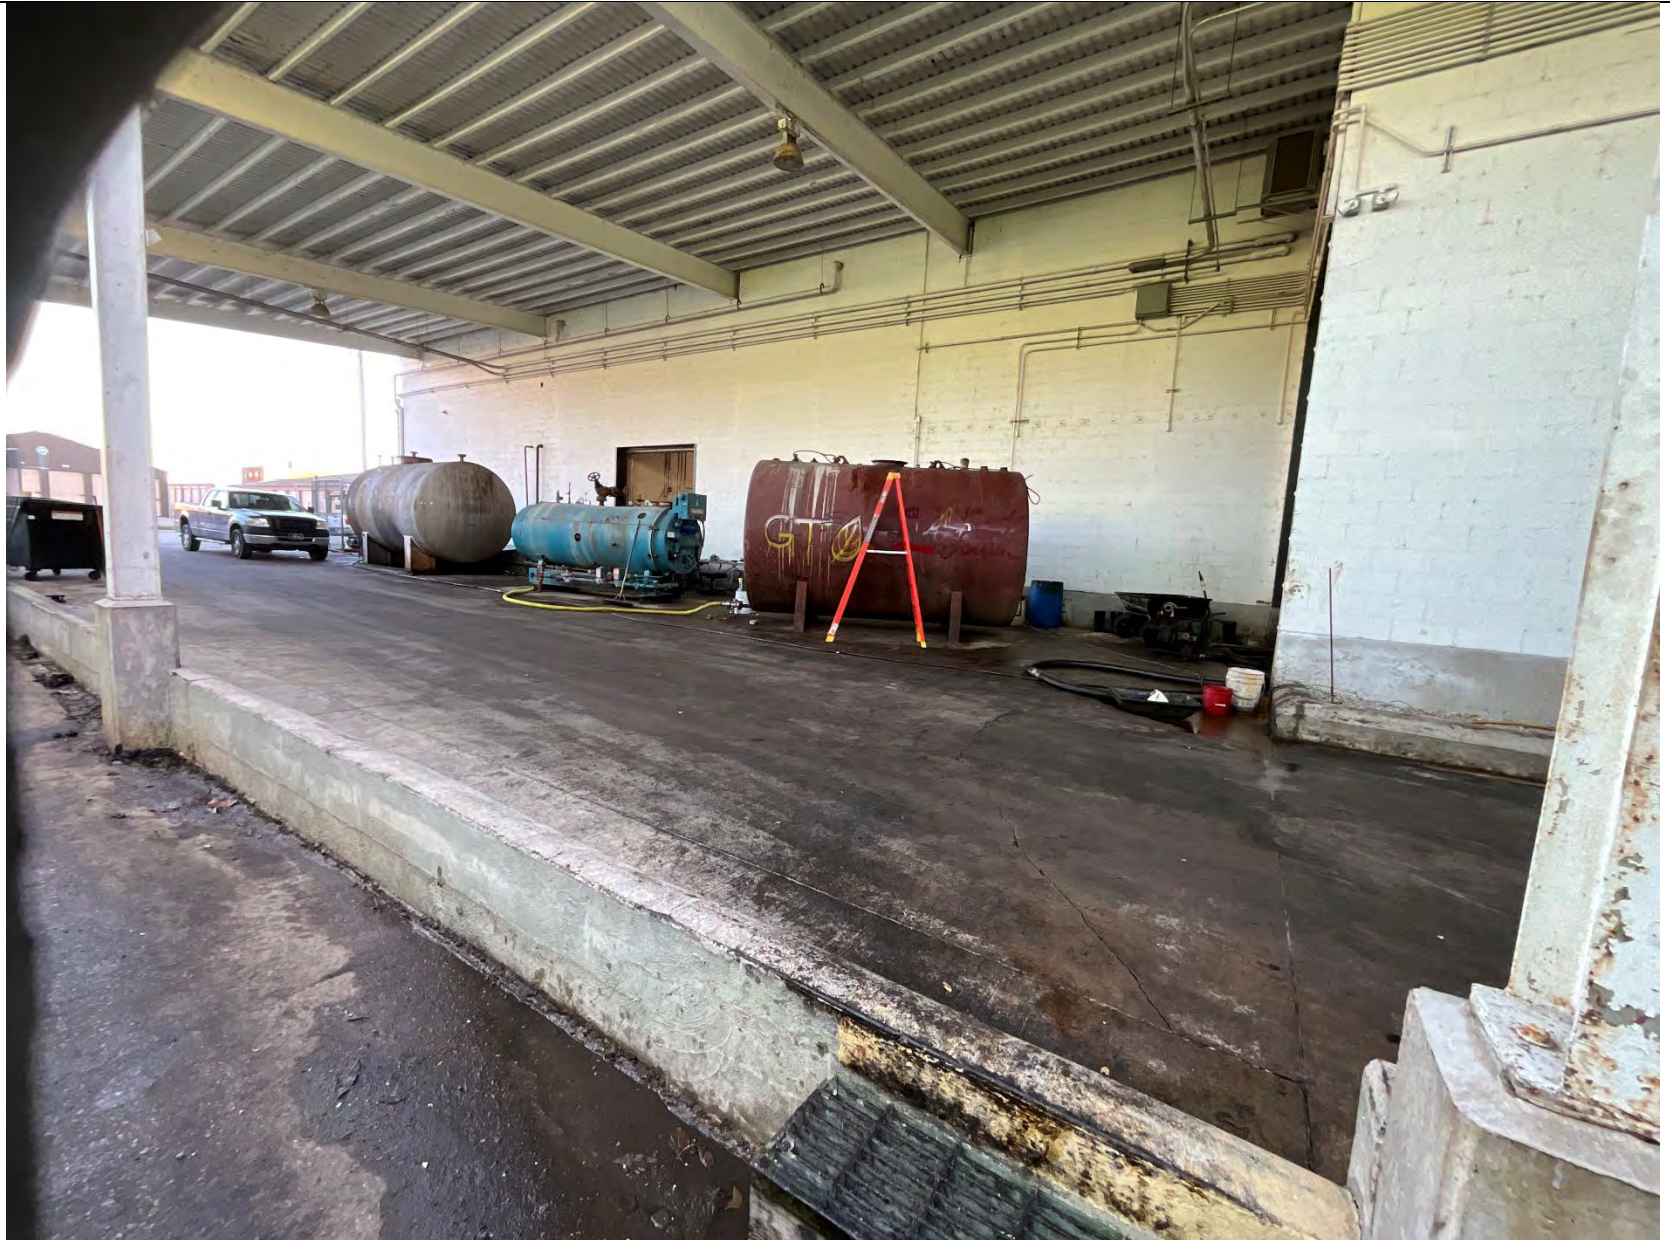
65

| 64 | IMG_0523.JPG | View of the tanks that were shown in Images 20 and 21 and also includes the boiler that was purchased to replace the current boiler but it as dropped during unloading and was damaged so it will not be used. There was a yellow hose connected to the tank that hadn't been the day prior. It was stated that this was going to temporarily store wastewater. | 2024:11:20 07:48:13 |

View of the tanks that were shown in Images 20 and 21 and also includes the boiler that was purchased to replace the current boiler but it as dropped during unloading and was damaged so it will not be used. There was a yellow hose connected to the tank that hadn't been the day prior. It was stated that this was going to temporarily store wastewater.

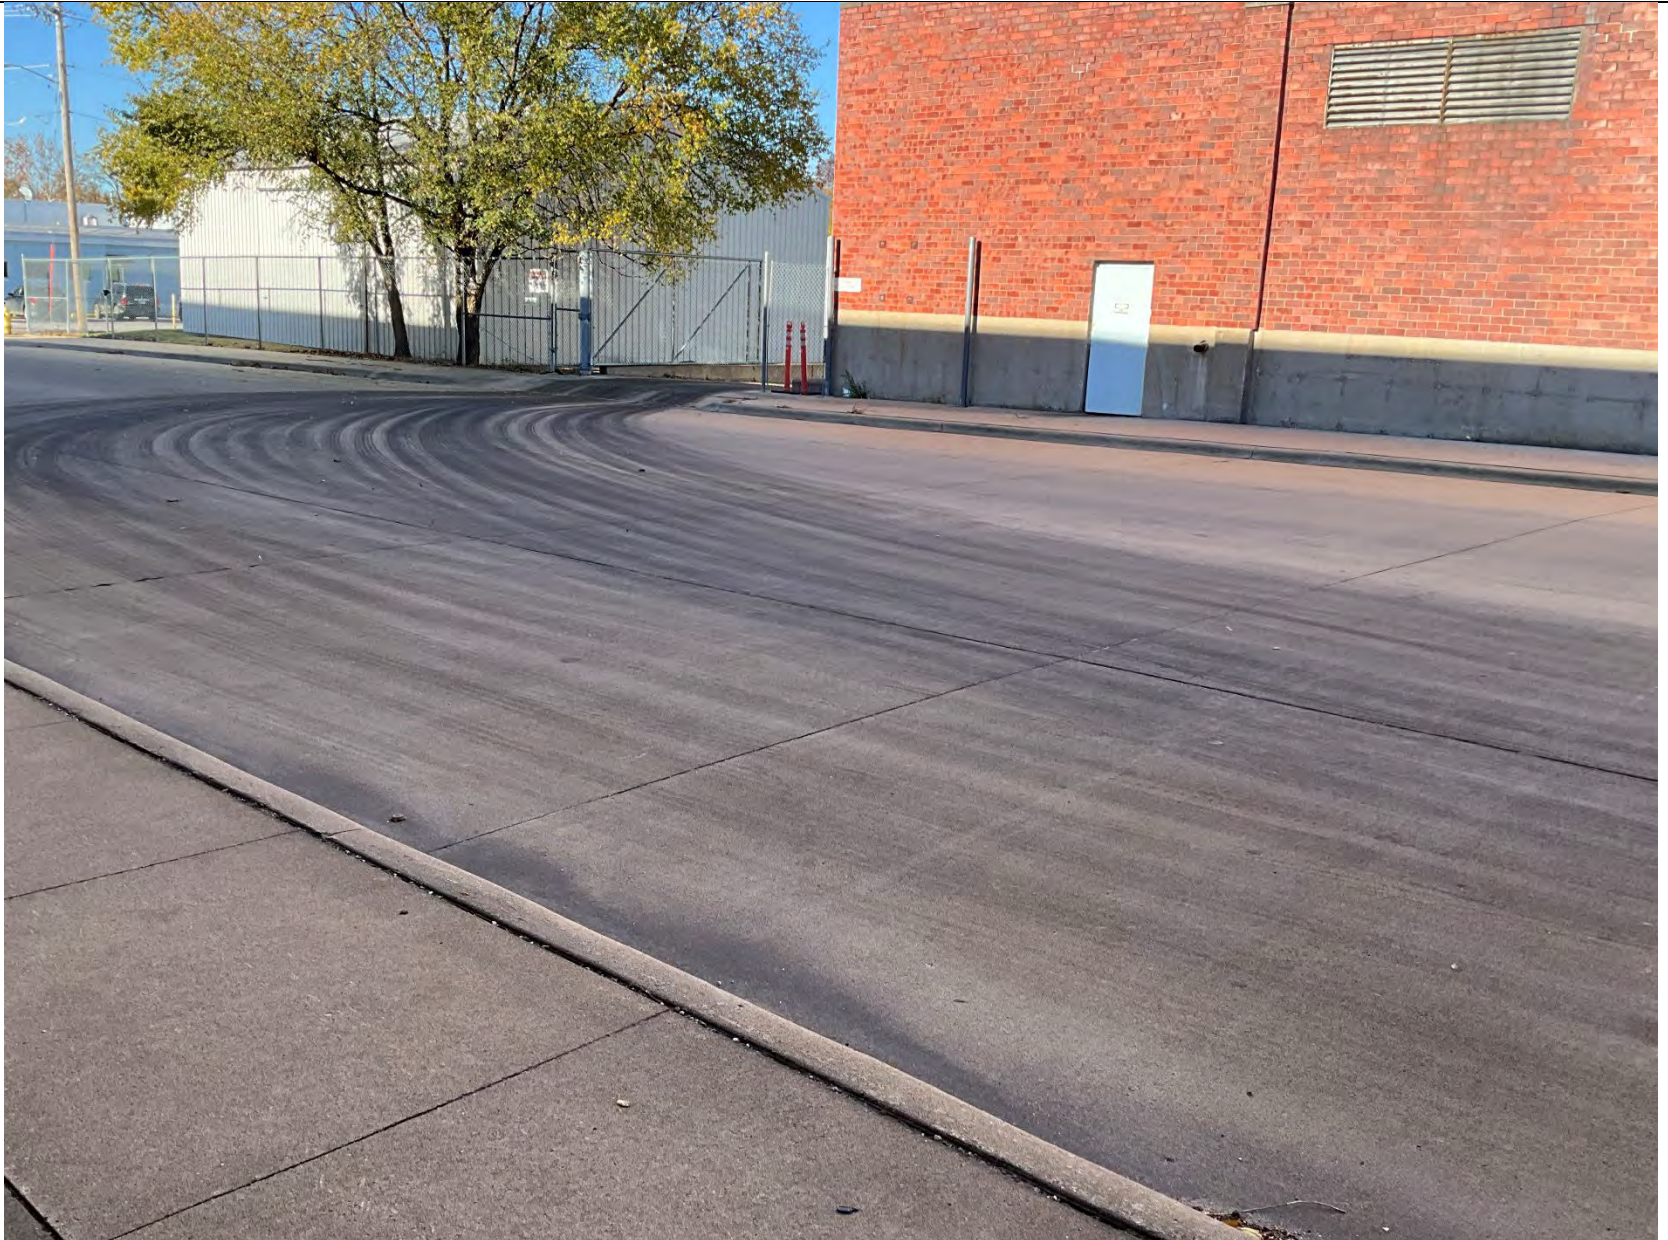
| 67 | IMG_0526.JPG | Similar image to Image 65. | 2024:11:20 09:59:23 |

Similar image to Image 65.
