**Region 6 Compliance Assurance and Enforcement Division  
INSPECTION REPORT**

| Inspection Date(s): | 08/8-9/2018 | | |
| Company Name: | <b>ConocoPhillips and Select Energy Services</b> | | |
| Facility Name: | <b>Conoco Phillips Pit</b> | | |

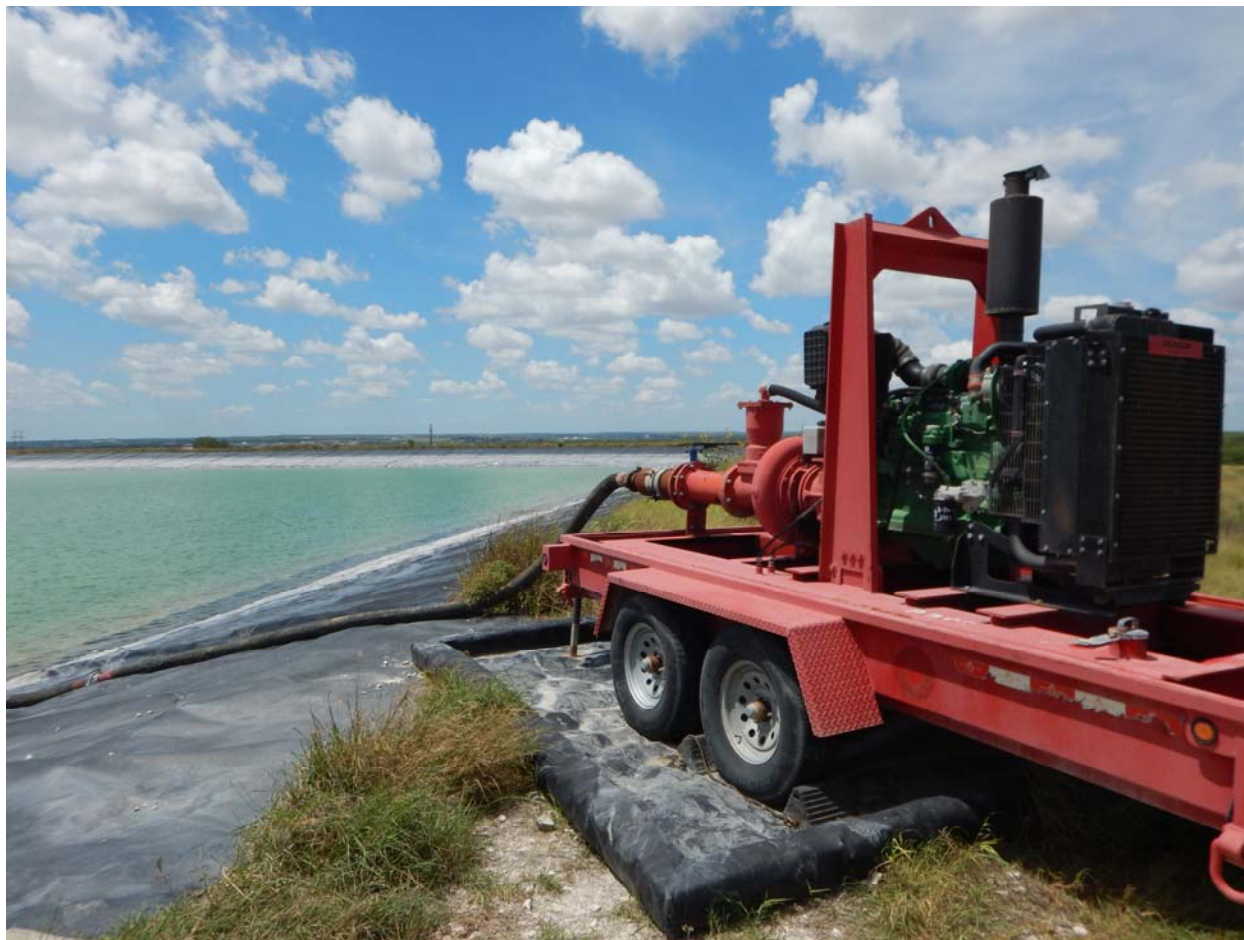
Photograph File Name: DSCN3606.JPG  
Date of Photograph: 08/09/2018  
Latitude: 28.852651 N  
Longitude: -97.854104 W  
Orientation: NE  
Map Datum: WGS-84  
Time of Photo: 12:23 AM  
Photographer: Jack Arias  
Description: This image shows a pump that transfers fluids from pit to flowlines.

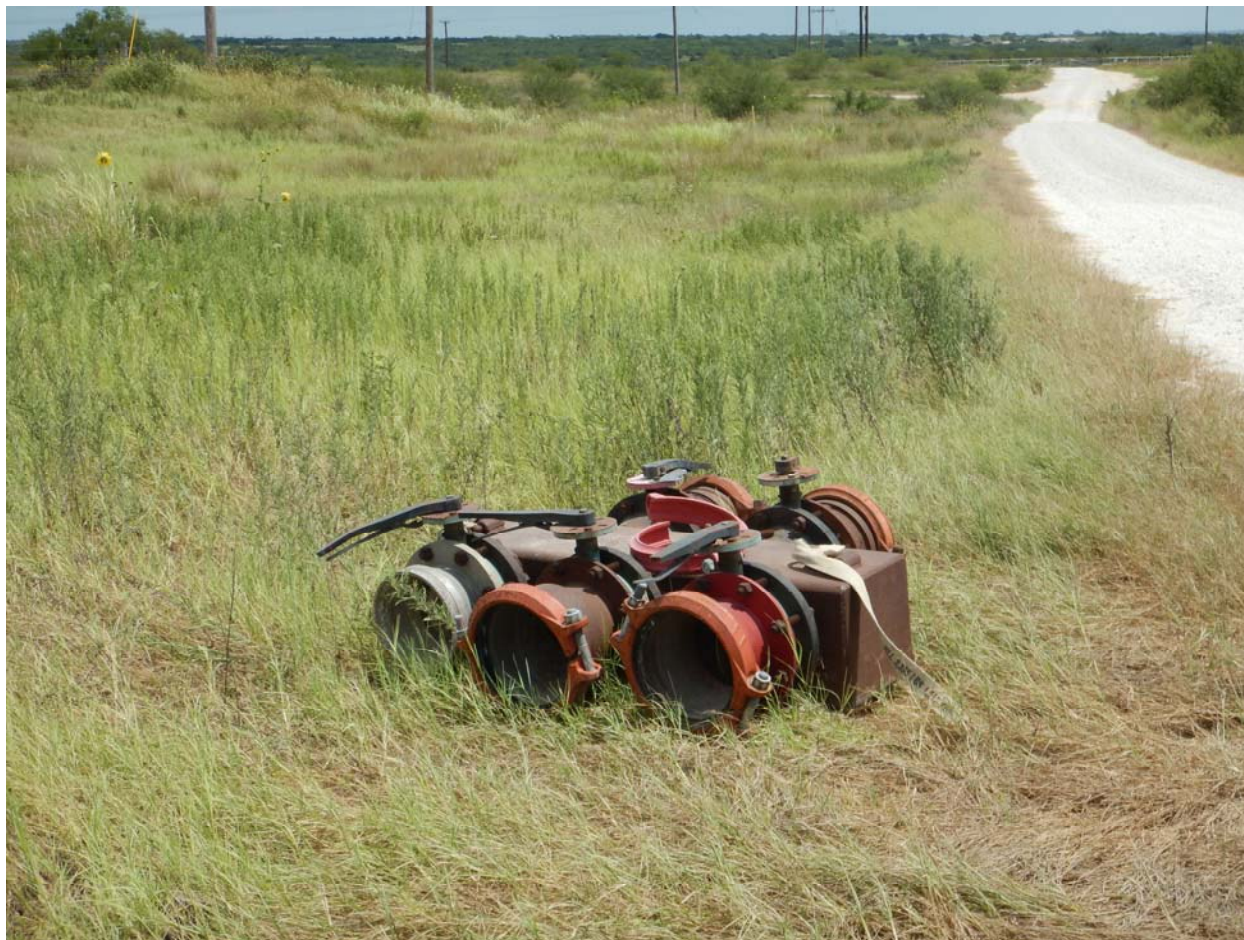
Photo No. 21

After I finished collecting TDS readings and observations at the pit, I followed the flow lines downstream from the pit. I observed that flowlines near the pit and downstream of the pit still contained saline water. (See Photo Nos. 21 – 23 in Appendix 1).

Photograph File Name: DSCN3609.JPG  
Date of Photograph: 08/09/2018  
Latitude: 28.853230 N  
Longitude: -97.854176 W  
Orientation: NE  
Map Datum: WGS-84  
Time of Photo: 12:34 PM  
Photographer: Jack Arias  
Description: This image shows a pump and flowlines connections used to transport fluids from pit to flowlines.

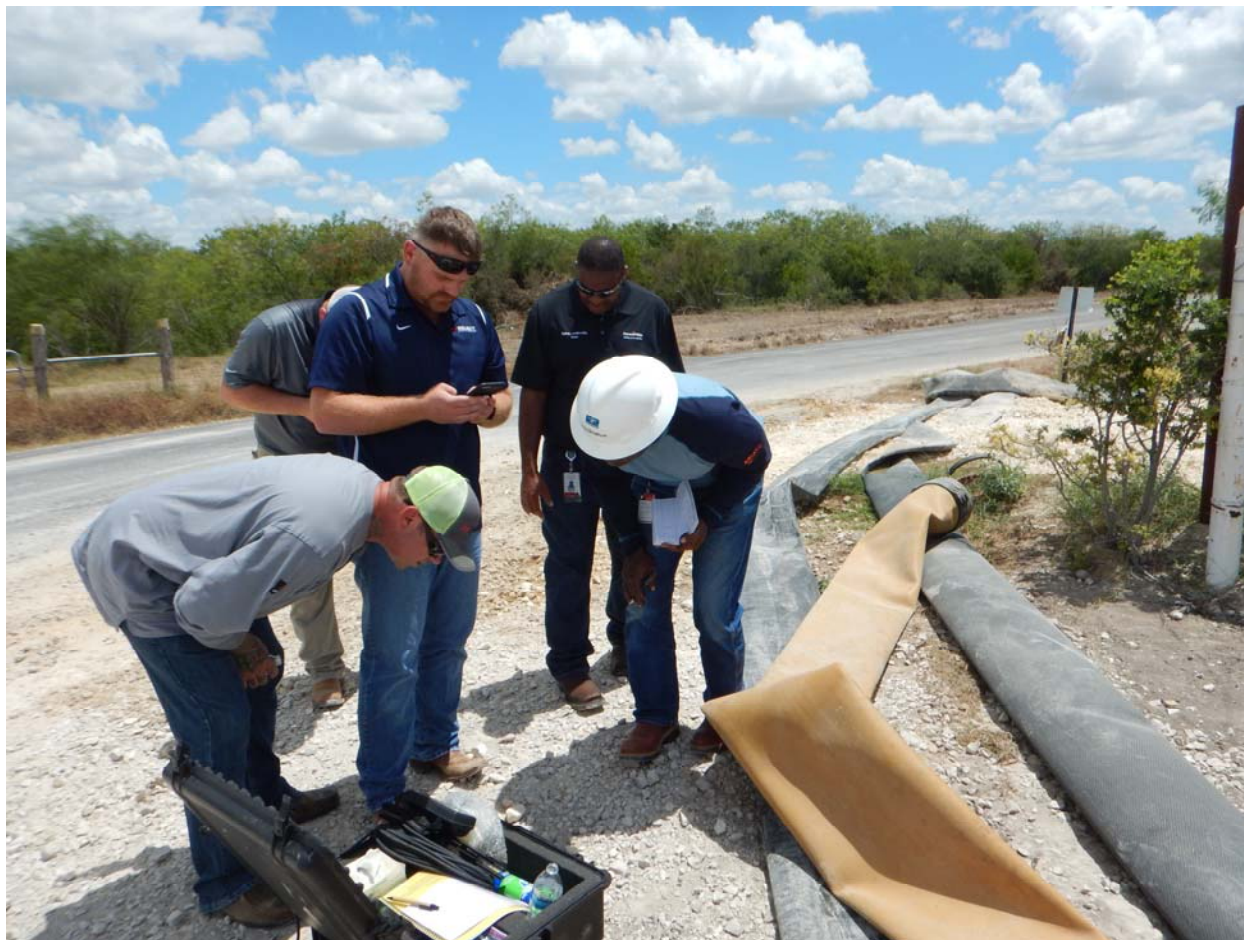
Photo No. 24

Description: This image shows Select Energy Services, ConocoPhillips, and EPA conducting a reading for TDS and salinity.

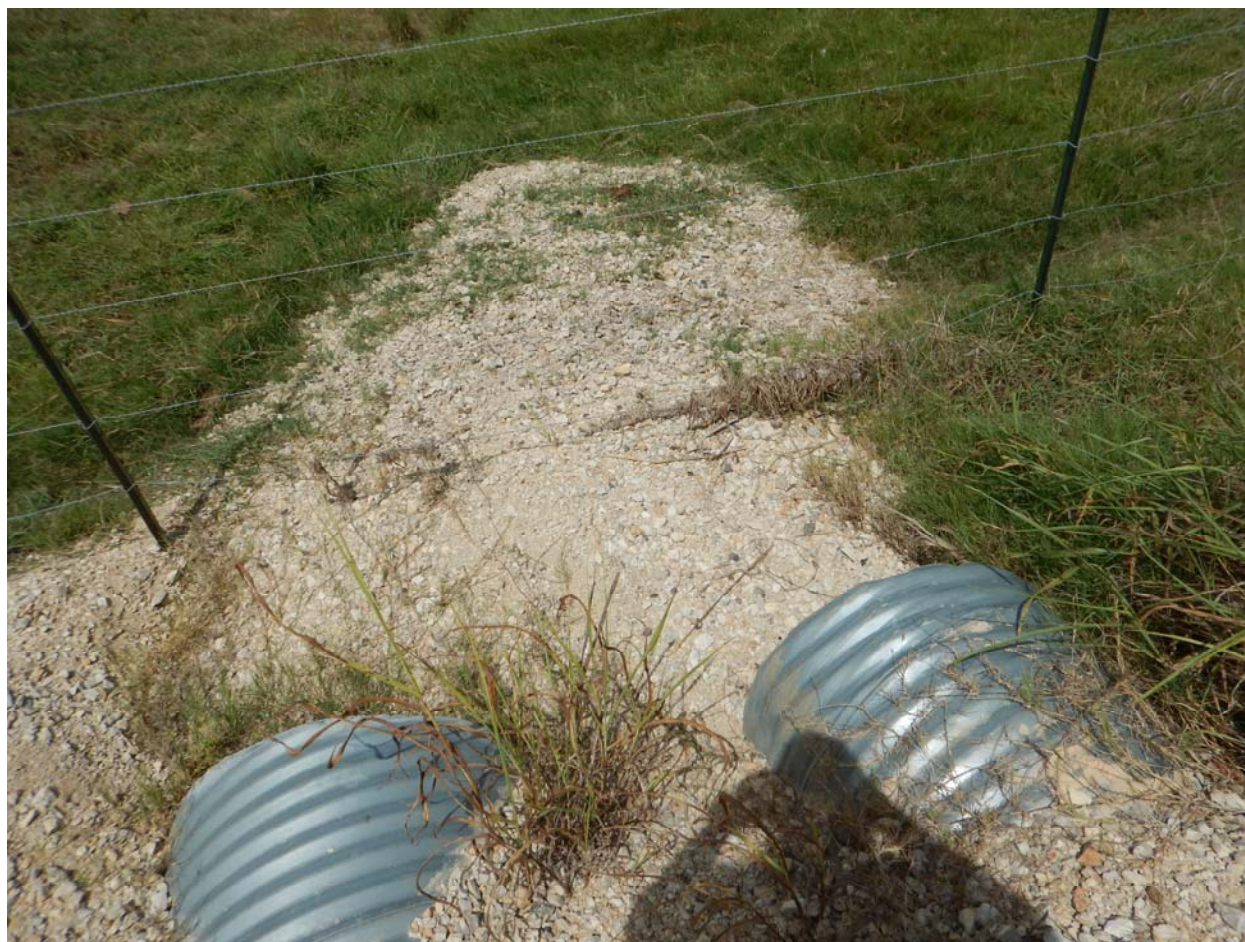
Photo No. 26

I followed the tributary upstream to determine if higher lying areas of the tributary were impacted by saline water discharges. I followed the flow path upstream from the point of entry to the tributary of Dry Escondido Creek and at approximately 150 feet from the point of discharge to the tributary (pond) at latitude 28.875168 N and longitude -97.880249 W. At this point using a calibrated YSI 30 Pro Conductivity Meter, I took a Total Dissolved Solids (TDS) measurement of 244 ppm. Now, I observed vegetation, defined bed and bank, high water marks, debris, and riparian vegetation growing along the tributary. (See Photo Nos. 26 – 29 in Appendix 1).

Photograph File Name: DSCN3622.JPG  
Date of Photograph: 08/09/2018  
Latitude: 28.875168 N  
Longitude: -97.880249 W  
Orientation: NE  
Map Datum: WGS-84  
Time of Photo: 3:41 PM  
Photographer: Jack Arias  
Description: This image shows an upstream flow path of the tributary of Dry Escondido Creek.

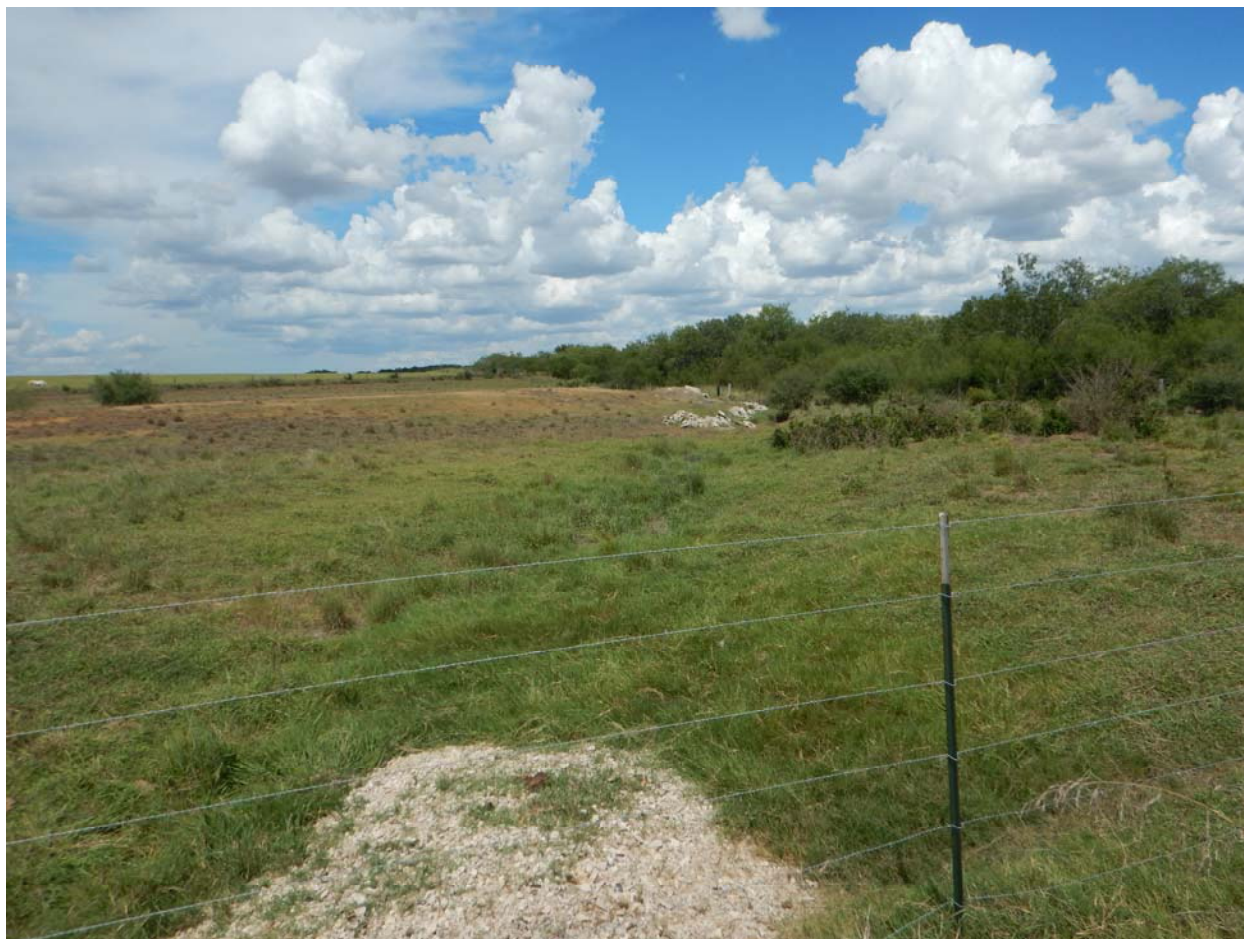
Photo No. 27

Photograph File Name: DSCN3623.JPG  
Date of Photograph: 08/09/2018  
Latitude: 28.875168 N  
Longitude: -97.880249 W  
Orientation: NE  
Map Datum: WGS-84  
Time of Photo: 3:41 PM  
Photographer: Jack Arias  
Description: This image shows an upstream flow path of the tributary of Dry Escondido Creek.
