## EPA Region 10 Enforcement Division

### INSPECTION REPORT

| Type of Inspection | CEI - Compliance Evaluation Inspection | |
| Company Name | Western Washington University (WWU) | |

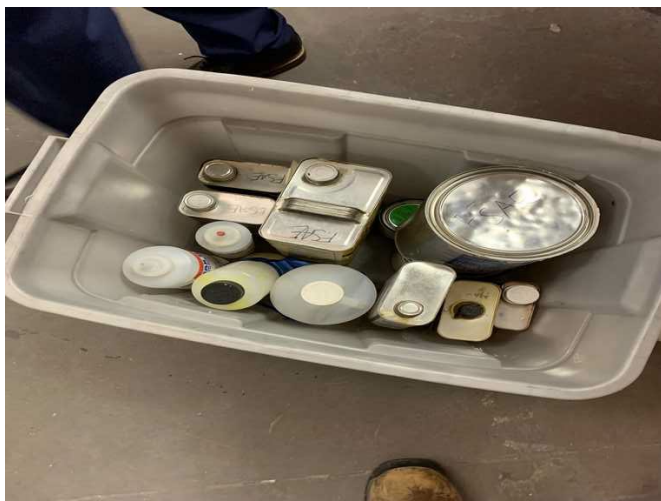
| [Title] | IMG_0266.jpg | |

| View of a plastic tote that contains waste that was generated by a previous employee on 9/10/22. The waste seen in the tote has not yet had a waste determination. | | |

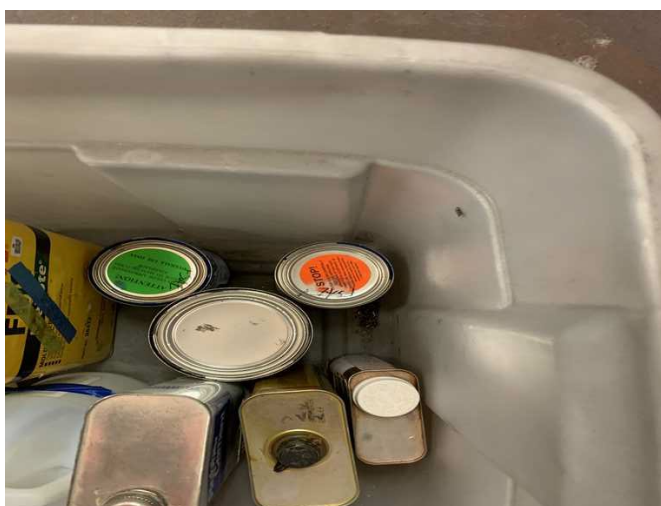
| [Title] | IMG_0267.jpg | |

| Another view of the plastic tote that contains waste that was generated by a previous employee on 9/10/22. The waste seen in the tote has not yet had a waste determination. | | |

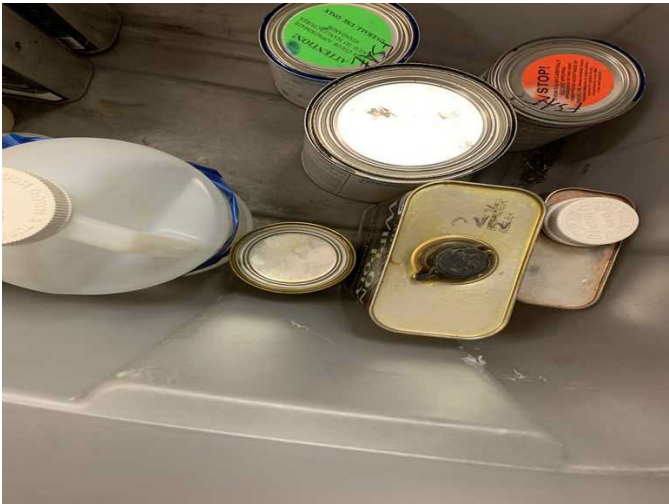
| [Title] | IMG_0268.jpg | |

| Another view of the plastic tote that contains waste that was generated by a previous employee on 9/10/22. The waste seen in the tote has not yet had a waste determination. | | |

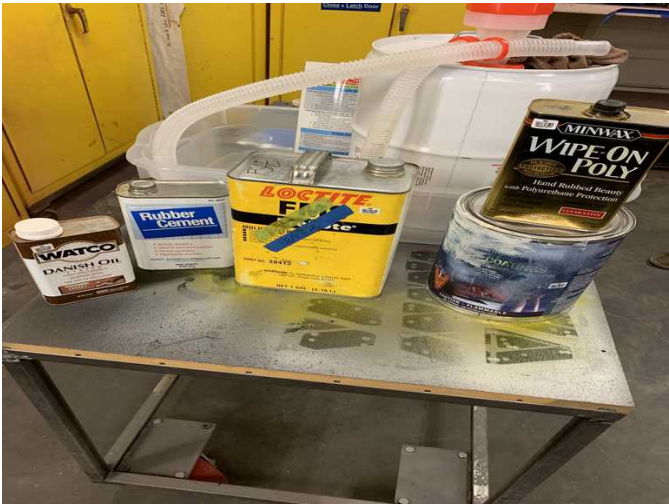
| [Title] | IMG_0269.jpg | |

| View of the wastes that were in the plastic tote and require a waste determination. | | |

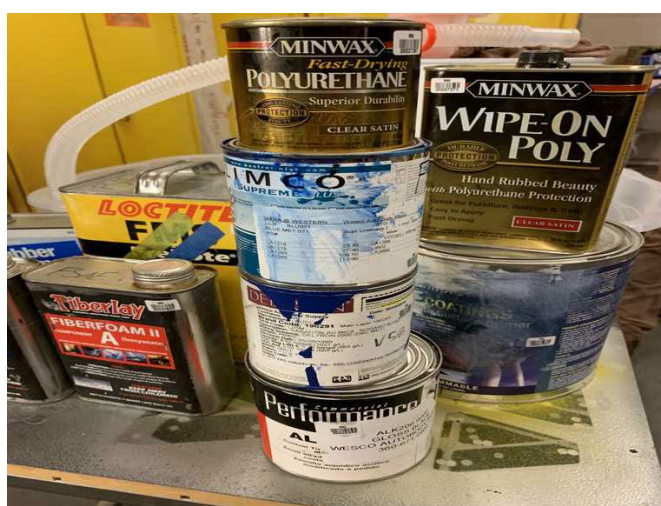
| [Title] | IMG_0275.jpg | |

| Another view of the wastes that were in the plastic tote and require a waste determination. | | |

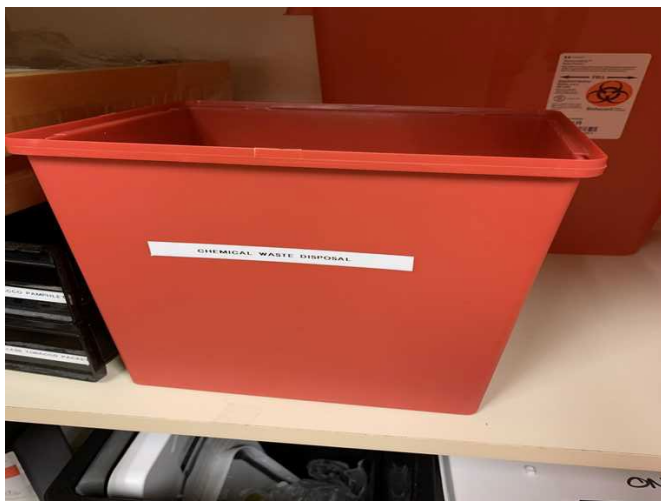
| [Title] | IMG_0095.jpg | |

| View of the container holding waste formalin | | |

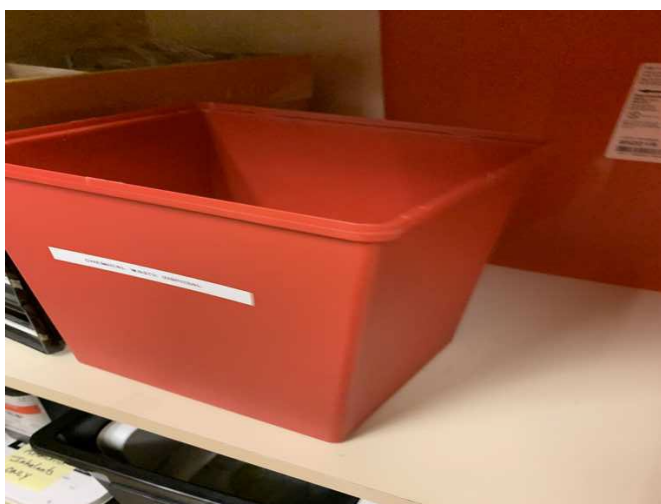
| [Title] | IMG_0096.jpg | |

| Another view of the same container seen in IMG_0095, that holds Waste formalin. | | |

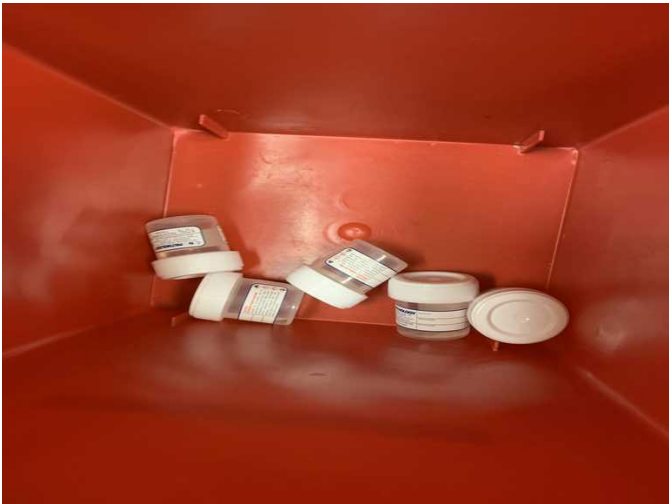
| [Title] | IMG_0097.jpg | |

| View inside container seen in IMG_0095 and IMG_0096 showing the waste formalin. | | |

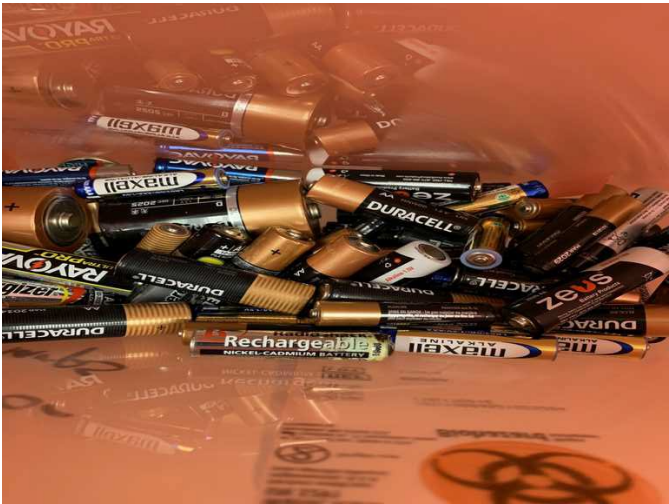
| [Title] | IMG_0098.jpg | |

| View of waste batteries in container. A waste nickel-cadmium battery can be seen at the bottom of the photo. | | |

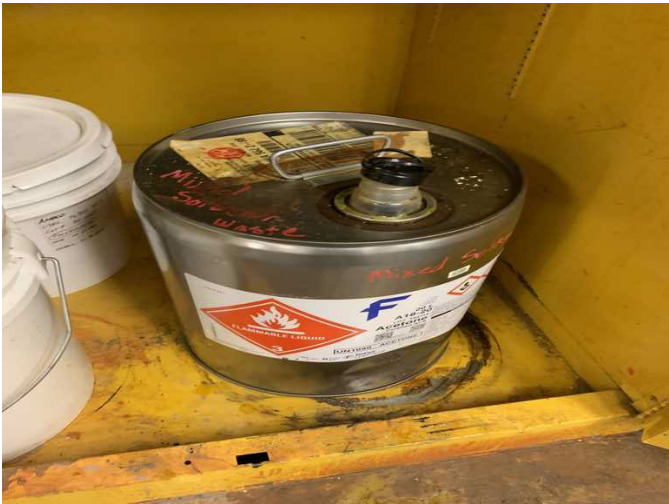
| [Title] | IMG_0263.jpg | |

| Close-up view of the same container seen in IMG_0262.jpg. The waste container is not labeled with the words "Hazardous Waste." The container lid is also seen here, not making a complete seal to close the container. | | |

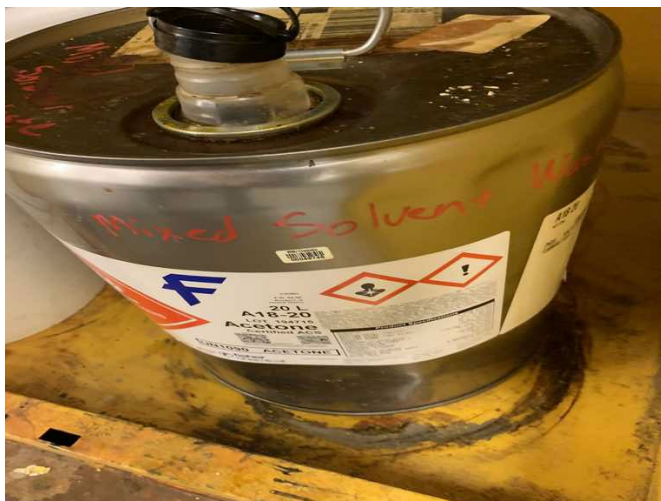
| [Title] | IMG_0265.jpg | |

| Another close-up view of the top of the waste container, seen here marked with the words, "Mixed Solvent Waste." The container is not marked with a hazardous waste label. The container lid is also seen here, not making a complete seal to close the container. | | |

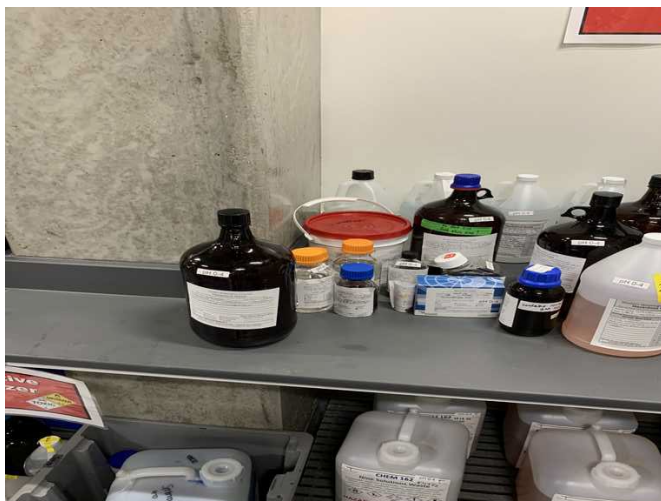
| [Title] | IMG_0233.jpg | |

| View of a 1-gallon brown, glass container holding hazardous waste that is not marked with a hazard risk/indicator. Container is seen here in the front, on the left side in the photo. | | |

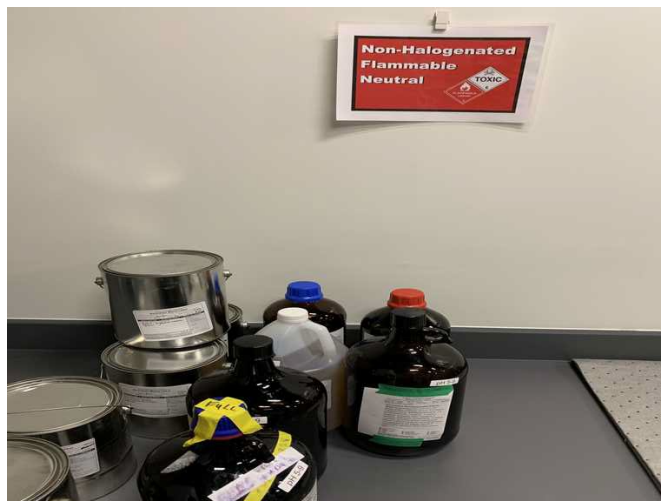
| [Title] | IMG_0237.jpg | |

| View of the "Non-Halogenated Flammable Neutral Area" of the CAA. The 1-gallon, metal waste container seen here on the left, is not marked with a hazard risk/indicator. | | |

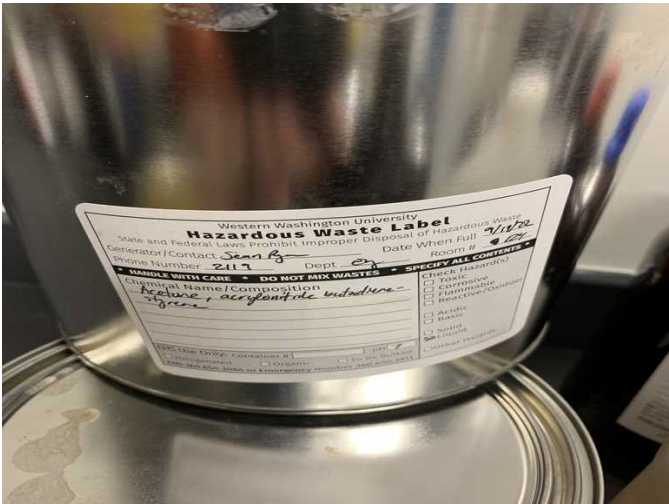
| [Title] | IMG_0239.jpg | |

| Close-up view of the label on the 1-gallon, metal waste container showing that it is not marked with a hazard risk/indicator. | | |

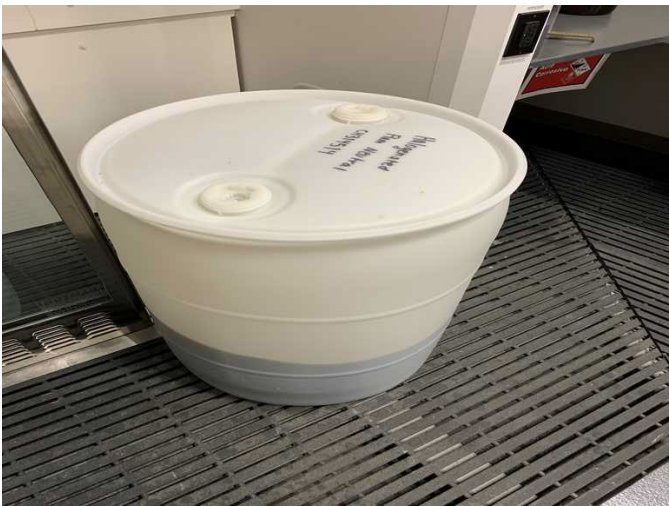
| View of a 55-gallon hazardous waste container that is located just outside of a stand-up fume hood. The container is seen here labeled as "Halogenated Flammable Neutral Waste." The container is not labeled with the words "Hazardous Waste" or marked with a hazard risk/indicator. | | |

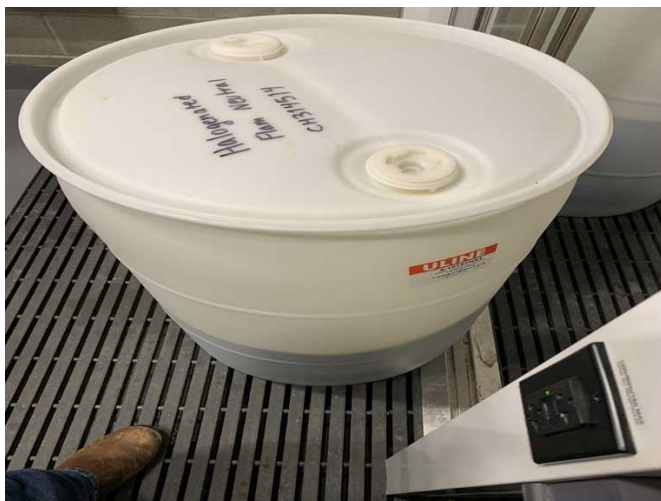
| [Title] | IMG_0242.jpg | |

| Another view of the same waste container, seen in IMG_0240.jpg and IMG_0241.jpg, show here with no hazardous waste label or hazard risk/indicator. | | |

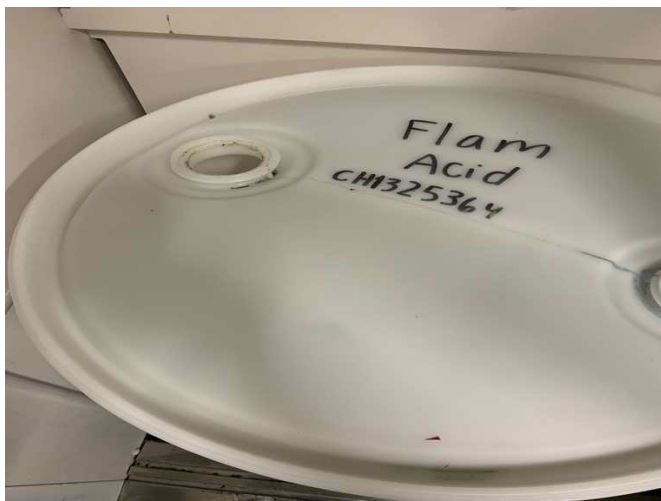
| [Title] | IMG_0244.jpg | |

| View of another 55-gallon hazardous waste container, seen here inside of the stand-up fume hood, that is labeled with the words, "Flam Acid Waste." The container is not marked with a hazardous waste label or a hazard risk/indicator. | | |

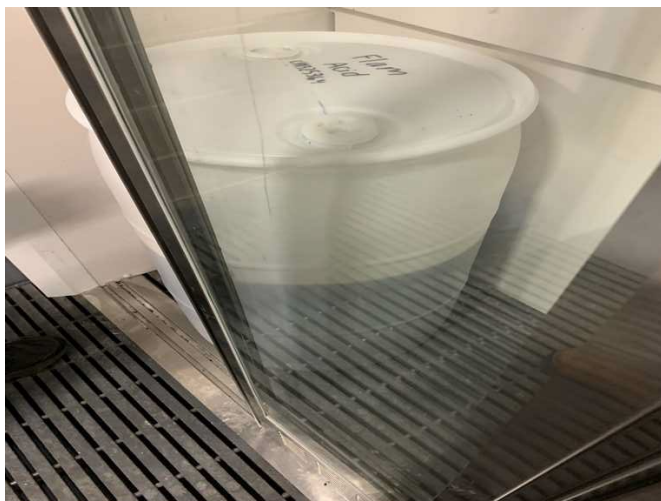
| [Title] | IMG_0246.jpg | |

| Another view of the same container, seen in IMG_0244.jpg and IMG_0245.jpg, showing that it is not marked with a hazardous waste label or a hazard risk/indicator. | | |

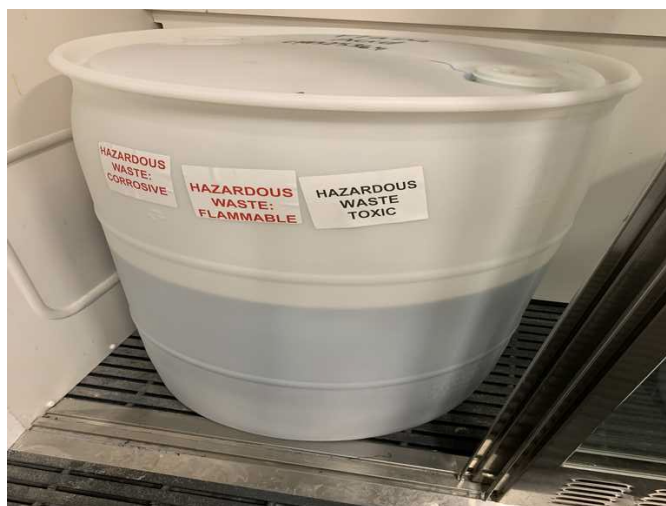
| [Title] | IMG_0249.jpg | |

| View of the waste container after being labeled with the words, "Hazardous Waste" and marked with a hazard risk/indicator. | | |

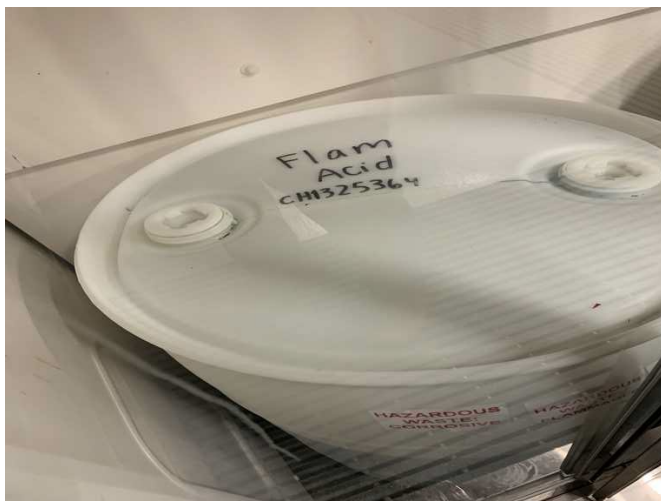
| [Title] | IMG_0250.jpg | |

| View of the flammable acid waste container after being closed. | | |

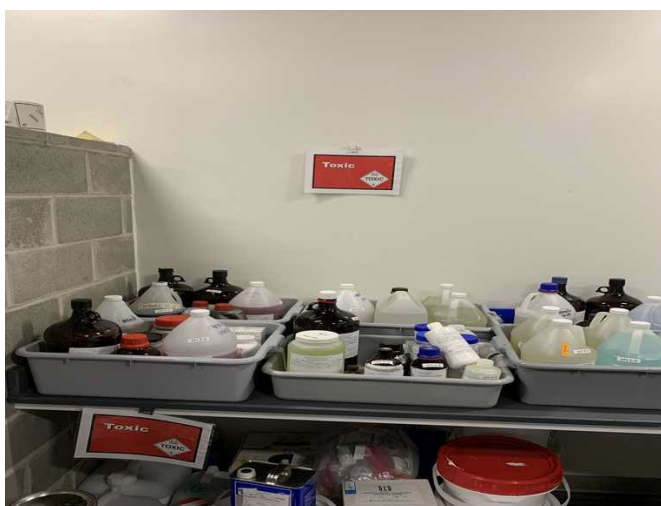
| [Title] | IMG_0228.jpg | |

| View of the hazardous waste being accumulated in the "Toxic Area" of the CAA. | | |

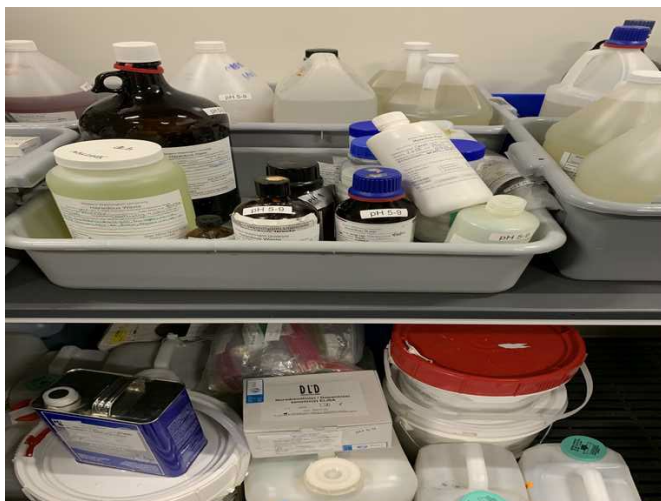
| [Title] | IMG_0229.jpg | |

| View of a white, pint sized container of hazardous waste, seen here sticking up in the center bin on the table. The container is not marked with a hazard risk/indicator. | | |

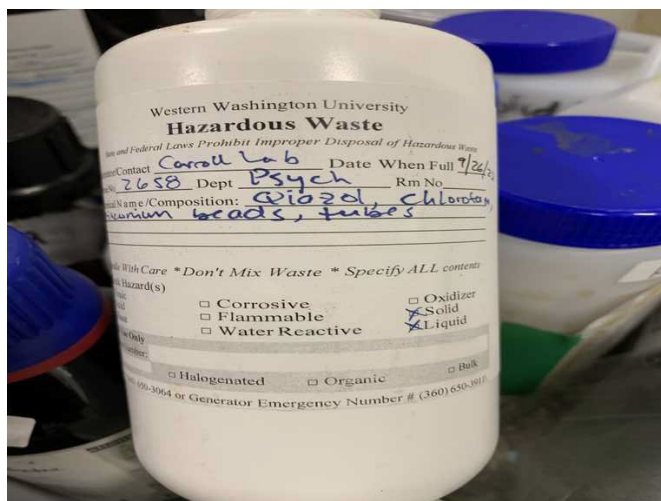
| [Title] | IMG_0231.jpg | |

| Another view of the same waste container, seen in IMG_0230.jpg, showing that it is not marked with a hazard risk/indicator. | | |

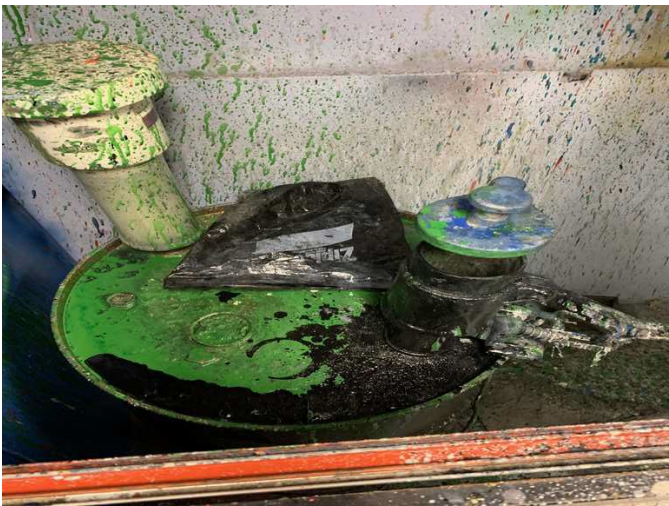
| [Title] | IMG_0209.jpg | |

| View of the top of the waste container, showing the aerosol can popping device and filter attached to the container. | | |

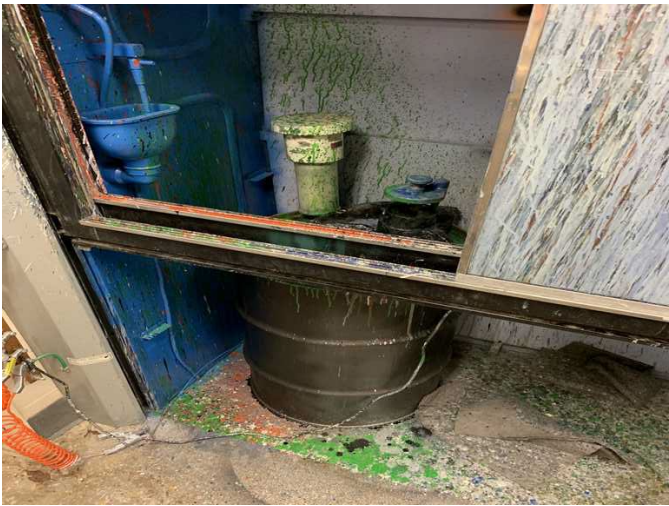
| [Title] | IMG_0210.jpg | |

| Another view of the floor size fume hood with the waste container used to accumulate residue from puncturing waste aerosol cans. | | |

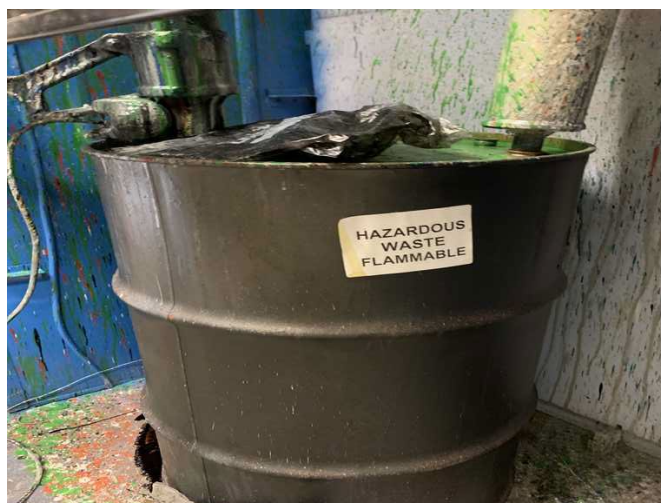
| [Title] | IMG_0215.jpg | |

| View of the hazardous waste label and hazard risk/indicator on the waste container. | | |

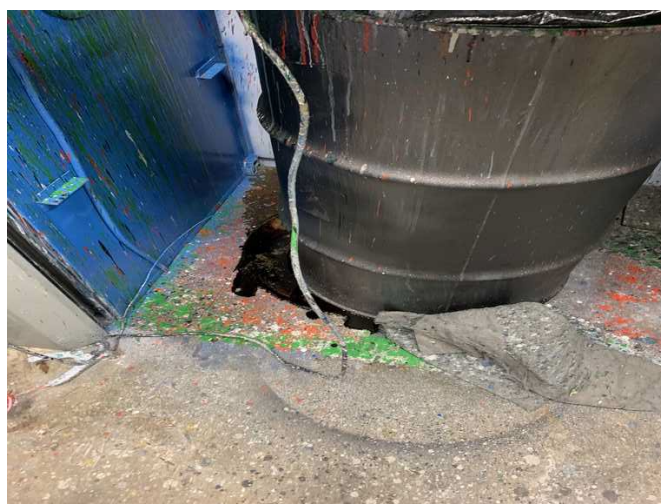
| [Title] | IMG_0216.jpg | |

| View of the bottom of the container, seen here after the container was turned, showing waste aerosol residue coming from underneath the container. | | |

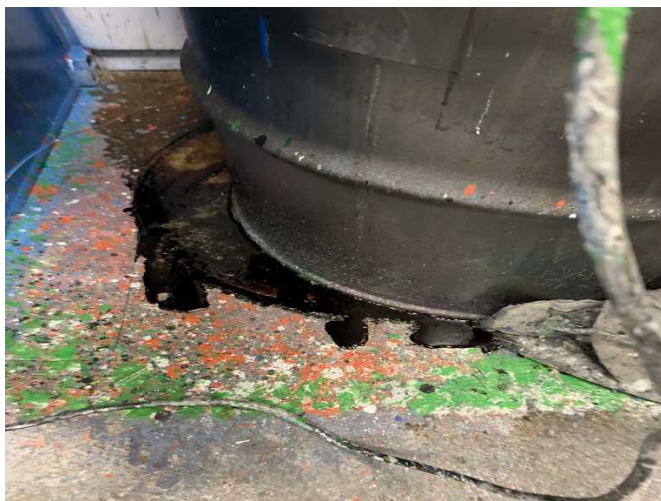
| [Title] | IMG_0217.jpg | |

| Closer view of the waste residue running out from beneath the container. | | |

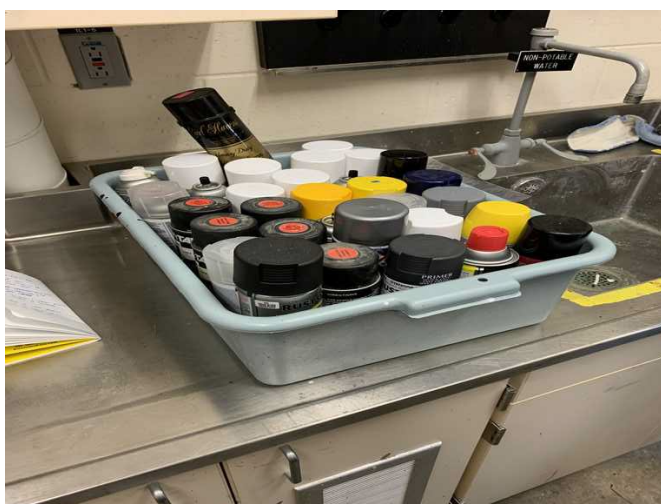
| [Title] | IMG_0219.jpg | |

| View of a plastic bin on the counter, directly across from the floor size fume hood, that contains waste aerosol cans to be punctured. The waste aerosol cans are seen here without any hazardous waste labeling or hazard risk/indicators. | | |

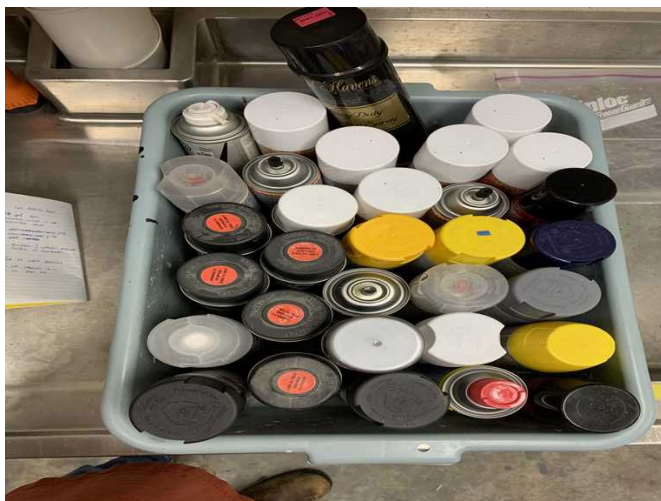
| [Title] | IMG_0220.jpg | |

| View of the waste aerosol cans in the plastic bin. | | |

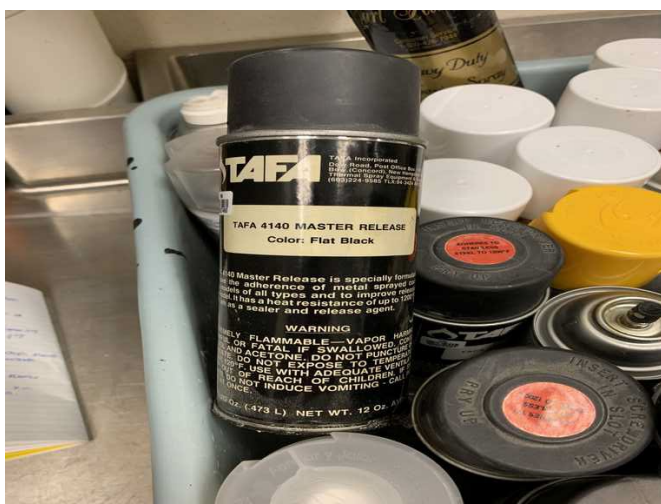
| [Title] | IMG_0221.jpg | |

| View of an individual waste aerosol taken from the bin to show the hazard markings on the can. | | |

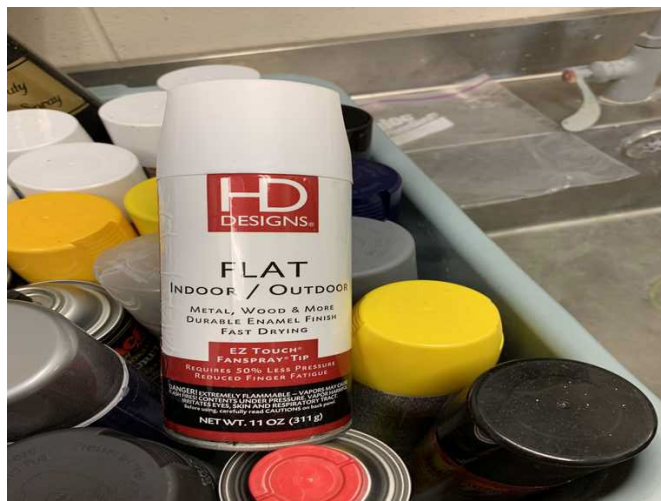
| [Title] | | IMG_0222.jpg | |

| View of another waste aerosol can, taken from the bin, to show the hazard markings and warnings on the can. | | | |

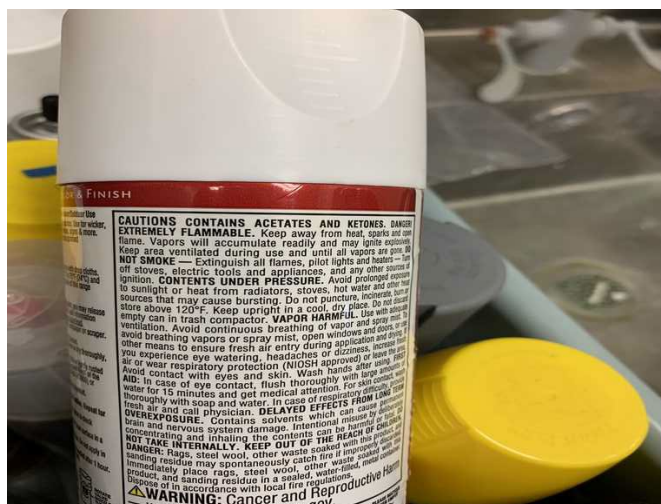
| [Title] | | IMG_0223.jpg | |

| View of the backside of the waste aerosol can, seen in IMG_0222.jpg, showing the hazard markings and warnings listed on the can. | | | |

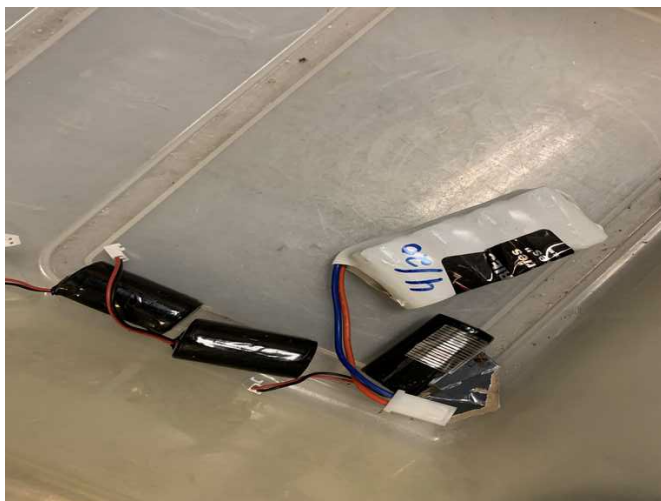
| [Title] | IMG_0120.jpg | |

| View of the waste batteries in the plastic tub. | | |

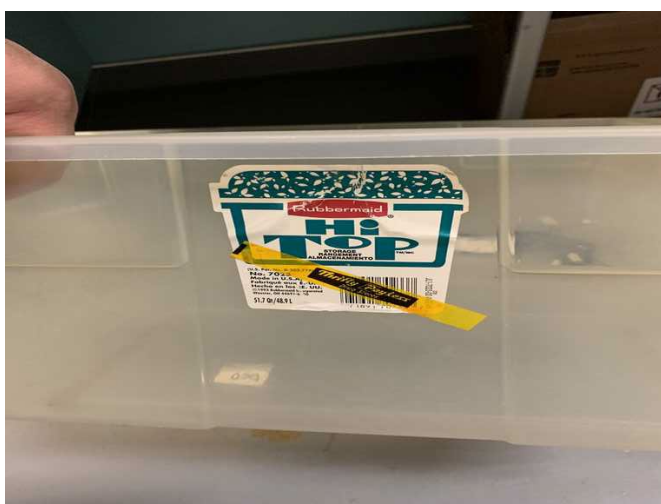
| [Title] | IMG_0121.jpg | |

| View of the plastic tub of waste batteries, showing that it is unlabeled and undated. | | |

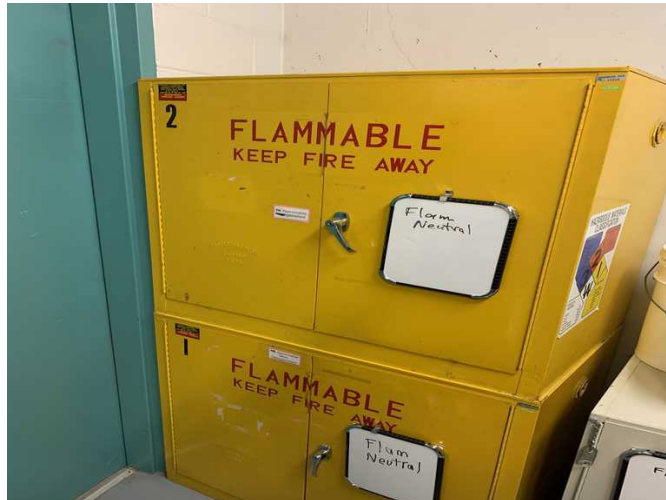
| [Title] | IMG_0122.jpg | |

| View of the stacked flammable storage cabinets, the one on top seen here contains waste. | | |

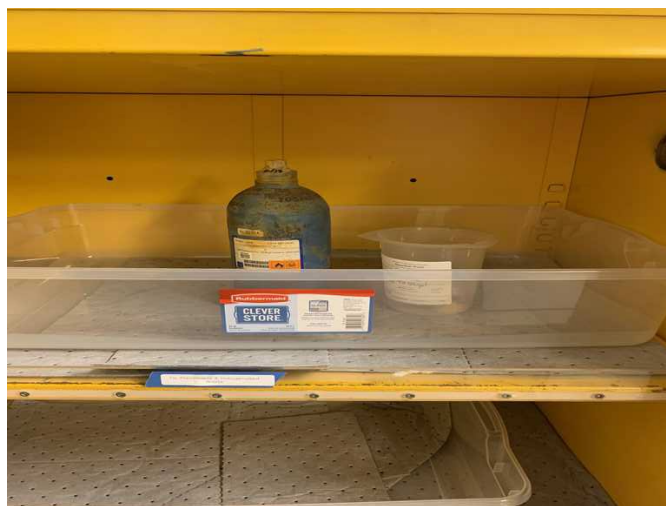
| [Title] | IMG_0123.jpg | |

| View of the interior of the flammable storage cabinet, showing accumulated waste in a plastic tub. | | |

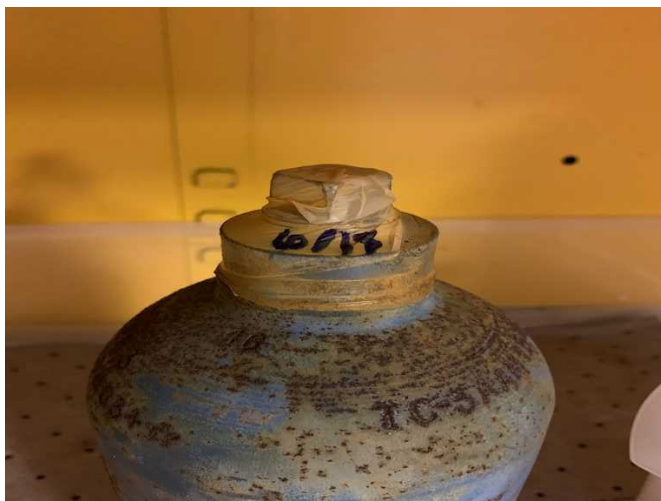
| [Title] | IMG_0128.jpg | |

| View of the date, "6/18", seen marked on the neck of the cylinder. | | |

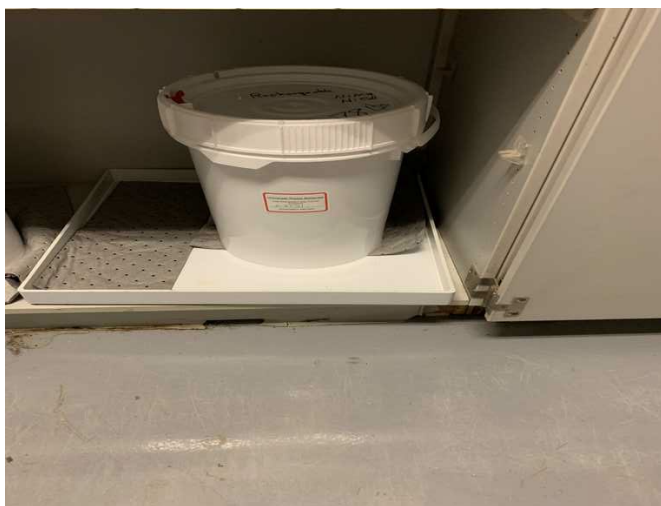
| [Title] | IMG_0133.jpg | |

| View of a waste battery container inside one of three waste battery accumulation areas. | | |

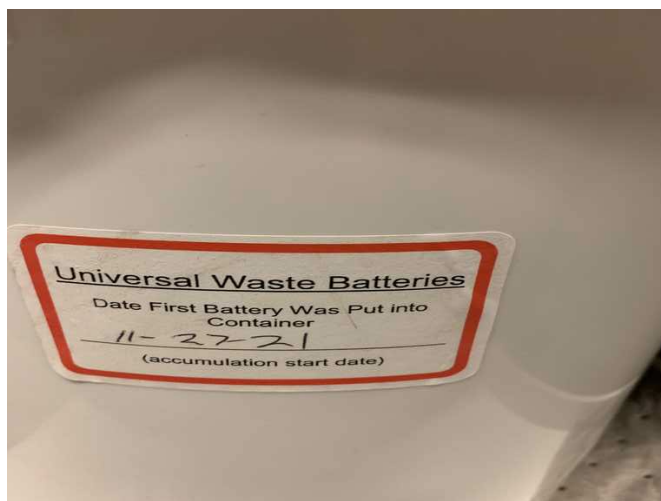
| [Title] | IMG_0134.jpg | |

| Close-up view of the label on the waste battery storage container seen in IMG_0133. | | |

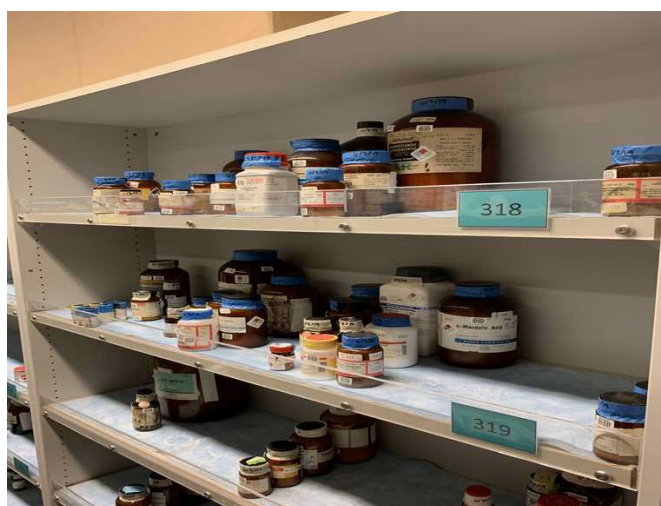
| [Title] | IMG_0190.jpg | |

| View of chemicals that were removed from decommissioned labs and have not been used since June of 2019. | | |

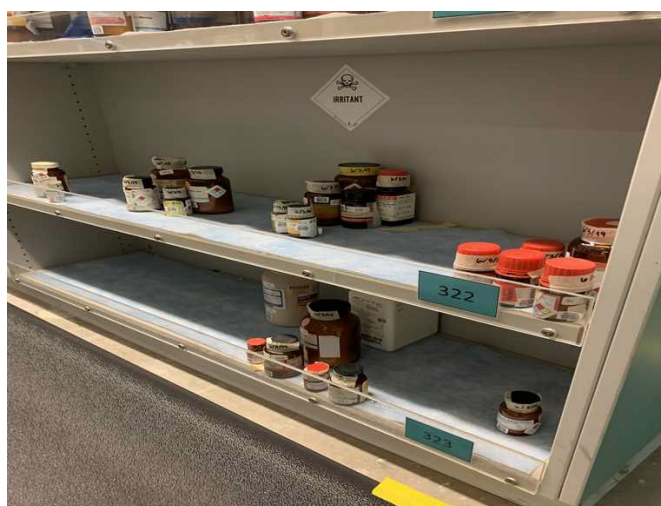
| [Title] | IMG_0192.jpg | |

| A view of additional chemicals that were from decommissioned labs and have not been used since June of 2019. | | |

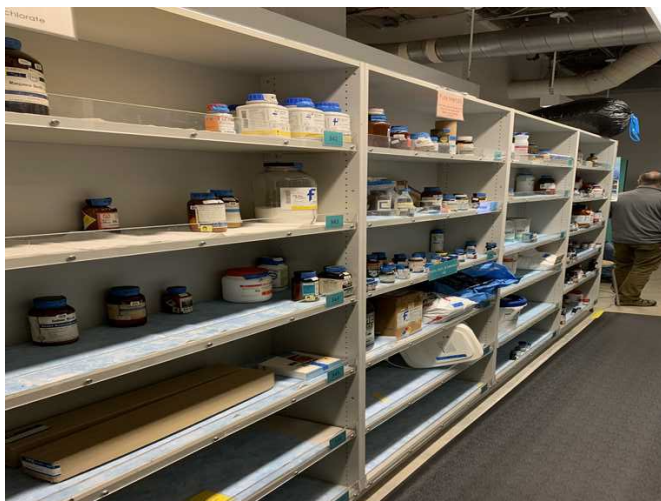
| [Title] | IMG_0193.jpg | |

| A view of additional chemicals that were removed from decommissioned labs and have not been used since June of 2019. | | |

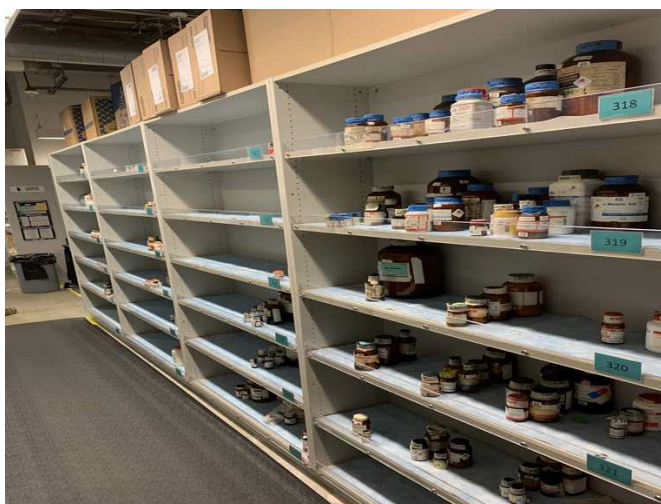
| [Title] | IMG_0194.jpg | |

| A view of additional chemicals that were removed from decommissioned labs and have not been used since June of 2019. | | |

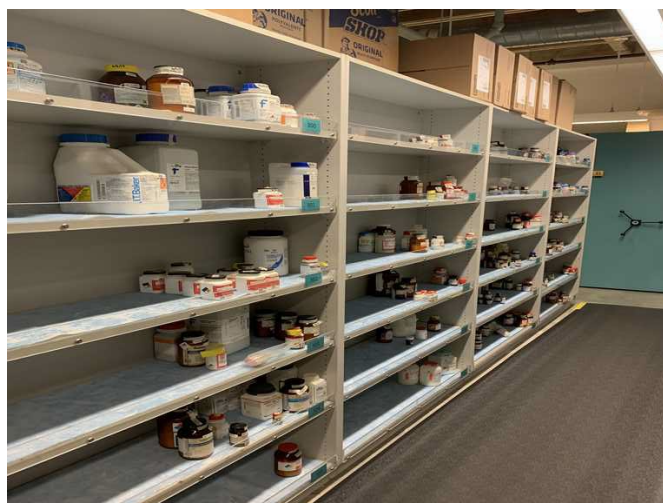
| [Title] | IMG_0195.jpg | |

| A view of additional chemicals that were removed from decommissioned labs and have not been used since June of 2019. | | |

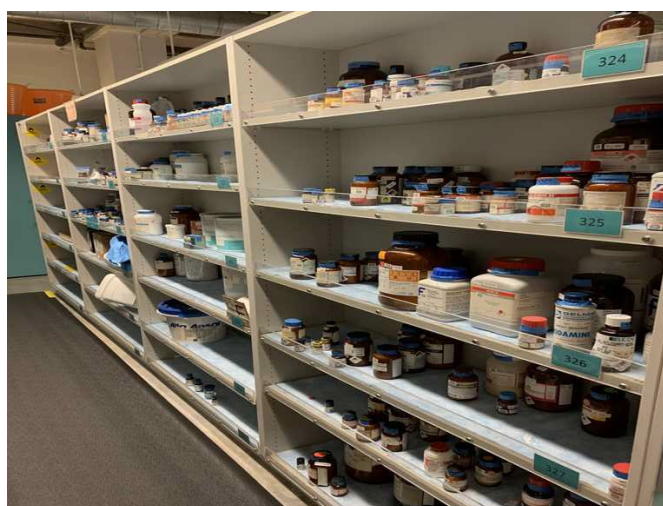
| [Title] | IMG_0196.jpg | |

| A view of additional chemicals that were removed from decommissioned labs and have not been used since June of 2019. | | |

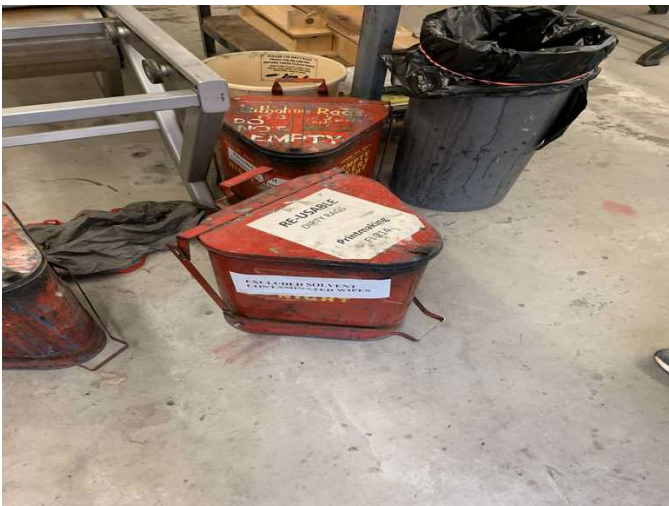
| [Title] | IMG_0321.jpg | |

| View of a step-can, containing waste rags contaminated with waste ink. The container is seen here labeled as "Excluded Solvent Contaminated Wipes." | | |

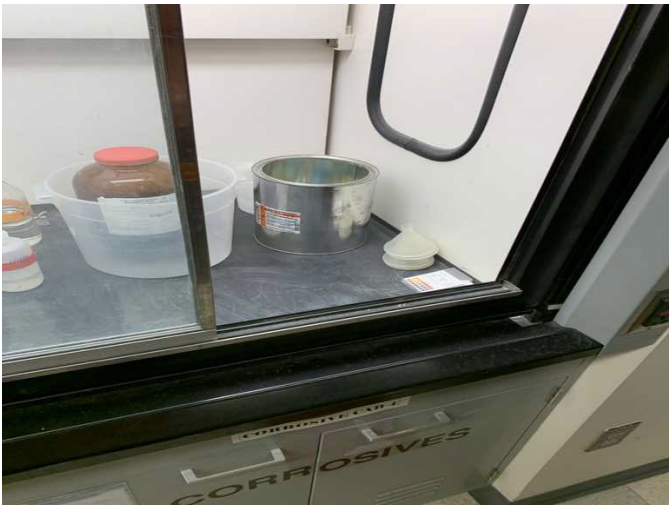
| [Title] | IMG_0204.jpg | |

| View of a metal container, seen here on the right, inside a fume hood that contains waste lizard eggs in alcohol. The container is shown here without a hazardous waste label and hazard risk/indicator. | | |

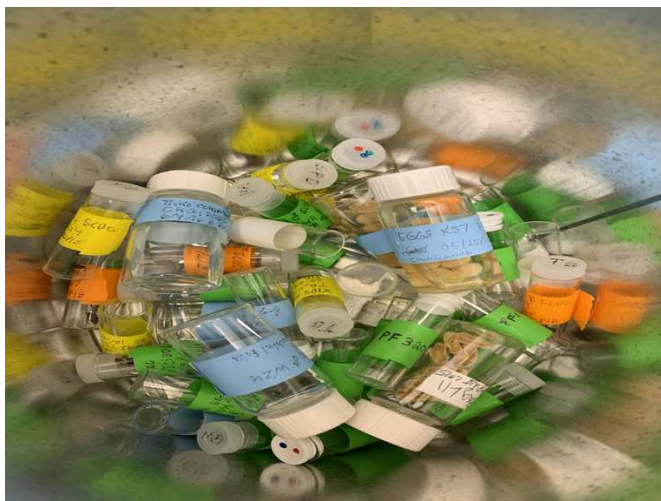
| [Title] | IMG_0205.jpg | |

| View of the waste lizard eggs in alcohol. | | |

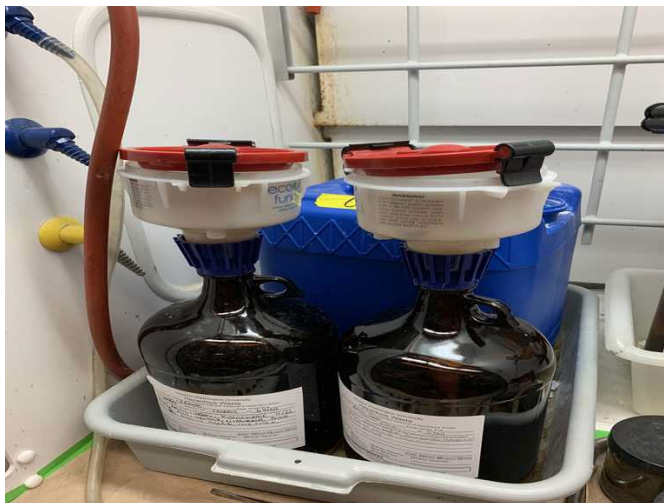
| [Title] | IMG_0136.jpg | |

| Another view of the waste containers, seen in IMG_0135. All three containers seen in this photo are not closed and the two glass waste containers are incompatible wastes. | | |

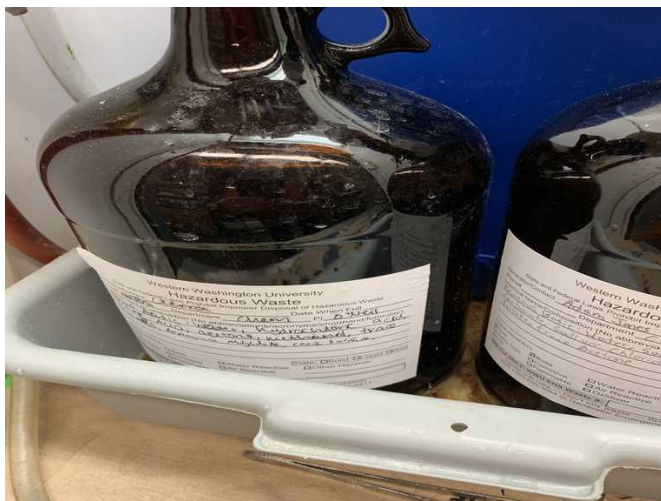
| [Title] | IMG_0137.jpg | |

| Close-up view of the two glass waste containers in the gray tub. The container on the left is seen here marked as containing waste acid and has no hazard risk/indicator label. | | |

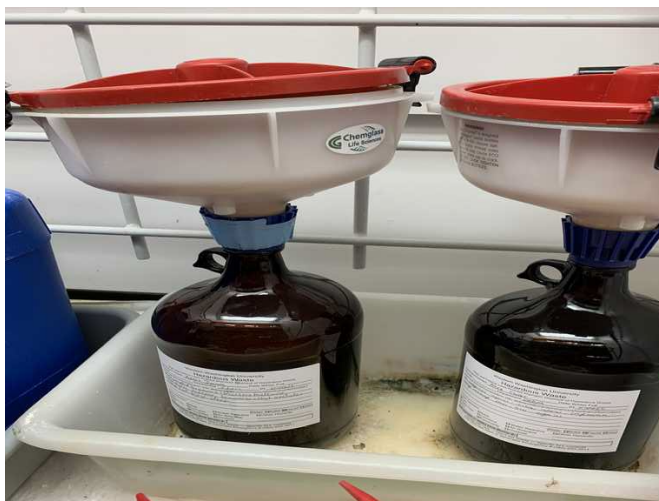
| [Title] | IMG_0139.jpg | |

| View of the other two glass waste containers in the white tub that are not closed. | | |

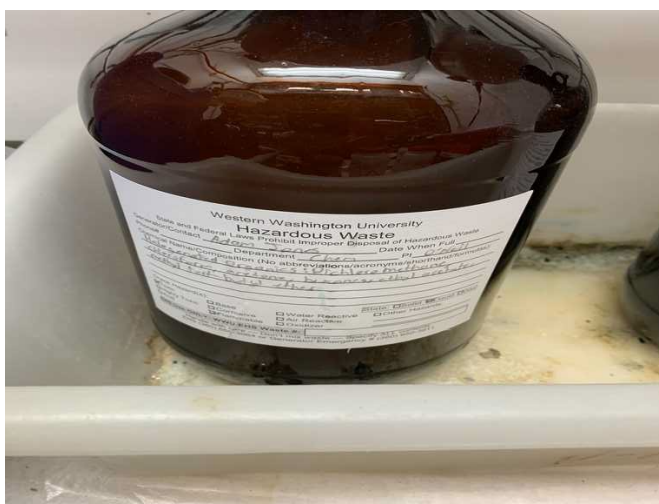
| [Title] | IMG_0140.jpg | |

| View of the label on the waste container seen on the left in IMG_0139. | | |

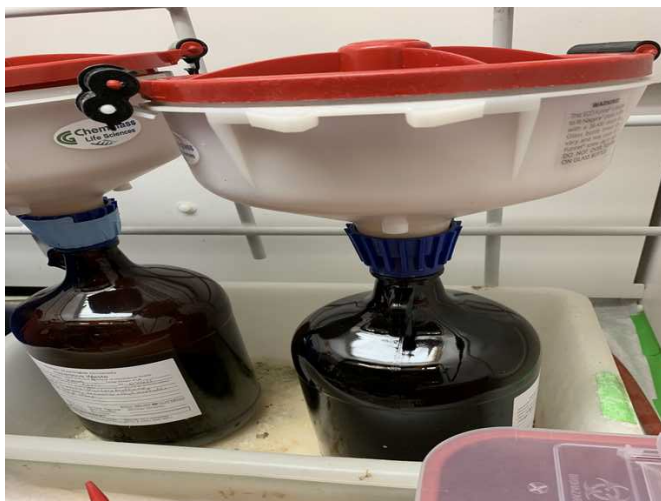
| [Title] | IMG_0141.jpg | |

| Close-up view of the funnel lid, showing that it is not making a complete seal with the containers funnel. | | |

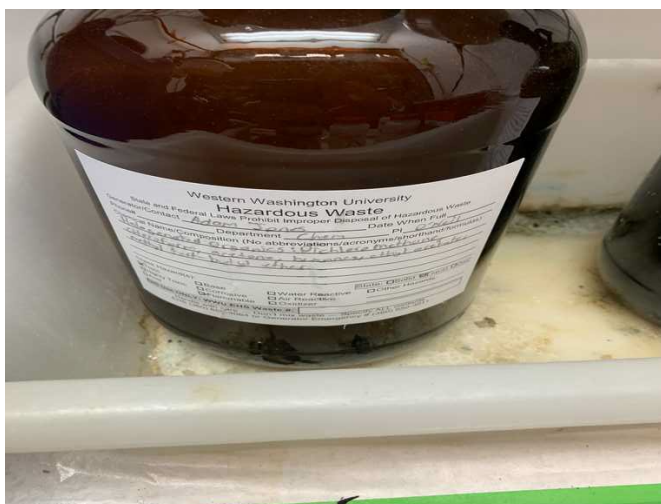
| [Title] | IMG_0143.jpg | |

| Close-up view of the label on the waste container that is on the left side of the white tub. | | |

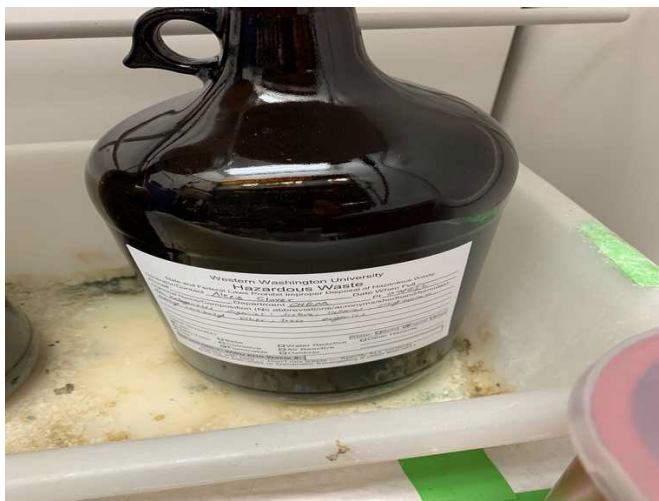
| [Title] | IMG_0144.jpg | |

| Close-up view of the label on the waste container seen on the right side of the white tub. | | |

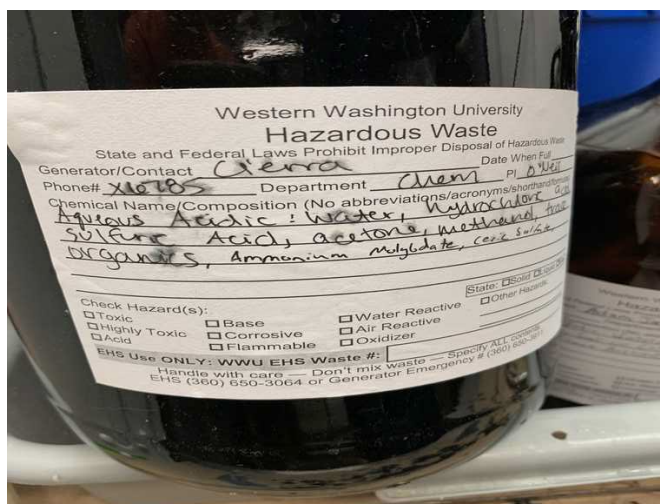
| [Title] | IMG_0145.jpg | |

| Close-up view of the waste container label for the container that was on the front left side of the gray tub. | | |

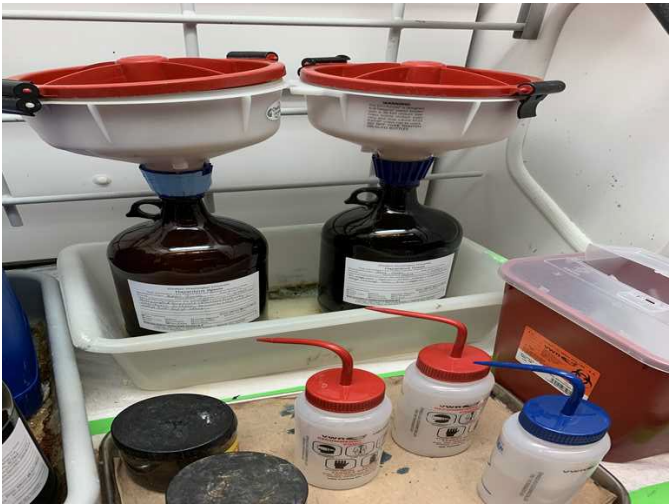
| [Title] | IMG_0146.jpg | |

| View of the two glass waste containers in the white tub and shown here not closed. | | |

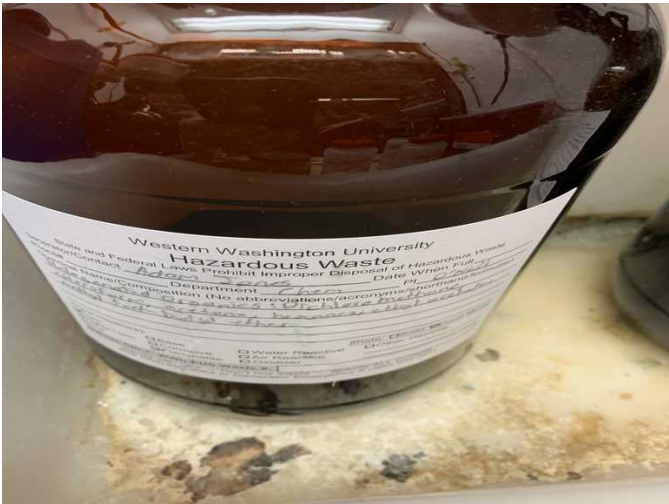
| [Title] | IMG_0147.jpg | |

| Close-up view of the label on the waste container seen on the left in the white tub. | | |

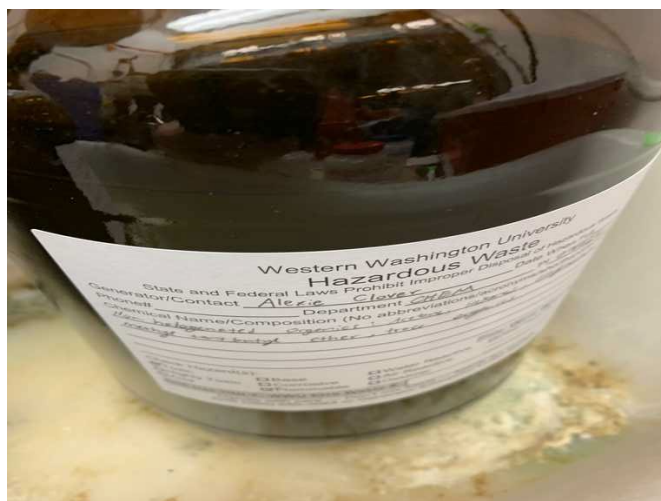
| [Title] | IMG_0148.jpg | |

| Close-up view of the label on the waste container seen on the right side of the white tub. | | |

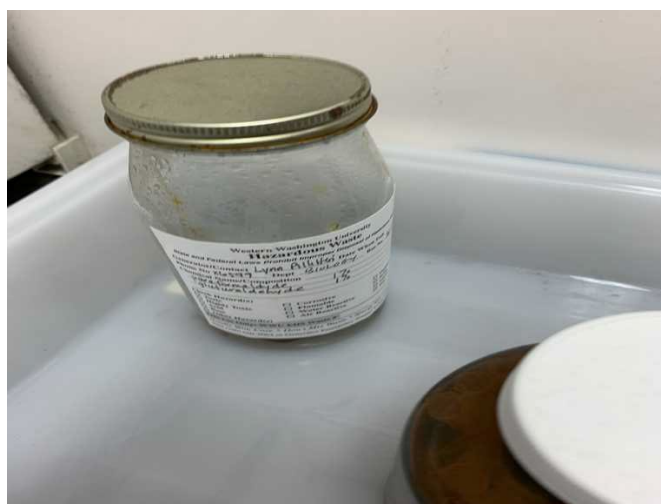
| [Title] | IMG_0201.jpg | |

| View of pint size waste container that is not marked with a hazard risk/indicator. | | |
