## EPA Region 10 Enforcement Division

### INSPECTION REPORT

| Type of Inspection | CEI - Compliance Evaluation Inspection | |
| Company Name | Western Washington University (WWU) | |

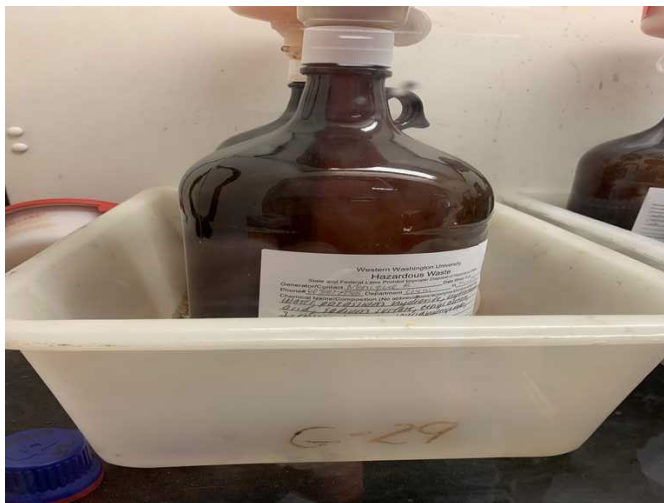
| [Title] | IMG_0156.jpg | |

| View of the 4-liter waste container that is not marked with a hazard risk/indicator. | | |

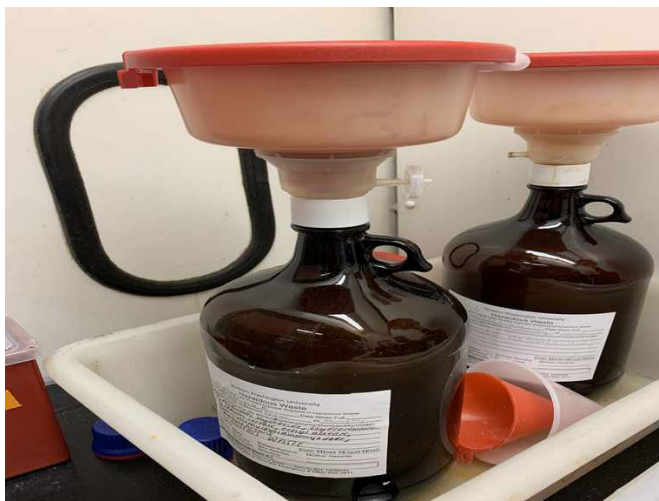
| [Title] | IMG_0157.jpg | |

| View of two, 4-liter waste containers with attached funnels. The container in the back and on the right is not closed. | | |

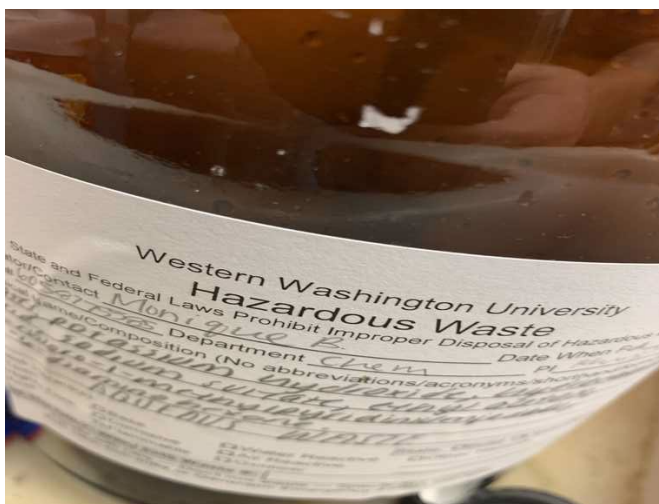
| [Title] | IMG_0158.jpg | |

| Close-up view of the label on the waste container that is not marked with a hazard risk/indicator. | | |

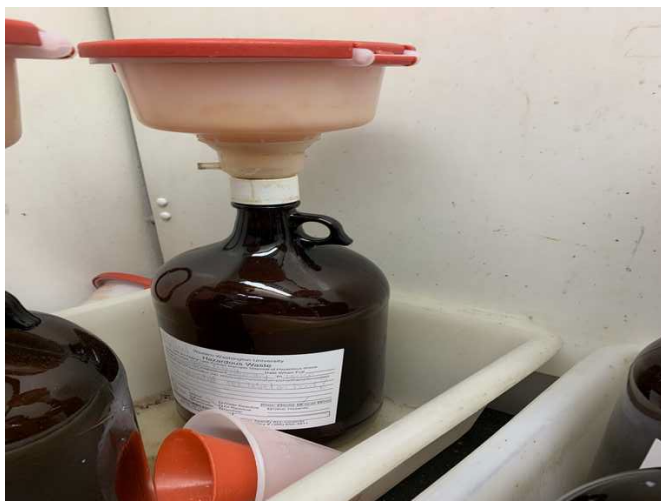
| [Title] | | IMG_0159.jpg | |

| Another view of the waste container in the back and to the right that is not closed. | | | |

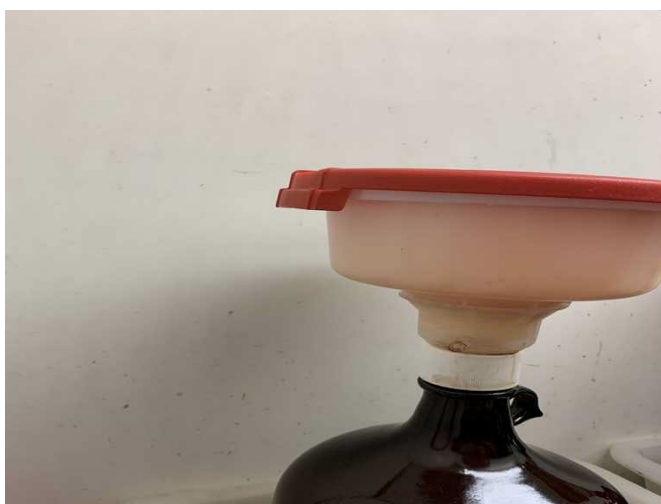
| [Title] | | IMG_0160.jpg | |

| View of the lid on the container in the rear of the plastic tub marked G-29, shown here not closed. | | | |

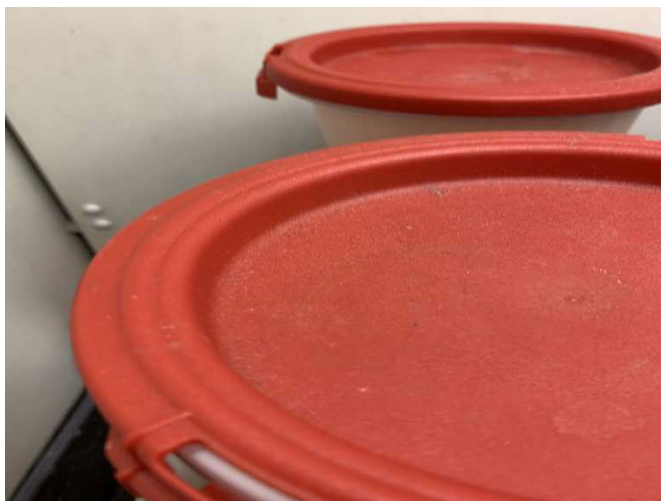
| [Title] | IMG_0161.jpg | |

| View of the lid on the container seen in the tub on the far right, showing that the container is not closed. | | |

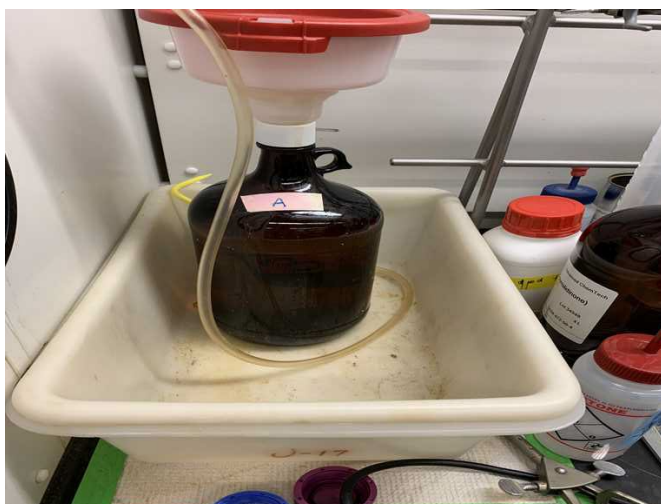
| [Title] | IMG_0181.jpg | |

| View of a 1-gallon brown, glass waste container labeled as "A," and seen here without a hazardous waste label and hazard risk/indicator. | | |

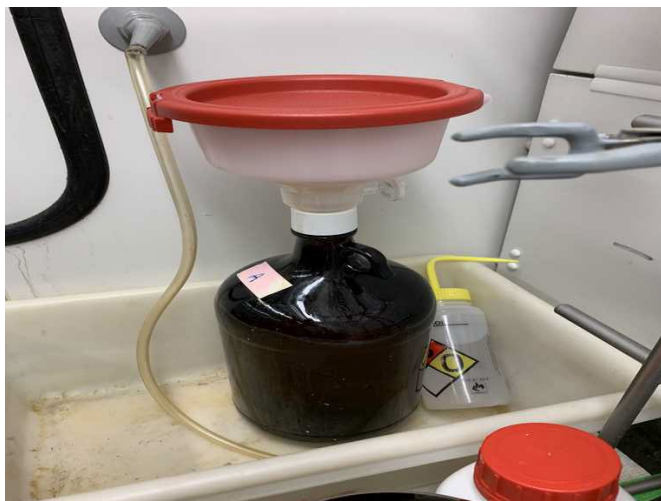
| [Title] | IMG_0182.jpg | |

| Another view of the same waste container, seen in IMG_181.jpg, shown here without a hazardous waste label and hazard risk/indicator. | | |

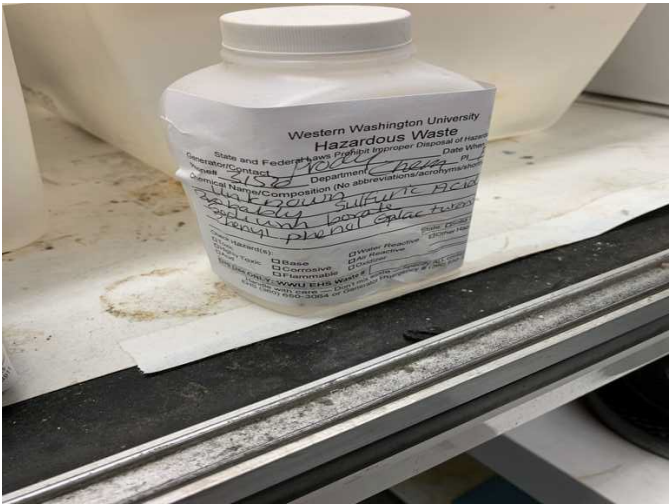
| [Title] | IMG_0184.jpg | |

| View of a pint size waste container, marked as an unknown, that is labeled as hazardous waste but not marked with a hazard risk/indicator. | | |

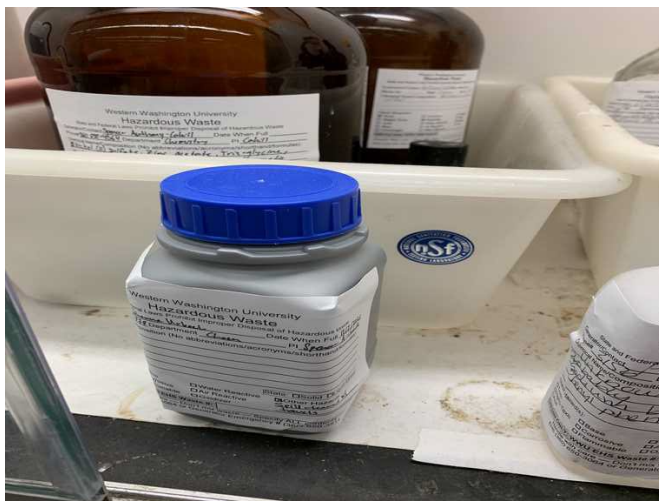
| [Title] | IMG_0188.jpg | |

| View of the markings on the bin (NSF) that contains the 1-gallon waste container, seen in the front of the bin, missing the hazard risk/indicator. | | |

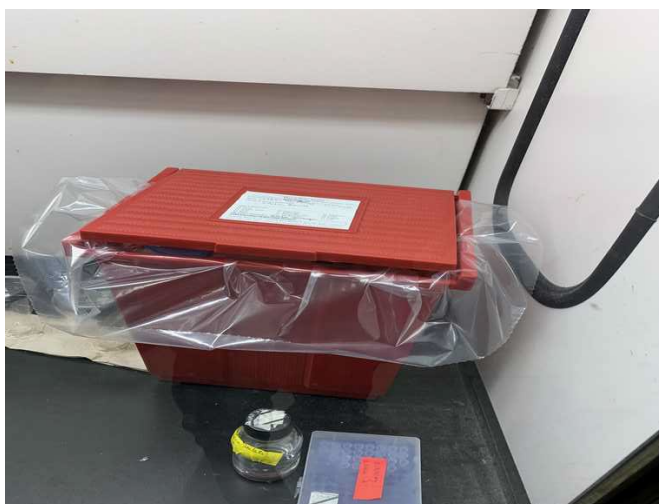
| [Title] | IMG_0197.jpg | |

| View of a waste container that contains PPE contaminated with ethidium bromide. The container is seen here labeled as hazardous waste, marked with a hazard risk/indicator, but not closed. | | |

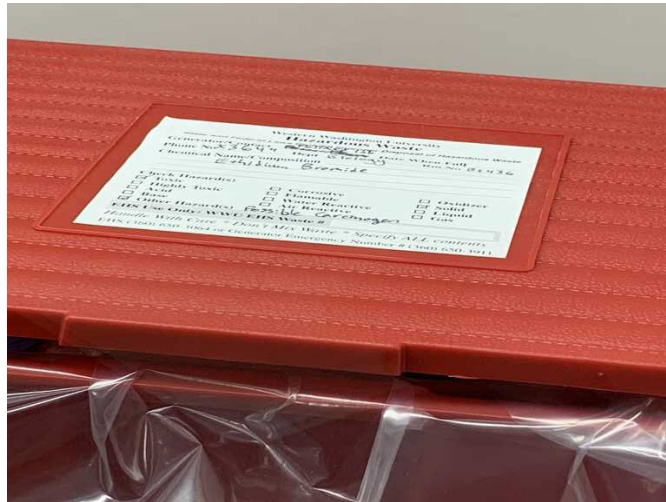
| [Title] | IMG_0198.jpg | |

| Close-up view of the label and lid not making a complete seal with the container, showing that the container is not closed. | | |

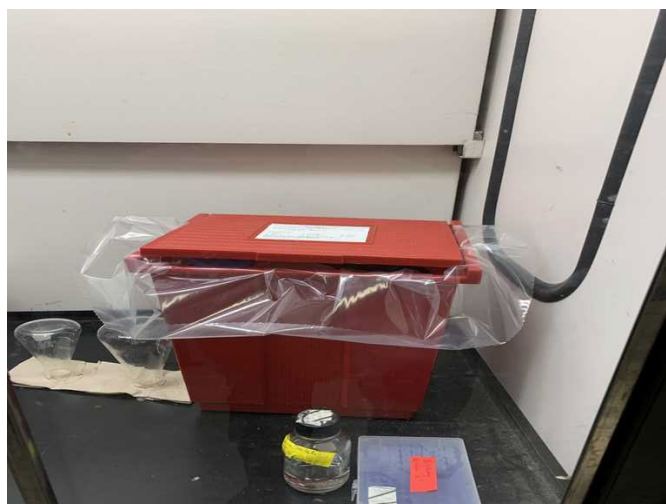
| [Title] | IMG_0199.jpg | |

| Another view of the same waste container, seen in IMG_197.jpg, showing that it is not closed. | | |

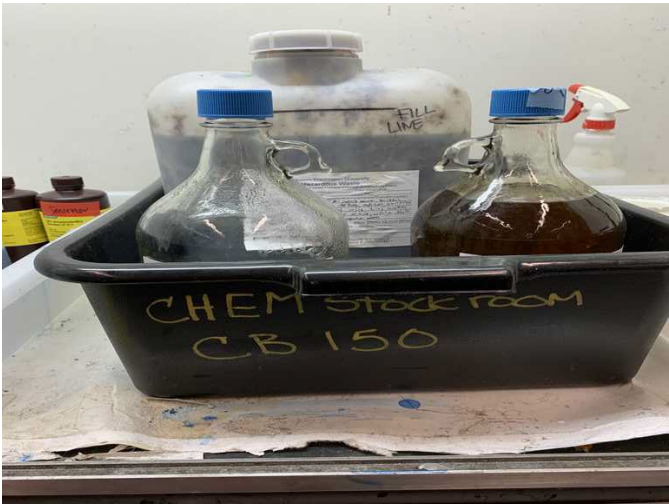
| [Title] | IMG_0170.jpg | |

| View of a waste container, seen here in the front of the blue tub, without a hazard risk/indicator. | | |

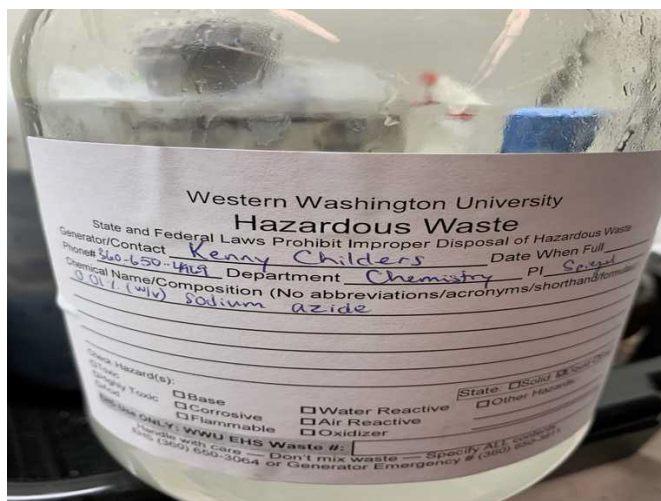
| [Title] | IMG_0174.jpg | |

| Close-up view of the label on the waste container seen in IMG_173.jpg, showing that it is not marked with a hazard risk/indicator. | | |

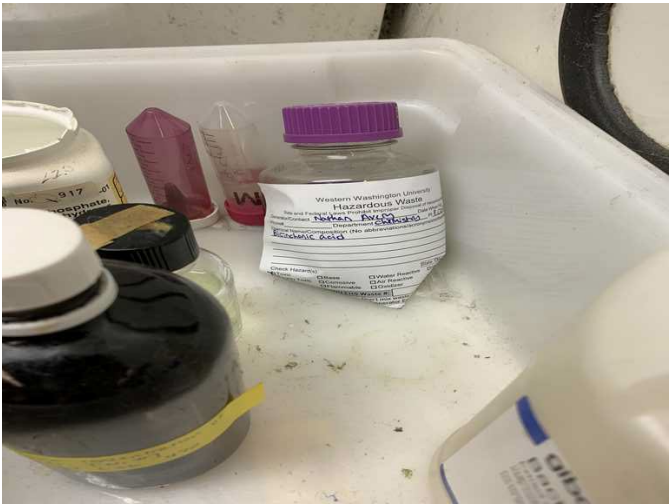
| [Title] | IMG_0176.jpg | |

| View of clear glass container that has approximately four ounces of an unknown liquid and two vials in the background that contain unknowns and require a waste determination. | | |

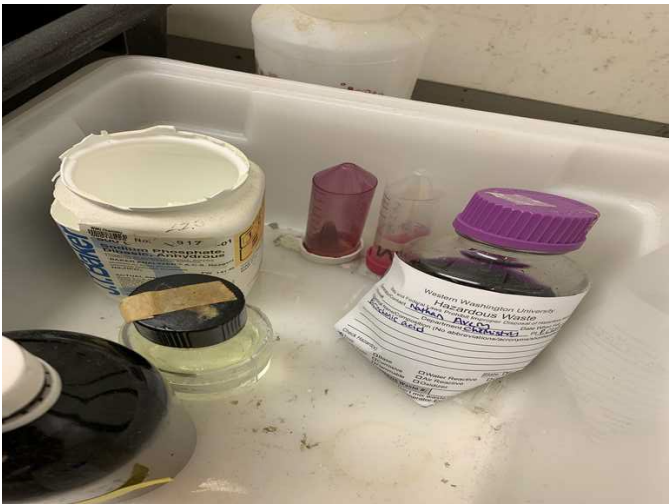
| [Title] | IMG_0178.jpg | |

| Another view of the clear glass container and vials that contain unknowns as well as a plastic container, seen here in the upper left of the photo, that is not closed and is labeled as "Sodium Phosphate Dibasic, Anhydrous," and requires a waste determination. | | |

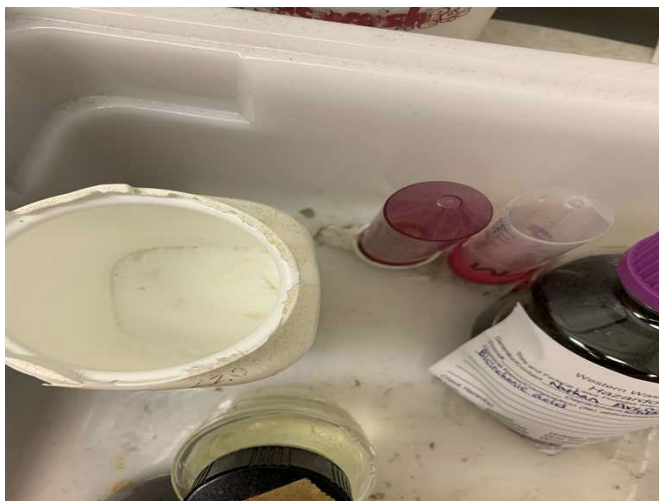
| [Title] | | IMG_0179.jpg | |

| Close up view, looking down into the same container, seen in IMG_178.jpg, that requires a waste determination. | | | |

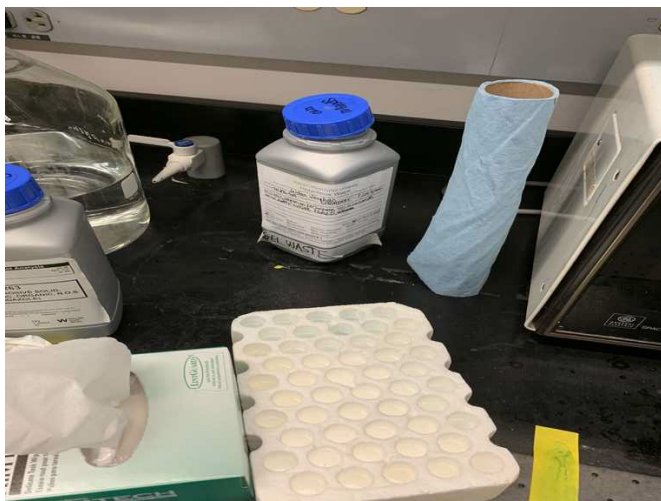
| [Title] | IMG_0162.jpg | |

| View of waste container that is not closed. | | |

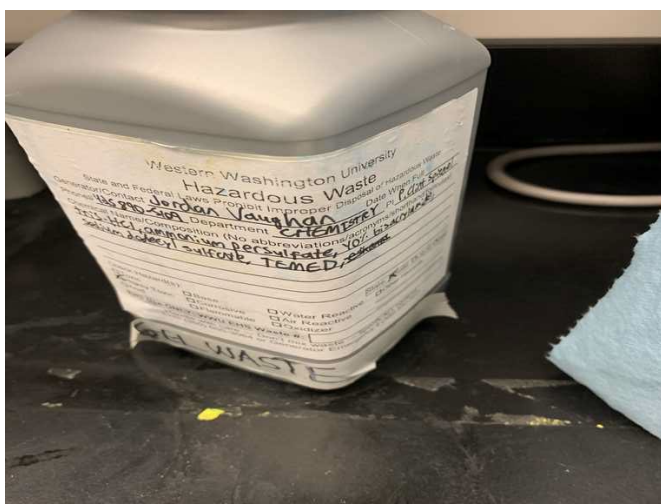
| [Title] | IMG_0163.jpg | |

| Close-up view of the label on the waste container that is not closed. | | |

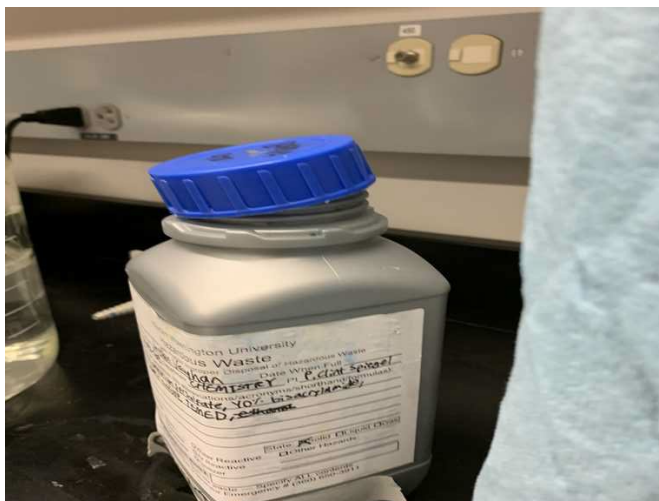
| [Title] | IMG_0164.jpg | |

| Another close-up view of the waste container, showing that the lid is not screwed onto the container. | | |

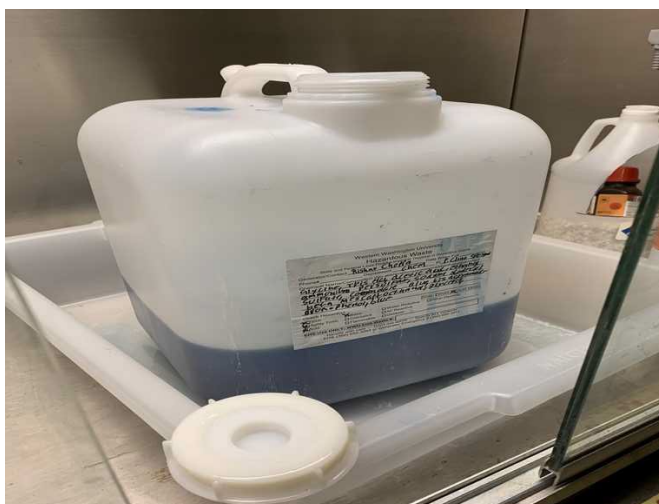
| [Title] | IMG_0165.jpg | |

| View of another waste container that is not closed. | | |

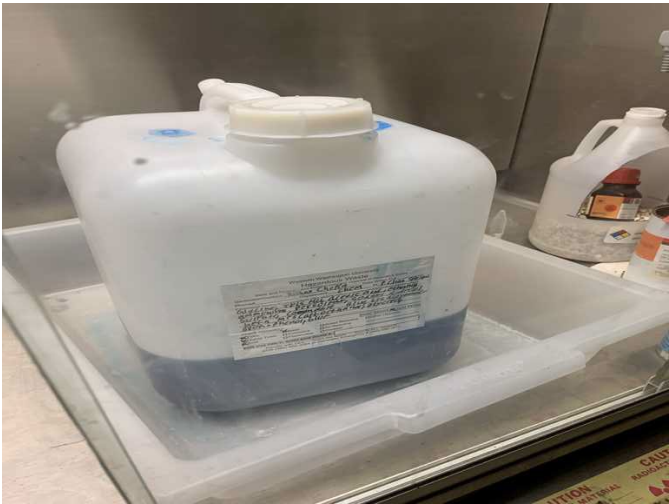
| [Title] | IMG_0166.jpg | |

| View of the same waste container, seen in IMG_165.jpg, after being closed by Mr. Carlton. | | |

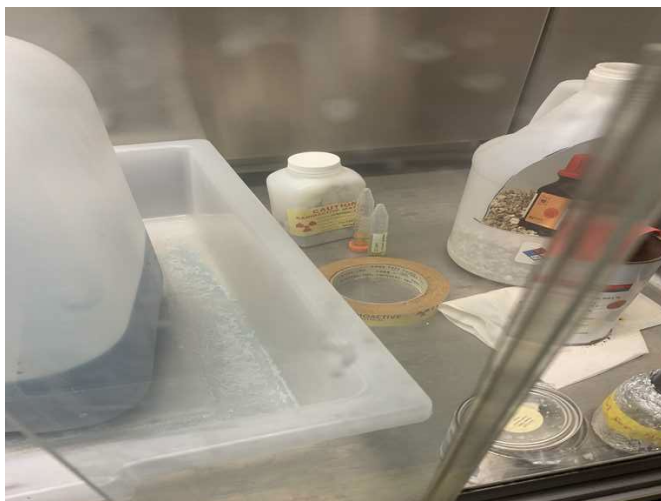
| [Title] | IMG_0168.jpg | |

| View of a container, thought to be waste, labeled uranium-238 and dated 11/1/21. | | |

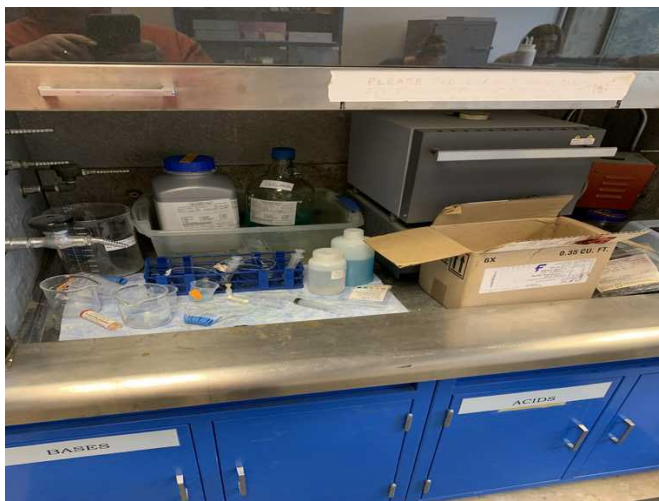
| [Title] | IMG_0251.jpg | |

| View of a 1-gallon waste container, seen here with a blue lid, that is not marked with a hazard risk/indicator. | | |

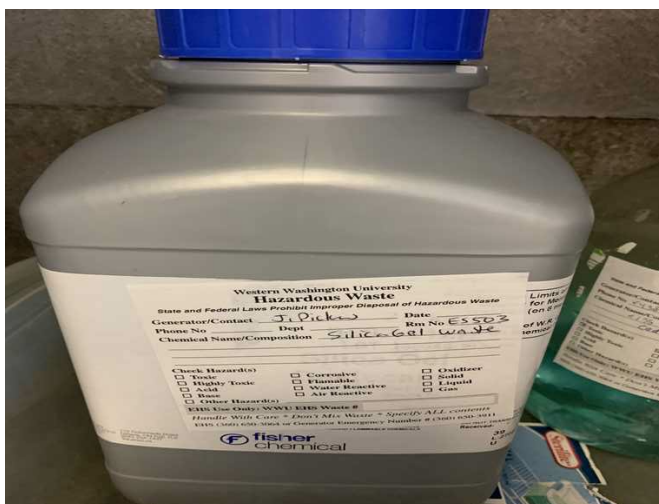
| [Title] | IMG_0252.jpg | |

| Close-up view of the label on the 1-gallon waste container, seen in IMG_0251.jpg with a blue lid, showing that it is not marked with a hazard risk/indicator. | | |

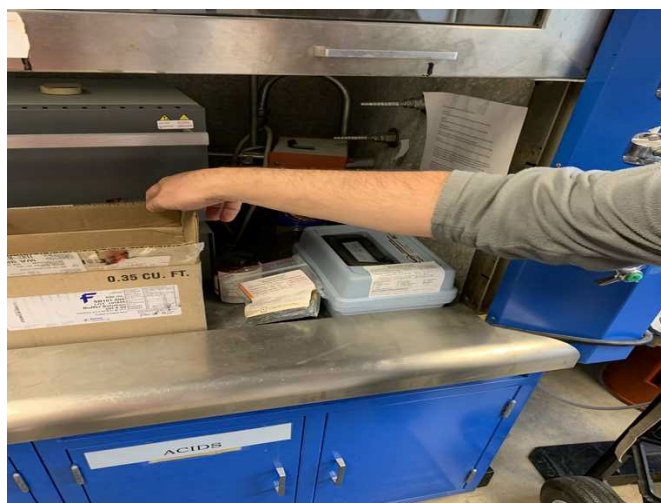
| [Title] | | IMG_0253.jpg | |

| View of a pint sized, brown glass waste container and a plastic bag, containing waste. Neither the plastic bag nor the glass container are marked with a hazard risk/indicator. | | | |

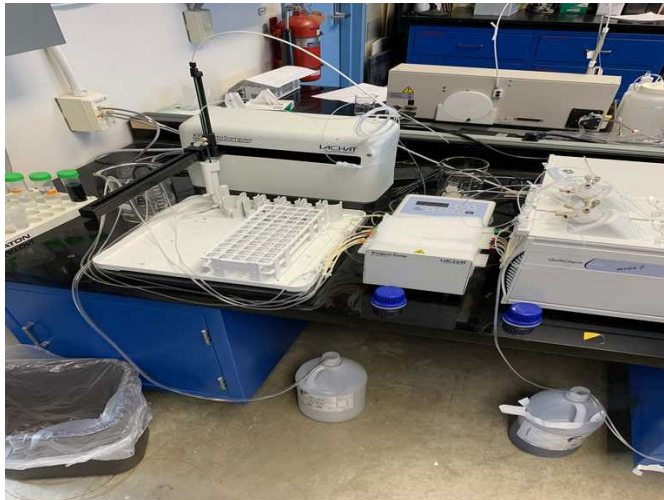
| [Title] | IMG_0257.jpg | |

| View of suspected waste containers that are connected to lab analyzing equipment in the lab. The containers are not marked with hazardous waste labels or marked with hazard indicators. | | |

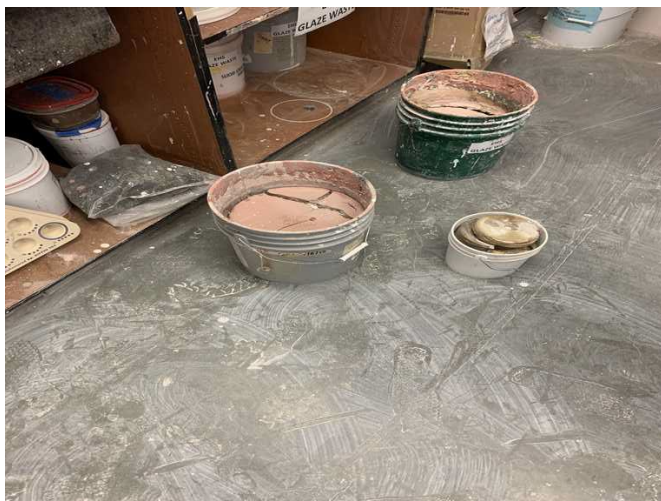
| [Title] | IMG_0312.jpg | |

| View of two, 5-gallon containers and a half-gallon container of waste glaze. The waste containers seen here are not closed, not labeled with the words "Hazardous Waste", or marked with hazard risks/indicators. | | |

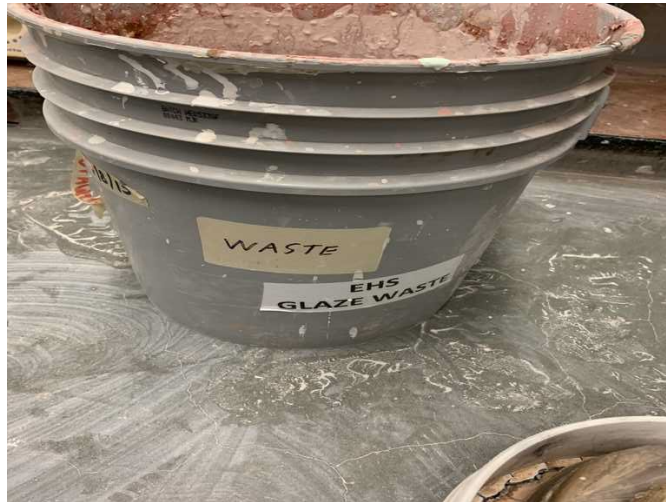
| [Title] | IMG_0314.jpg | |

| Close-up view of one of the 5-gallon waste containers, showing that it is not closed, not marked with a hazardous waste label or a hazard risk/indicator. | | |

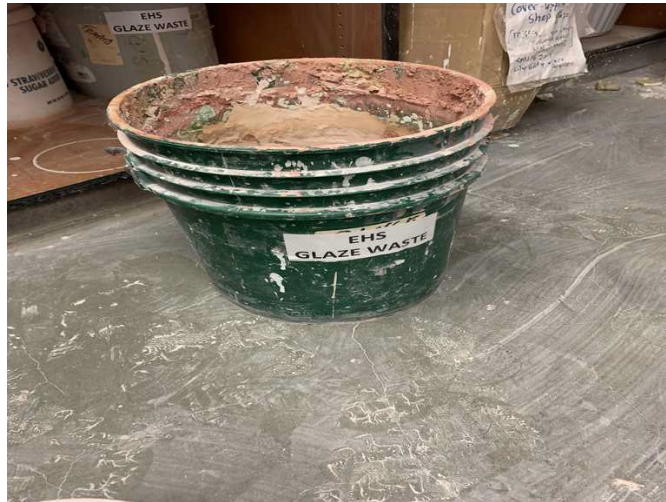
| [Title] | IMG_0316.jpg | |

| Close-up view of the other 5-gallon waste container, showing that it is not closed, not marked with a hazardous waste label or a hazard risk/indicator. | | |

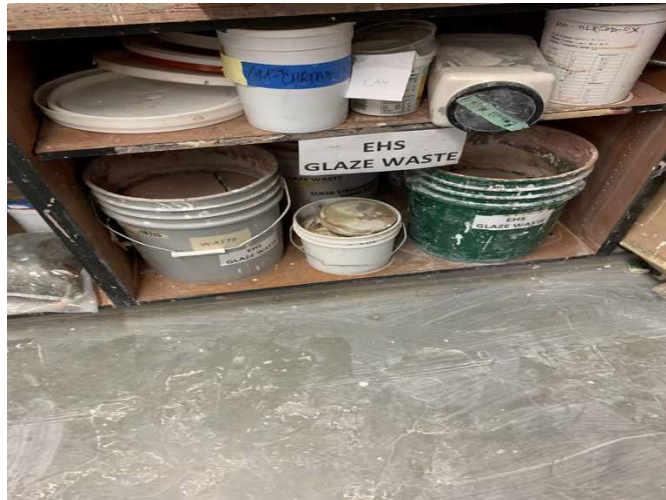
| [Title] | IMG_0318.jpg | |

| Another view of two, 5-gallon containers and a half-gallon container of waste glaze. The waste containers seen here are not closed, not labeled with the words "Hazardous Waste", or marked with hazard risks/indicators. | | |

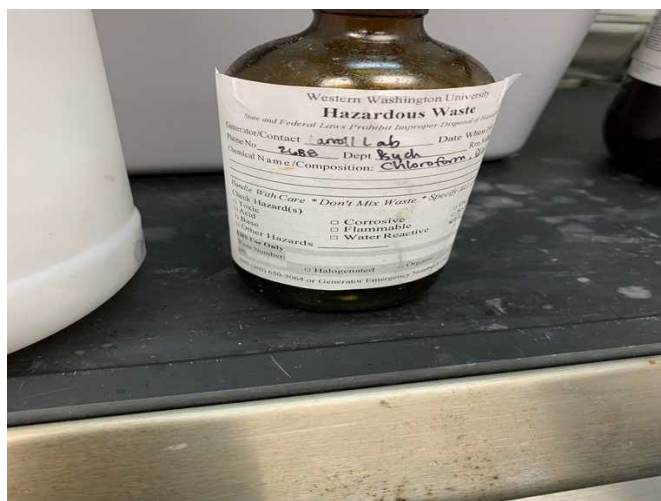
| [Title] | IMG_0309.jpg | |

| Close-up view of the labels showing that no hazard risk/indicator is marked. | | |

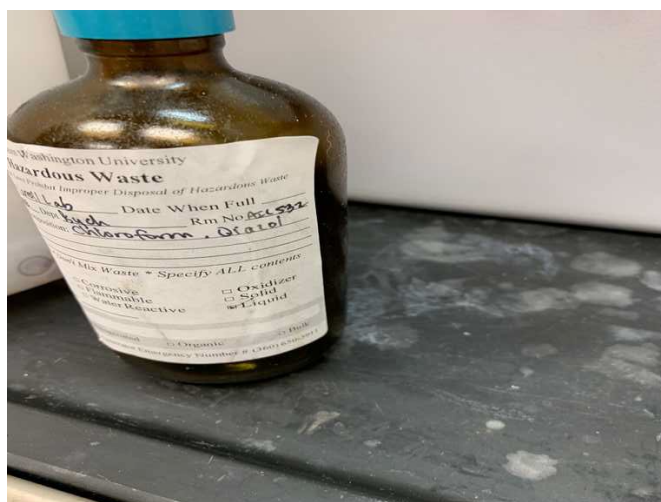
| [Title] | IMG_0310.jpg | |

| Close-up view of the labels showing that no hazard risk/indicator is marked. | | |

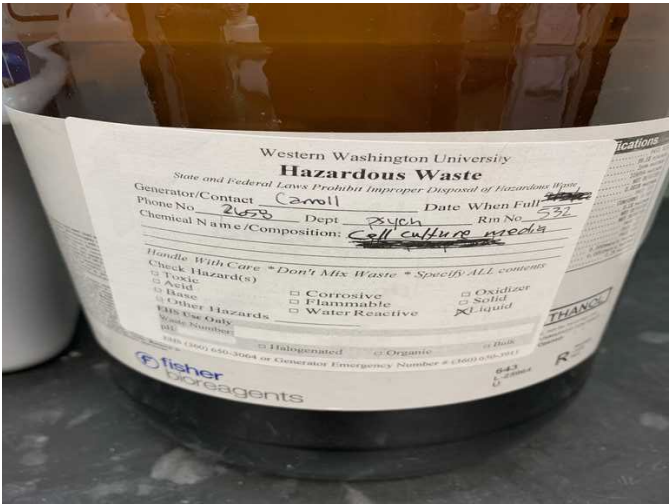
| [Title] | IMG_0311.jpg | |

| Close-up view of the labels showing that no hazard risk/indicator is marked. | | |

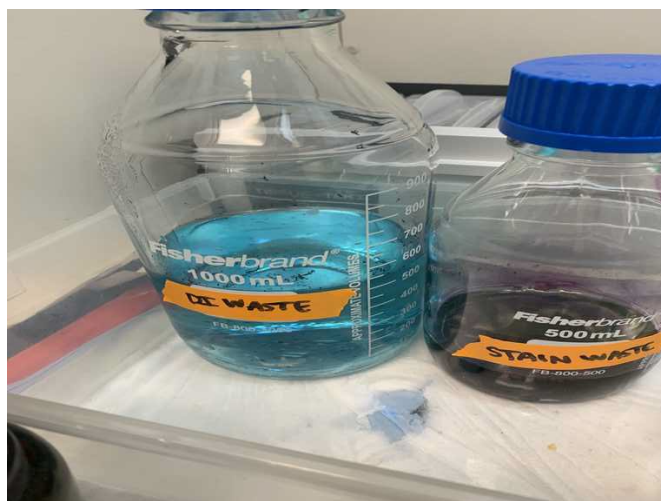
| [Title] | IMG_0298.jpg | |

| Close-up view of some of the containers seen in IMG_0295.jpg, not marked with a hazardous waste label or a hazard risk/indicator. | | |

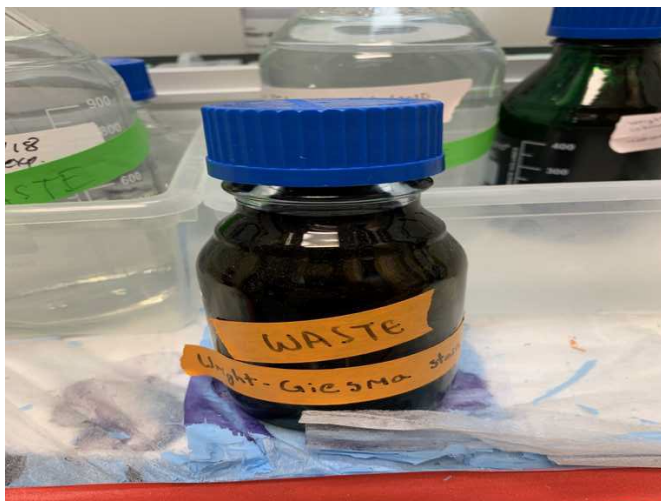
| [Title] | IMG_0302.jpg | |

| Close-up view of one of the containers seen in IMG_0295.jpg, not marked with a hazardous waste label or a hazard risk/indicator. | | |

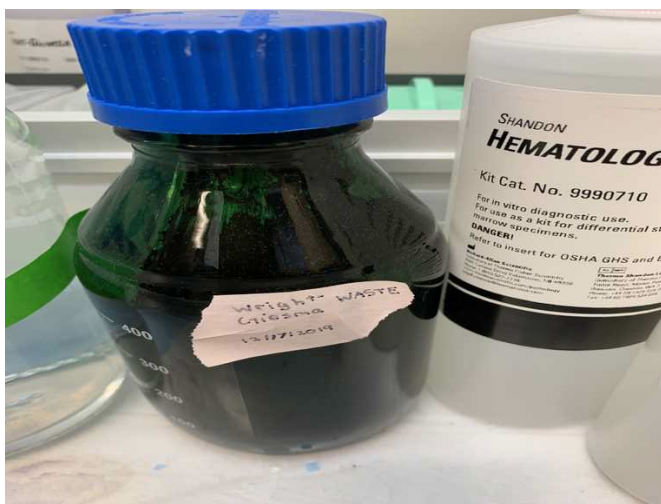
| [Title] | IMG_0304.jpg | |

| Close-up view of one of the containers seen in IMG_0295.jpg, not marked with a hazardous waste label or a hazard risk/indicator. | | |

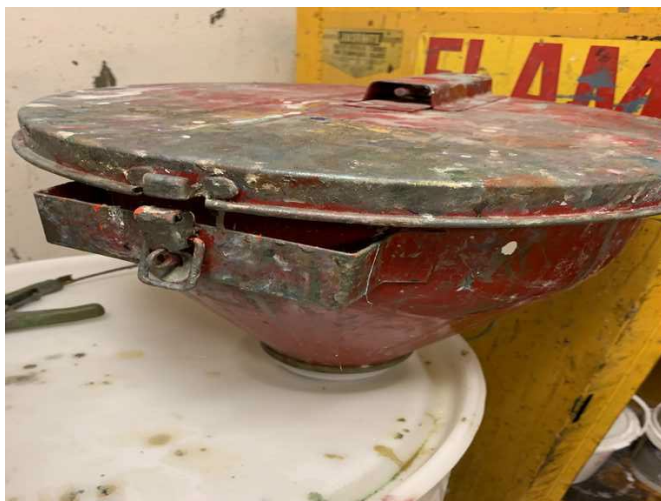
| [Title] | IMG_0323.jpg | |

| Close-up view of the funnel latch, showing that the container is not closed. | | |

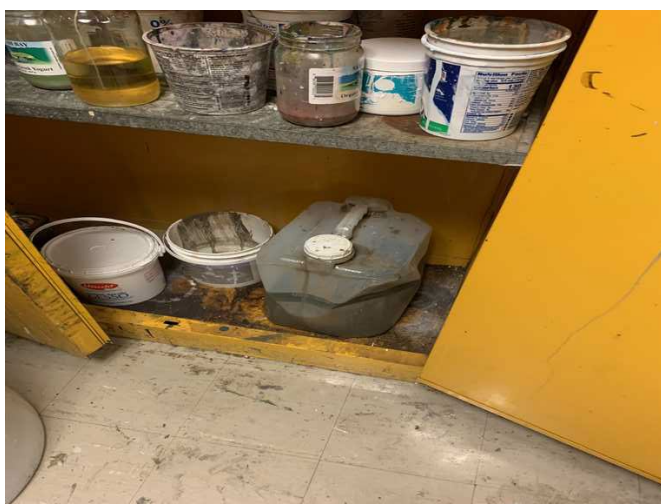
| [Title] | IMG_0324.jpg | |

| View of a 5-gallon plastic container, seen in the bottom and on the right, that is holding an unknown liquid. | | |

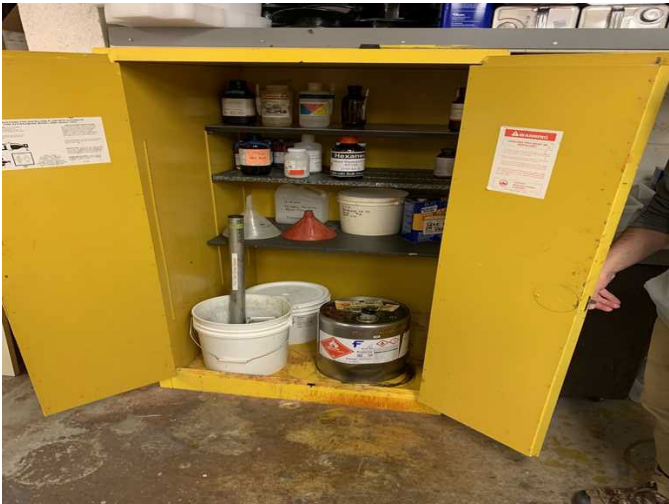
| [Title] | IMG_0262.jpg | |

| View of a 5-gallon waste container of mixed solvent, seen here at the bottom, right side of the flammables cabinet. The container is not labeled with the words "Hazardous Waste." | | |

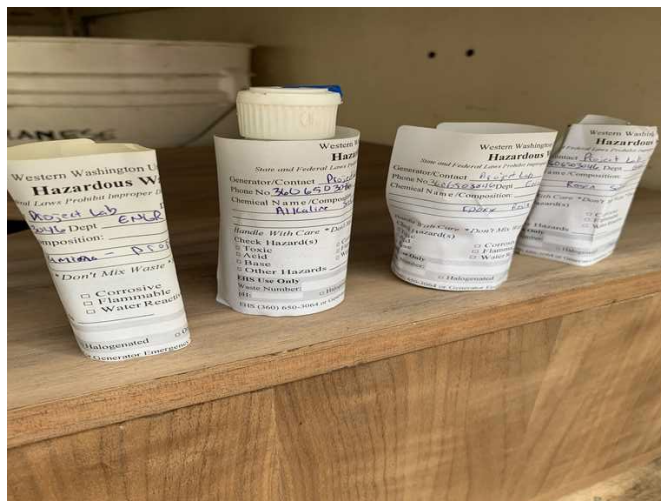
| [Title] | IMG_0278.jpg | |

| View of waste containers that are not marked with hazard risks/indicators. | | |

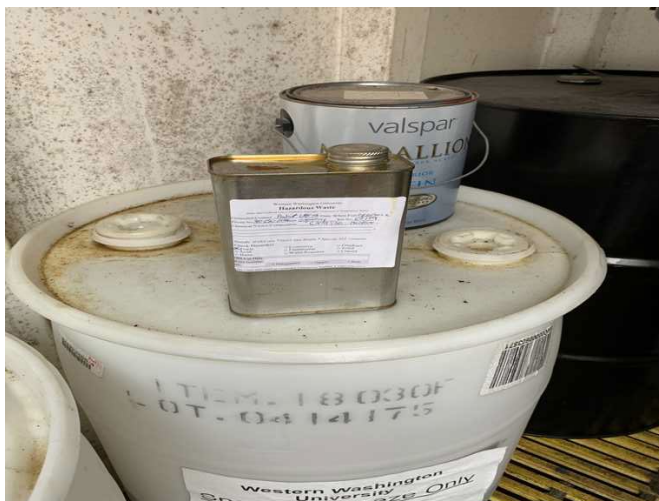
| [Title] | IMG_0284.jpg | |

| View of waste container that has been in accumulation for greater than 90-days. The container is seen here marked with the date 3/31/22. | | |

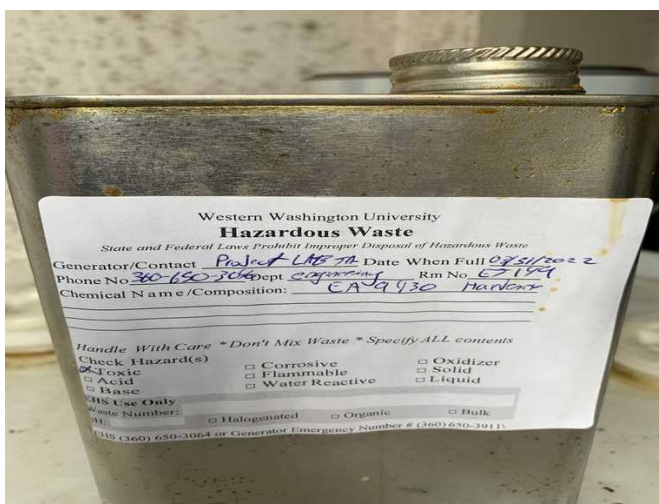
| [Title] | IMG_0285.jpg | |

| Close-up view of waste container that has been in accumulation for greater than 90-days. The container is seen here marked with the date 3/31/22. | | |

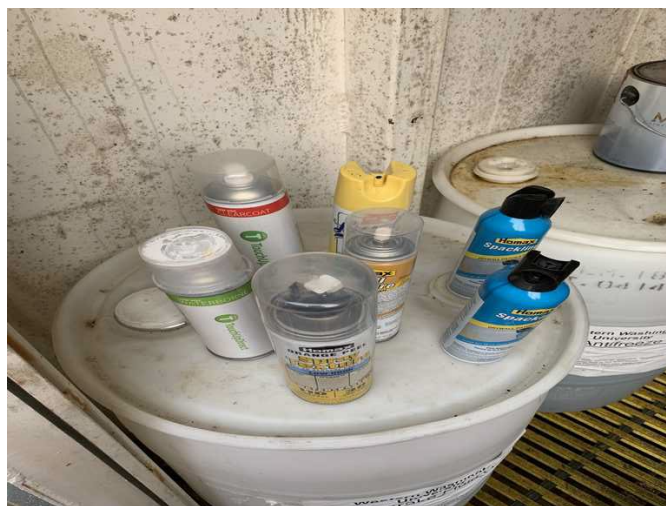
| [Title] | IMG_0287.jpg | |

| View of seven waste aerosol cans that are not marked with hazardous waste labels or hazard risks/indicators. | | |

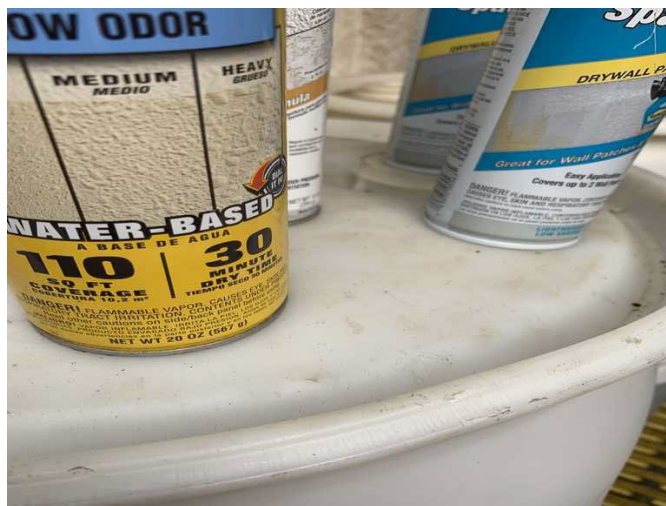
| [Title] | IMG_0289.jpg | |

| Close-up view, showing the hazards/warnings on the labels. | | |

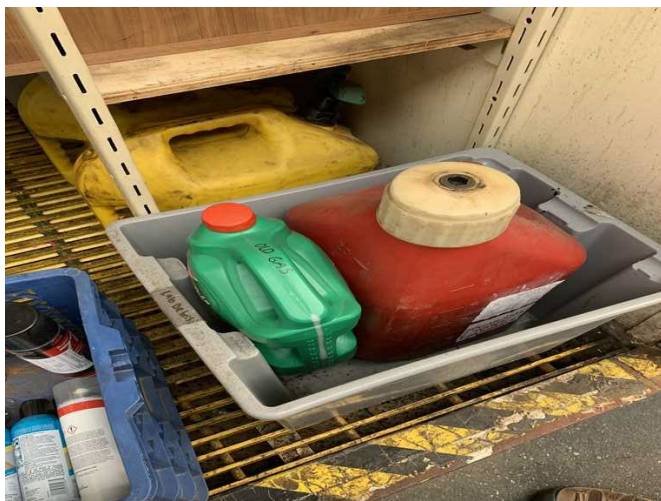
| [Title] | IMG_0290.jpg | |

| View of the waste gas containers. | | |

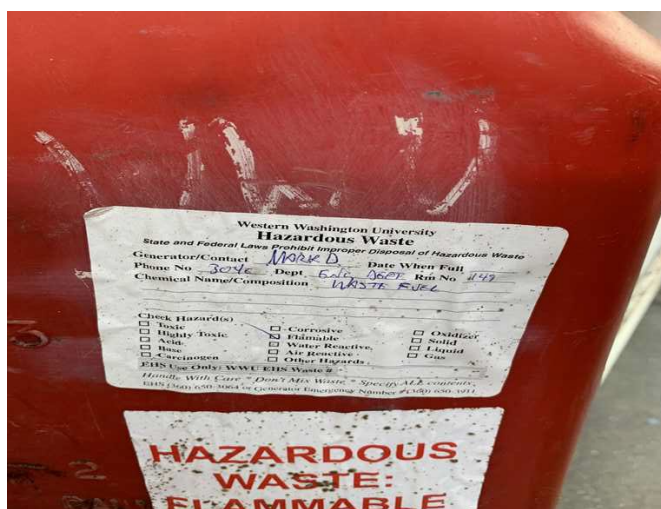
| [Title] | IMG_0291.jpg | |

| View of the hazardous waste label on the waste gas container. | | |
