**Region 6 Compliance Assurance and Enforcement Division  
INSPECTION REPORT**

| Inspection Date(s): | 05/14/2015 | | |
| Facility Name: | <b>Nambe Headstart Water System</b> | | |
| Identification/Permit Number: | NM3598726 | | |

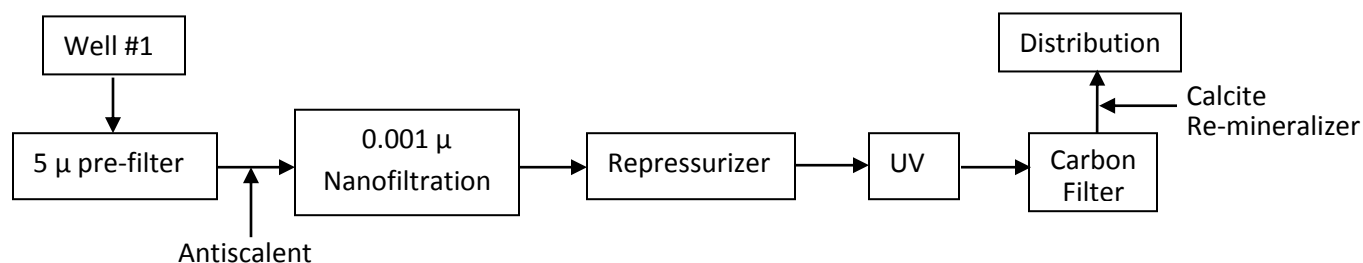
In February 2013, an interim "bare-bone" treatment system was installed for cooking water only. Then on July 28, 2014, a Good Water 0.001  $\mu$  nanofiltration system (schematic below) was installed, designed to remove both arsenic and selenium, for a total cost of \$40,000.
