**UNITED STATES ENVIRONMENTAL PROTECTION AGENCY, REGION 2**  
**CARIBBEAN ENVIRONMENTAL PROTECTION DIVISION**  
**MULTIMEDIA PERMITS AND COMPLIANCE BRANCH**

**NPDES COMPLIANCE EVALUATION INSPECTION**  
**Industrial Activities**

**BOVONI MUNICIPAL SOLID WASTE LANDFILL FACILITY**  
1-19 Estate Bovoni, St. Thomas, Virgin Islands 00802  
Latitude: 18° 31' 31.81" N; Longitude: 64° 88' 59.83" W  
Telephone Number: (340) 715-9100

**NPDES ID: VIU000019**

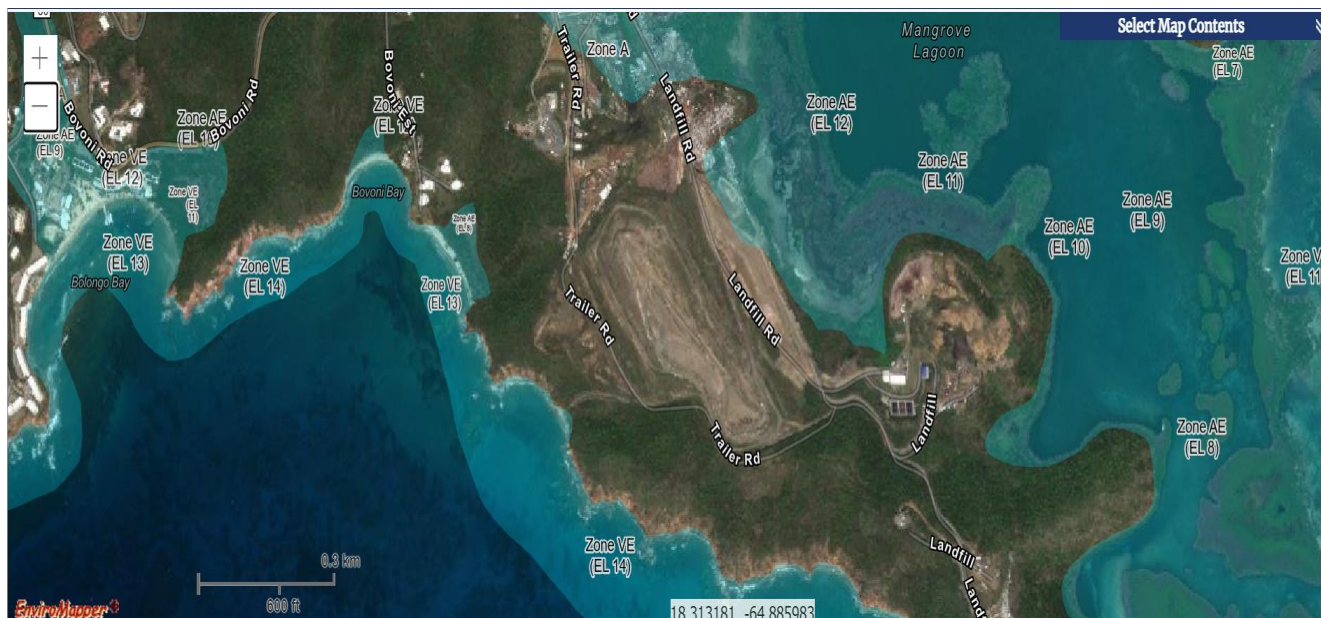
Figure 2

Facility is situated within the southeastern section the watershed

The Facility is situated along the south-eastern shoreline of St. Thomas, and specifically, within the southeastern section of the watershed that drains into Mangrove Lagoon and Kings Bay (Caribbean Sea). An aerial view of the location of the Facility and immediate surroundings are depicted in a satellite imagery of the referenced Watershed featured in **Figure 2**, on the next page (Source: <https://nepassisttool.epa.gov/nepassist/nepamap.aspx>).
