**United States Environmental Protection Agency, Region 2**  
Caribbean Environmental Protection Division  
Multimedia Permits and Compliance Branch

**NPDES Stormwater Inspection  
Industrial Facility**

**R&F ASPHALT UNLIMITED, INC.**  
P.O. Box 801028, Ponce, Puerto Rico 00780  
Telephone Numbers: (787) 848-1210 / (787) 848-1212

**ASPHALT CEMENT MANUFACTURING FACILITY**  
PR-14 Road, Km. 9.6, Coto Laurel Ward  
Ponce, Puerto Rico 00780  
Coordinates: 18.050906° N; 66.543734° W  
Telephone Number: (787) 376-3923

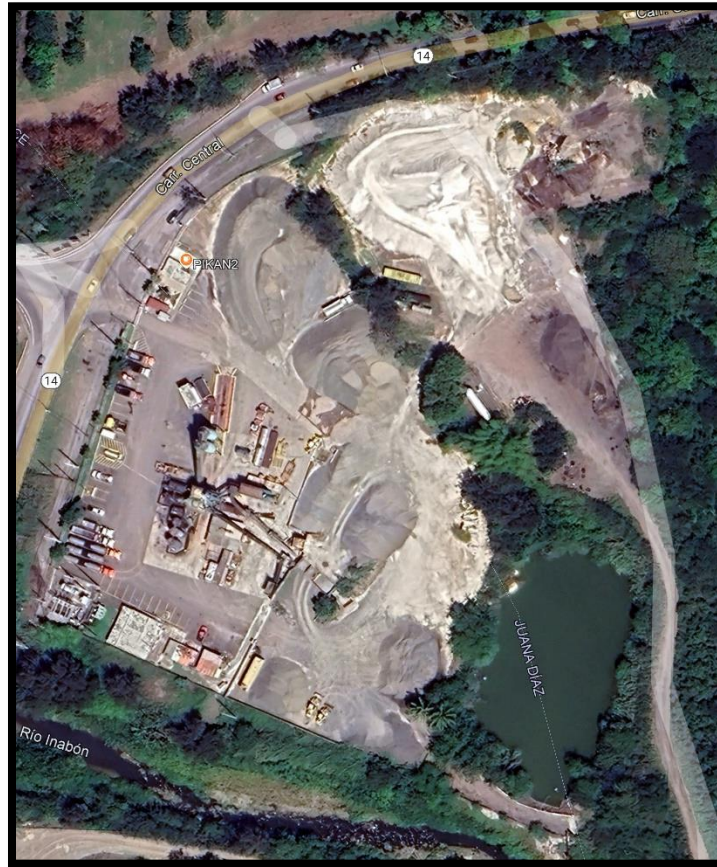
*Image 1: Aerial image of the Site (Source: Google Earth Pro™, 2024).*

The Facility is located at PR-14 Road, Km. 9.6, Coto Laure Ward, Ponce, Puerto Rico (the “Site”). **Image 1** (below) shows an aerial image of the Site.

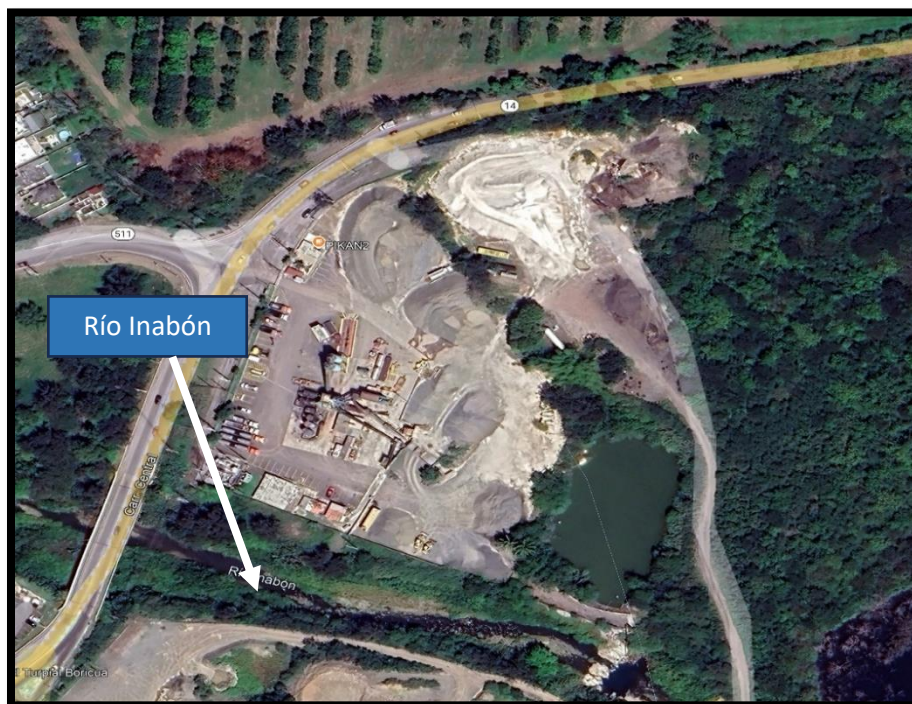
*Image 2: Shows the body of water within the Facility Action Area (Source: Google Earth Pro™, dated, 2024).*

The Inabón River is the nearby surface water near the south boundary of the Site. The River is classified as a SD water in the Puerto Rico Water Quality Standards Regulation (“PRWQSR”) promulgated by the Puerto Rico Department of Natural and Environmental Resources (“DNER”) on November 23, 2022. **Image 2** (below) shows an aerial image of the Facility and the River location within the Facility action area.
