## Bendix Two-Shoe Brake (Single Anchor) (Continued)

### Eccentric Type Anchor

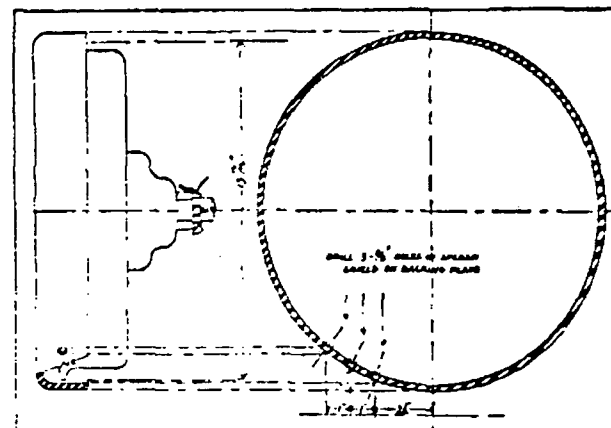
Fig. 8

Erratic wet weather performance on the 1934 Pontiac may be due to the collection of trapped mud and water inside the brake mechanism. This condition may be overcome by drilling the splash shield which is integral with the backing plate. Drill three 3/8" holes in this shield on all four BACKING PLATES at points 2 1/4", 3 1/2", and 4 1/2" back from center line of the plate.

Machining flange of brake drums to 13 11/16" O. D. gives approximately 1/8" clearance between brake drum flange and splash shield and allows water and mud to drain off.
