## U.S. EPA Region 8 NPDES Inspection Report

| National Database Information | |
|---|---|
| NAICS Code: <b>212321 (Construction Sand and Gravel Mining)</b> | Inspection ID: <b>202405_MTU000074</b> |

| Site/Facility Location Information | |
|---|---|
| Site/Facility Name & Location:<br><b>Uffelman Property</b><br><b>(inactive sand and gravel mine)</b><br><b>45.538706, -107.673056</b><br><b>Big Horn County, Montana</b> | Email Report to:<br><b>Scott Uffelman</b><br><b>(b) (6)</b> |

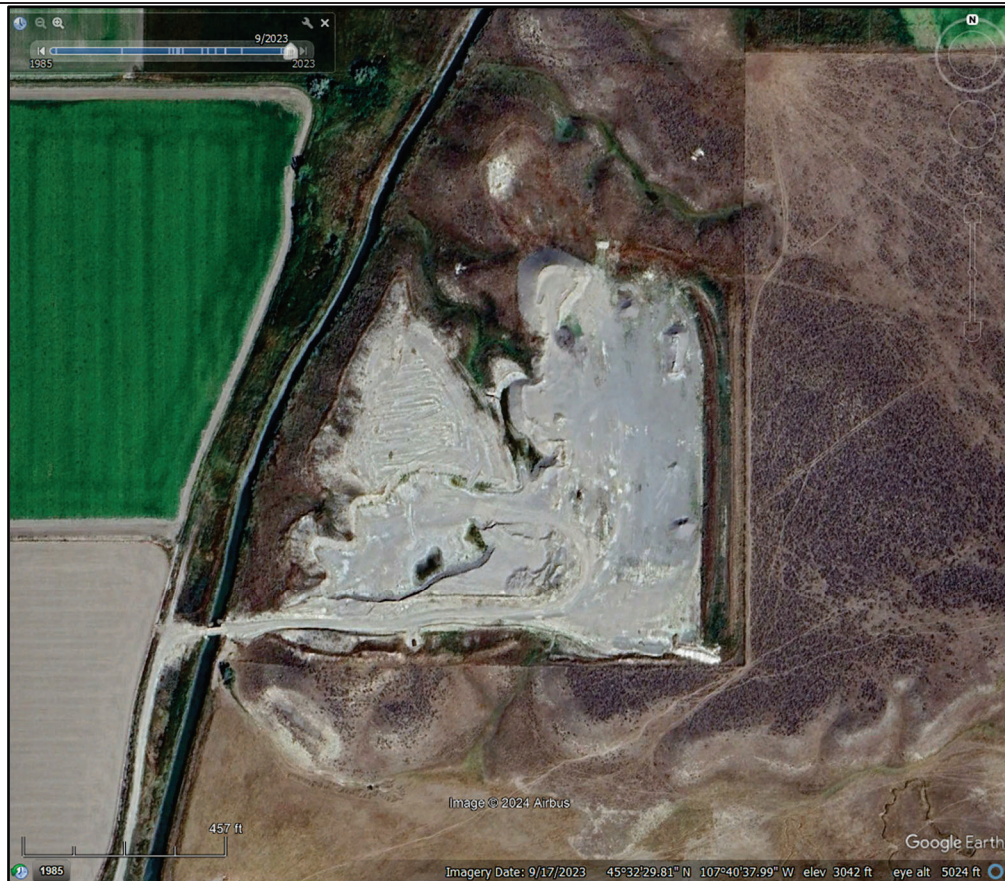
Figure 1. Aerial image of the site and surroundings  
Imagery Date: September 17, 2023  
Source: Google Earth Pro

A 2023 aerial image of the site is shown in Figure 1. Based on estimates made using the “Polygon” measurement tool and aerial imagery available in Google Earth Pro, approximately 15-20 acres have been disturbed at the site. Based on historical aerial imagery and information provided by Scott Uffelman during the inspection, the site was generally undeveloped prior to the commencement of mining activities. Scott Uffelman indicated sand and gravel mining and asphalt batch plant operations at the site had been conducted by Century Companies, Inc. (Century) during a 2-3 month window in the latter half of 2020 to support nearby construction activities associated with “Rotten Grass Highway.”
