REGION 3

Report Title: Clean Water Act Compliance Inspection Report
Inspection Date(s): 09/25/2024
Regulatory Program(s): National Pollutant Discharge Elimination System (NPDES)
Type of Activity: Industrial Wastewater & Stormwater Inspection
Site/Facility Name: Tradepoint Atlantic Shipyard
Permittee(s): Tradepoint Atlantic & U.S. Wind
Site/Facility Operator: Tradepoint Atlantic & U.S. Wind
Site/Facility Address: 6995 Bethlehem Boulevard
 Edgemere, MD 21219
Latitude: 39°14'10"N **Longitude:** -76°28'37"W
County/Parish: Baltimore County
Permit Number: Four total permits: MD0001201, MDR003099, IU Permit (#1711),
 MD0001180, MDR003791
NAICS Code: 336611, 423930 **SIC:** 3731, 5093
Unique Project #: ECAD-522

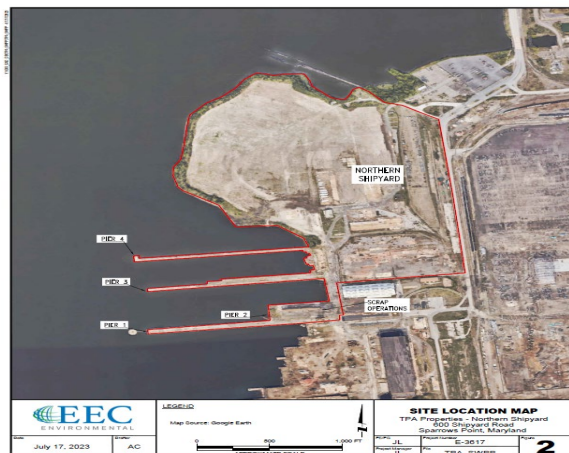
Facility Map (Southern Portion)**Facility Map (Northern Portion)***Facility History*
