## NPDES Tribal Wastewater Lagoon

| National Database Information | |
|---|---|
| Inspection Date: November 16, 2023 | Inspection Type: CEI-Unpermitted Lagoon |

| Facility Location Information | |
|---|---|
| Site/Facility Name & Location:<br>Kicking Horse Job Corps WWTF<br>33091 Mollman Pass Trail<br>Flathead Reservation, Montana<br>47.477259°N, 114.063694°W | Email Report to:<br>John Neiss, Facilities Maintenance Manager<br>Confederated Salish and Kootenai Tribes<br><a href="mailto:John.neiss@cskt.org">John.neiss@cskt.org</a> |

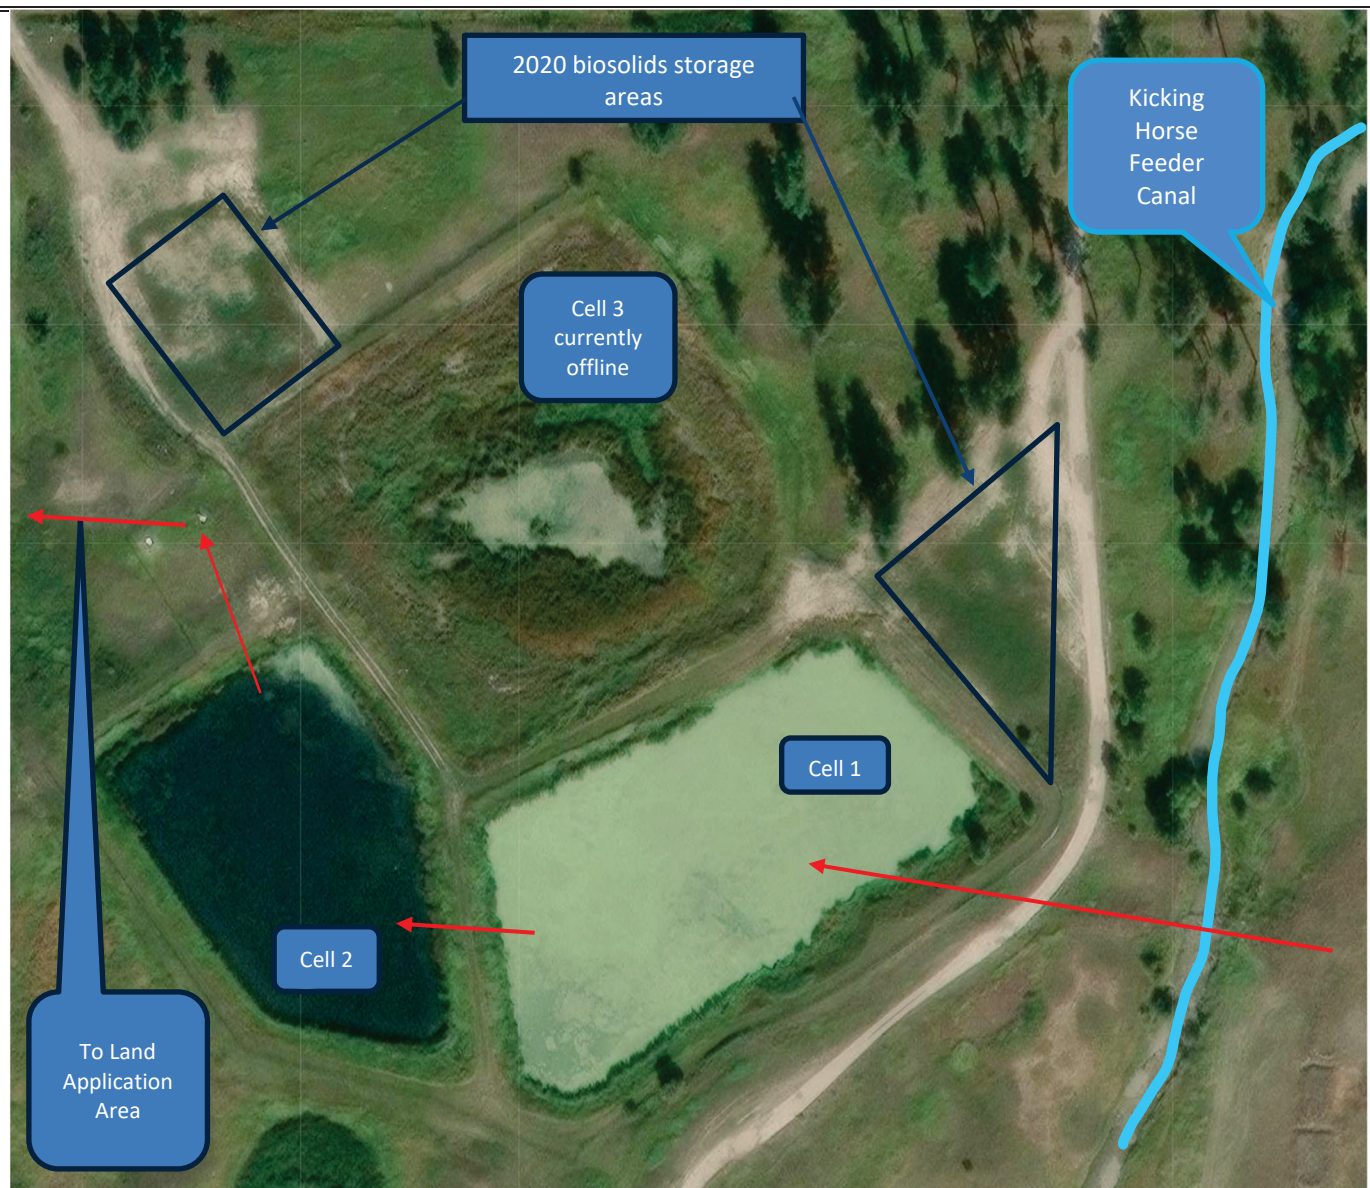
Kicking Horse Job Corps Wastewater Treatment Lagoons

Evan and I proceeded to walk the lagoon treatment area. We did not walk around the KHJC grounds. The collection system gathers all waste stream into a pipe which crosses over the Kicking Horse Feeder Canal (photo 825) and enters the wastewater treatment system. The system consists of three facultative wastewater treatment lagoons which run in series. Cell 1 is the southeast cell (photos 823 and 824), cell 2 is to the northwest (photos 819 and 820), and cell 3, which is currently offline (photos 821 and 822), is located to the north of both cells 1 and 2. Observations noted include the thick vegetation within the lagoon walls of lagoon cells 1 and 2, and the wet soils and standing water in cell 3. Evan and I did not observe the land application area, nor Moiese Valley Ranch. The areas used for sludge dewatering observed, and no disturbance remains (no photos).
