VISTA CHEMICAL COMPANY

ABERDEEN, MISSISSIPPI

HAZARD AND OPERABILITY STUDY

NEW MODULE

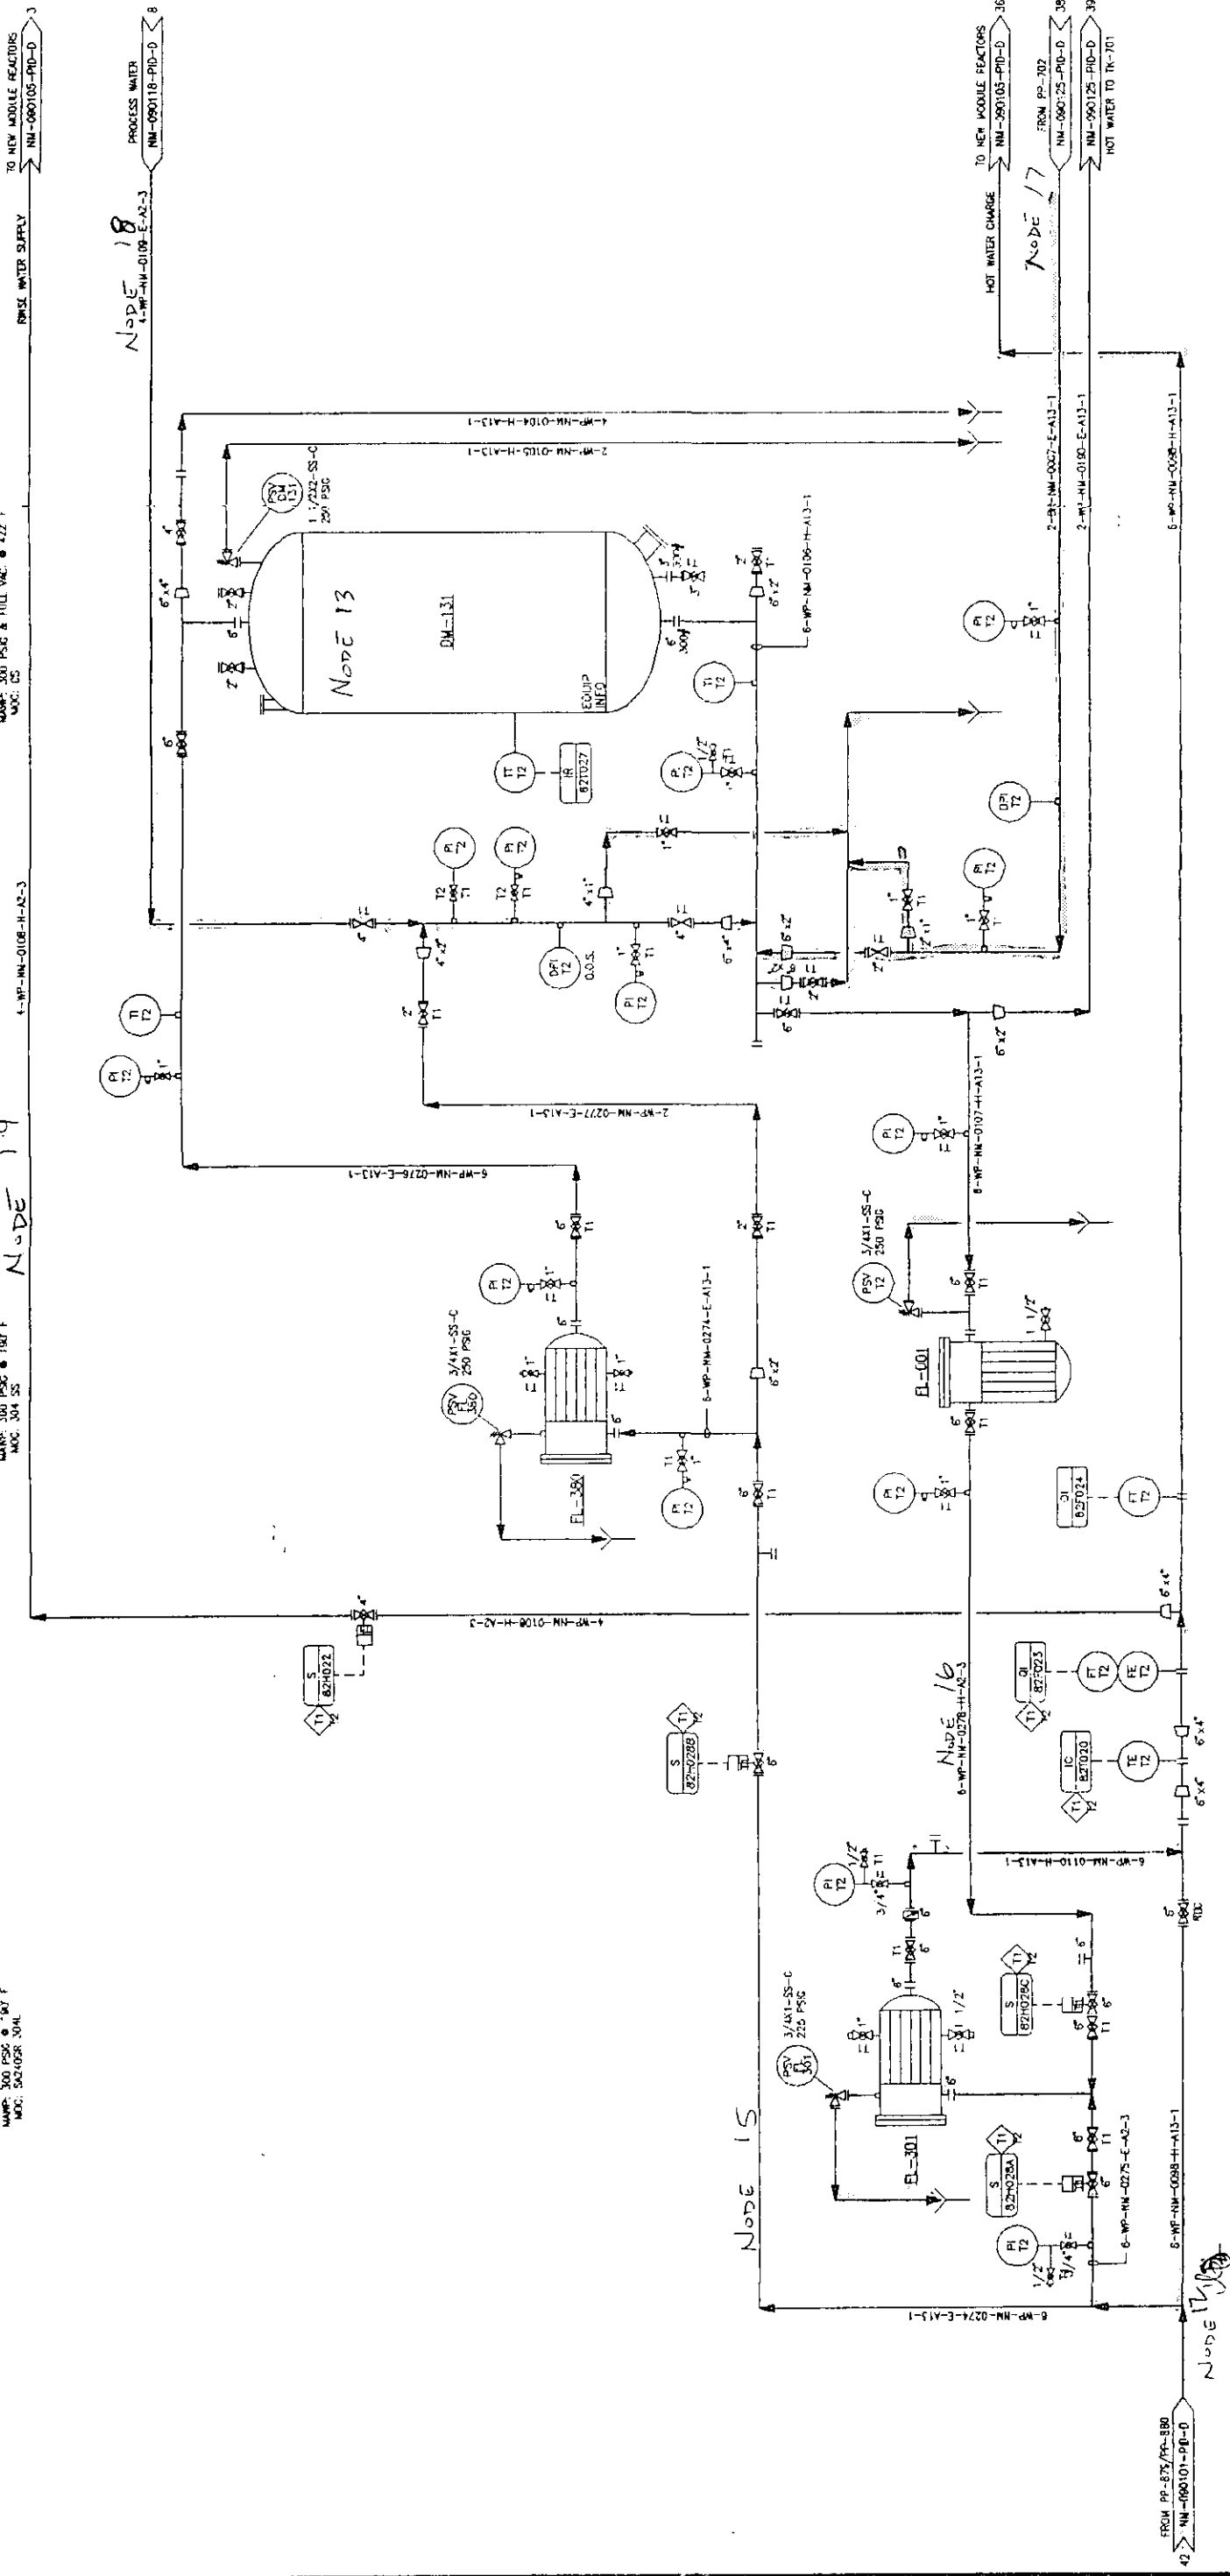
| NC. NM-090102-PID--D | ISSUE | 1 |

PROCESS & INSTRUMENTATION DIAGRAM  
NEW MODULE  
HOT WATER CHARGE & RINSE SYSTEM  
SHEET 2 OF 2
