**UNITED STATES ENVIRONMENTAL PROTECTION AGENCY, REGION 2**  
**CARIBBEAN ENVIRONMENTAL PROTECTION DIVISION**  
**MULTIMEDIA PERMITS AND COMPLIANCE BRANCH**

**NPDES STORMWATER RECONNAISSANCE INSPECTION**  
**Industrial Activities**

**ANGUILLA MUNICIPAL SOLID WASTE LANDFILL FACILITY**  
3C Estate Bethlehem Middle Works, St. Croix, USVI 00820  
Latitude: 17°41'55.46" N; Longitude: 64°46'51.78" W  
Telephone Number: 340-712-4962

**NPDES ID: VIU056746**

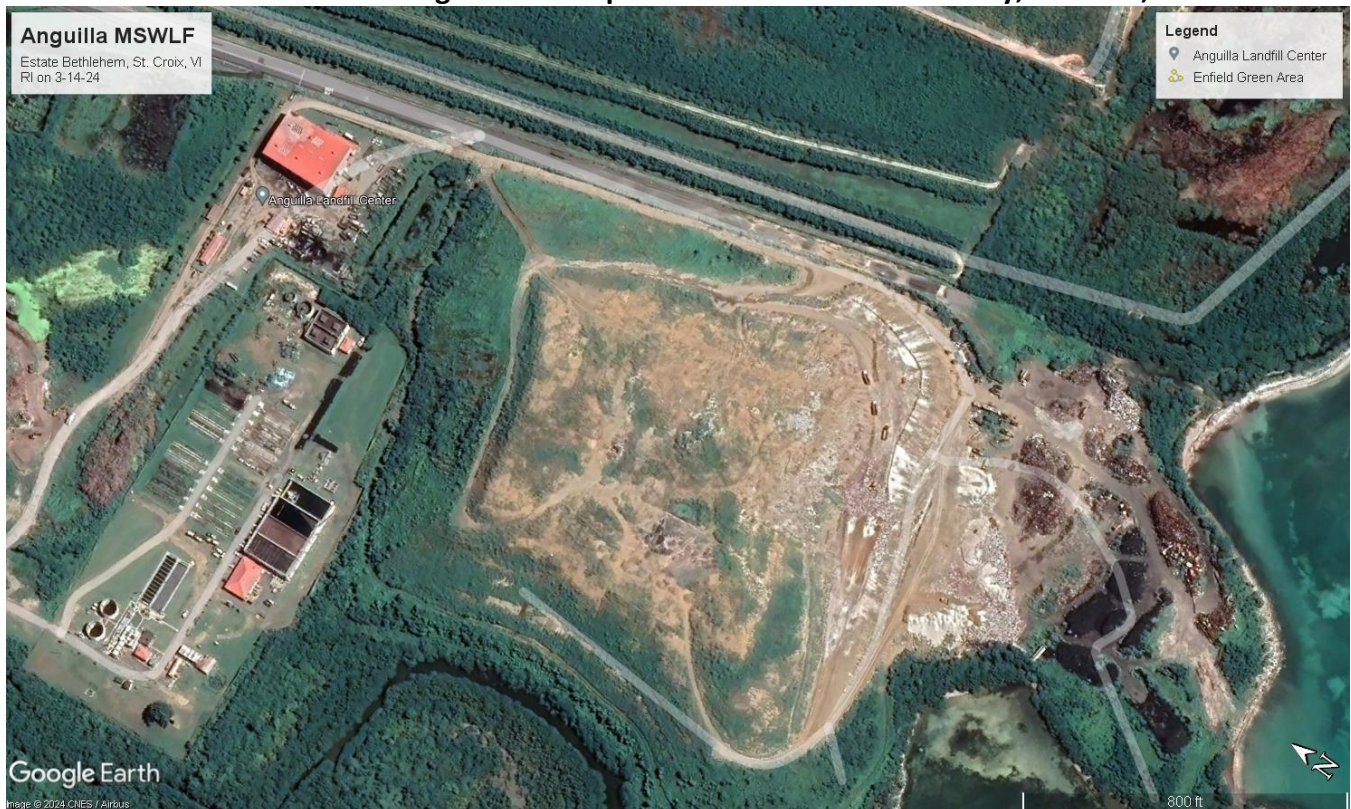
**VIWMA's Anguilla Municipal Solid Waste Landfill Facility, St. Croix, VI**

Satellite Imagery of the Facility<sup>6</sup> is presented as **Figure 1** (immediately below) of this Inspection Report. The date of the satellite imagery is November 30, 2022.

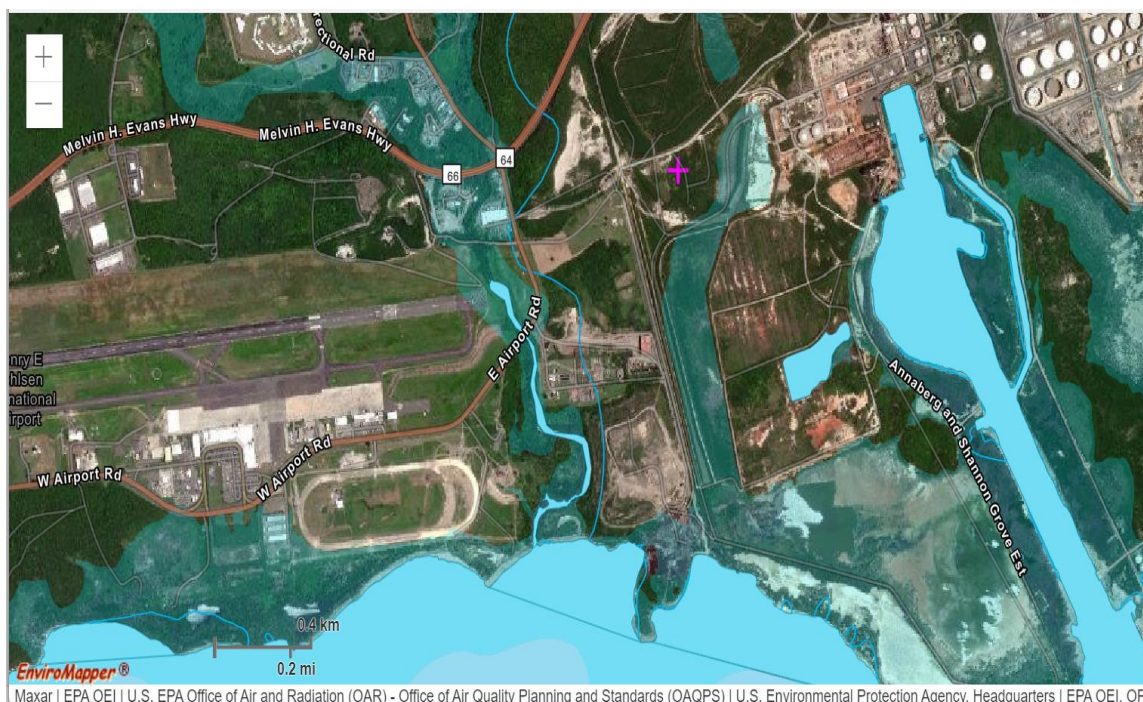
**Figure 2**

**VIWMA's Anguilla MSWLF situated within the southeastern section the watershed**

The Facility is situated along the south-central shoreline of St. Croix, and specifically, within the southeastern section of the watershed that drains into Negro Bay and Kings Bay (Caribbean Sea). An aerial view of the location of the Facility and immediate surroundings are depicted in a satellite imagery of the referenced Watershed featured in **Figure 2**, on the next page (Source: <https://nepassisttool.epa.gov/nepassist/nepamap.aspx>).
