## Attachment 7

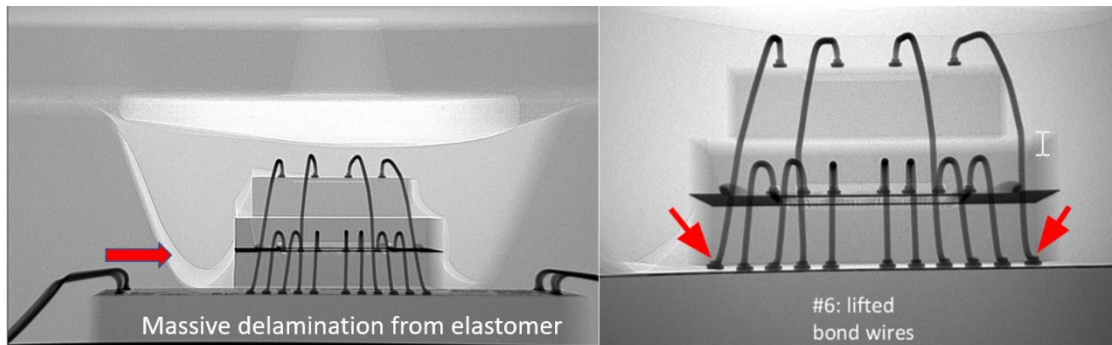
Elastomer delamination and broken wires after decompression test using non fluoroelastomers

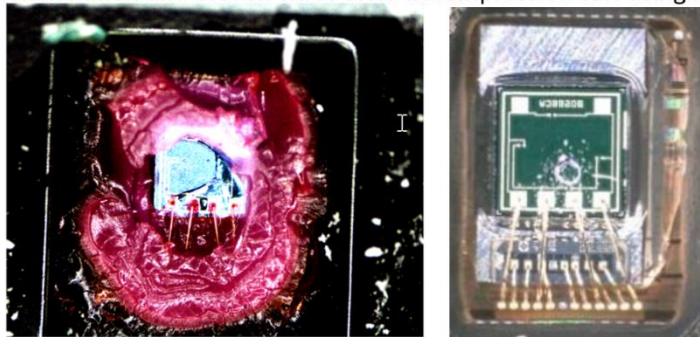
Catastrophic status of elastomer after soapy water exposure in comparison with robust fluoroelastomer
