**UNITED STATES ENVIRONMENTAL PROTECTION AGENCY, REGION 2**  
**CARIBBEAN ENVIRONMENTAL PROTECTION DIVISION**  
**MULTIMEDIA PERMITS AND COMPLIANCE BRANCH**

**NPDES Inspection**  
**Animal Feeding Operation**

**FINCA BETANIA DAIRY FARM**

**NPDES Tracking Number PRU201809**

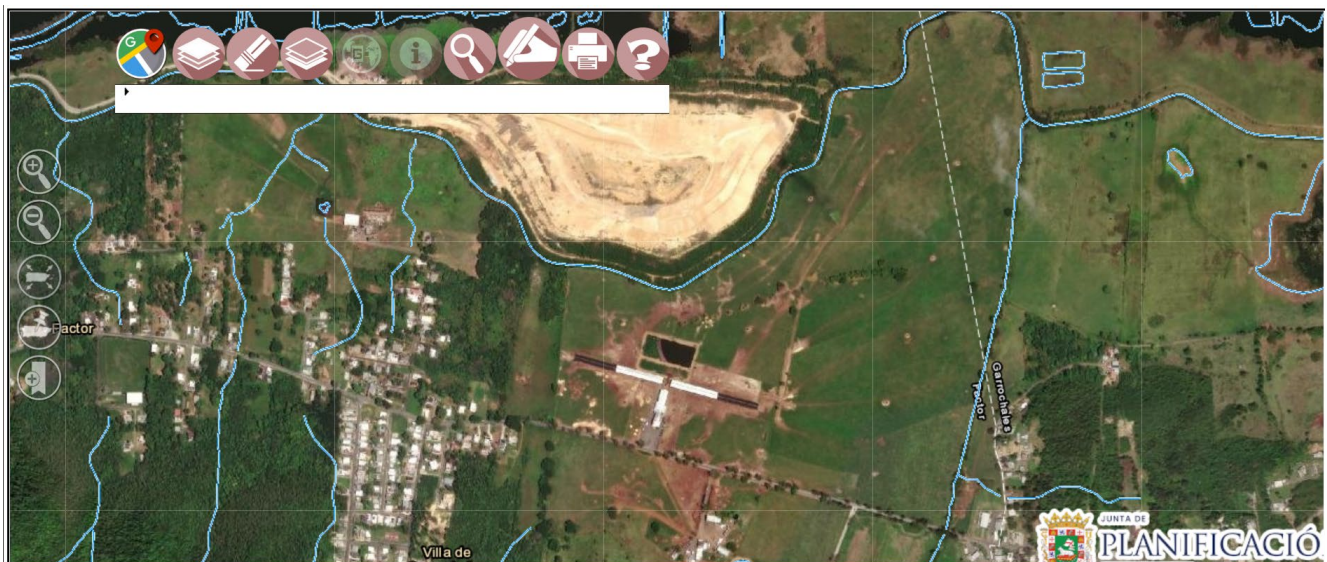
Image 2<sup>2</sup>

**Image 2** (next page) depicts the hydrographic area surrounding the Site, including Caño Tiburones.

<sup>2</sup> PR Planning Board MIPR database.
