# NPDES Compliance Inspection Report

## Cherry City Metals Salem, Oregon

Permit #: ORR603637

Inspection Date: December 13, 2021

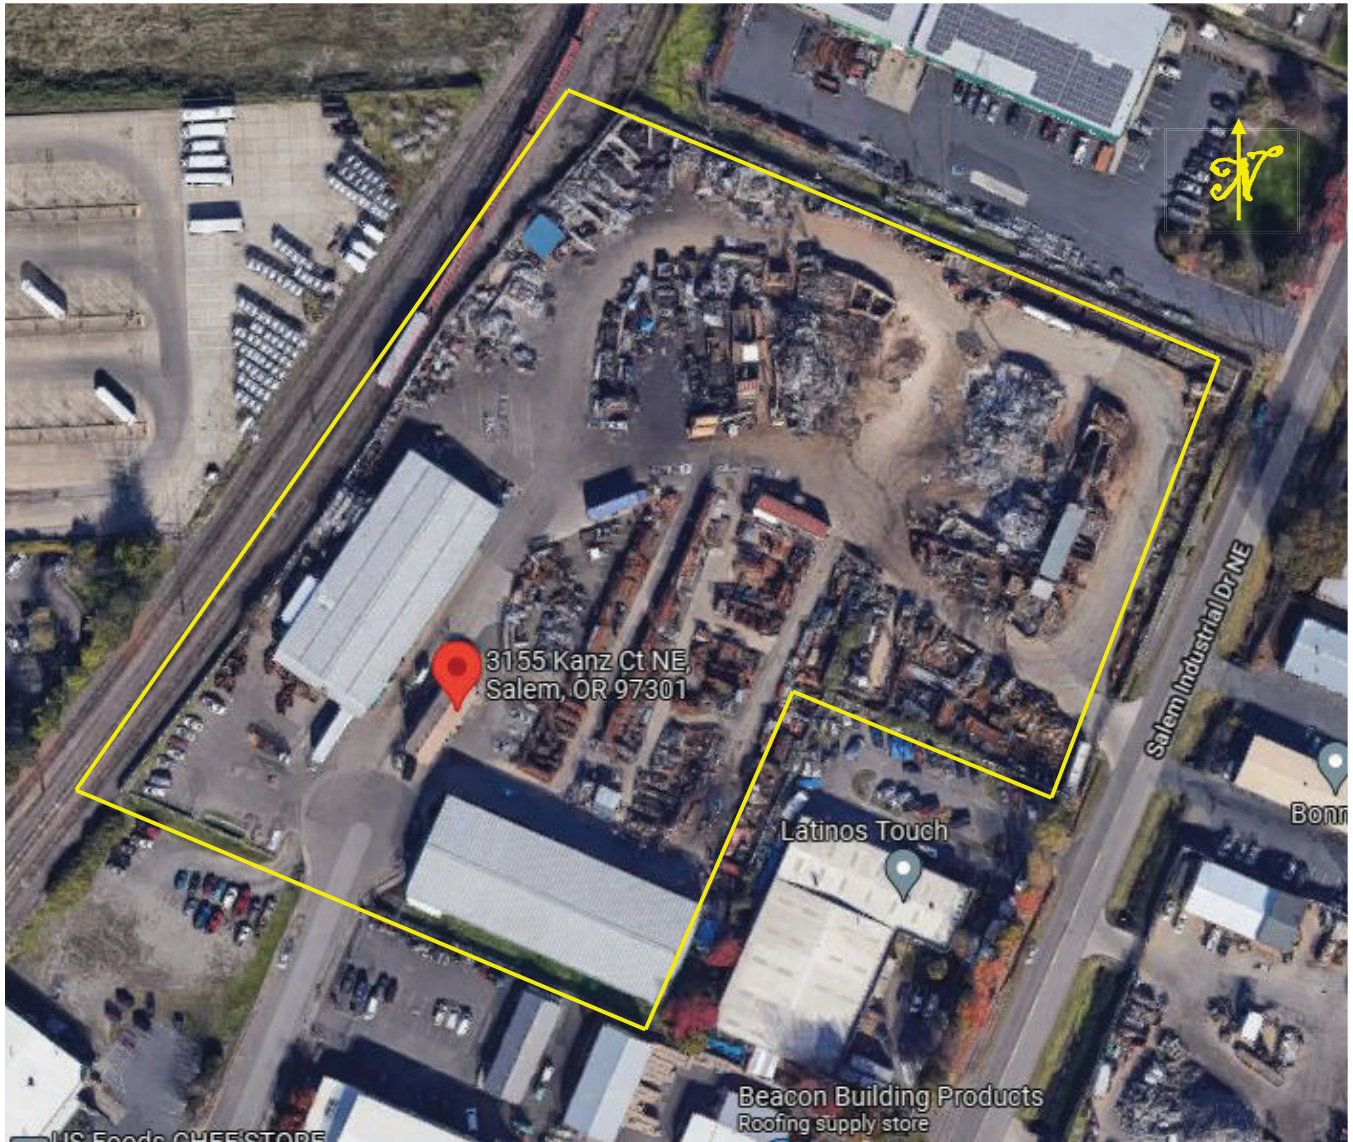
### Aerial Image of Site Provided by Google

Yellow outline denotes approximate site border.
