## Region 6 Compliance Assurance and Enforcement Division

### INSPECTION REPORT

| Facility Name: | <b>Bloomfield Wastewater Treatment Plant</b> | | |

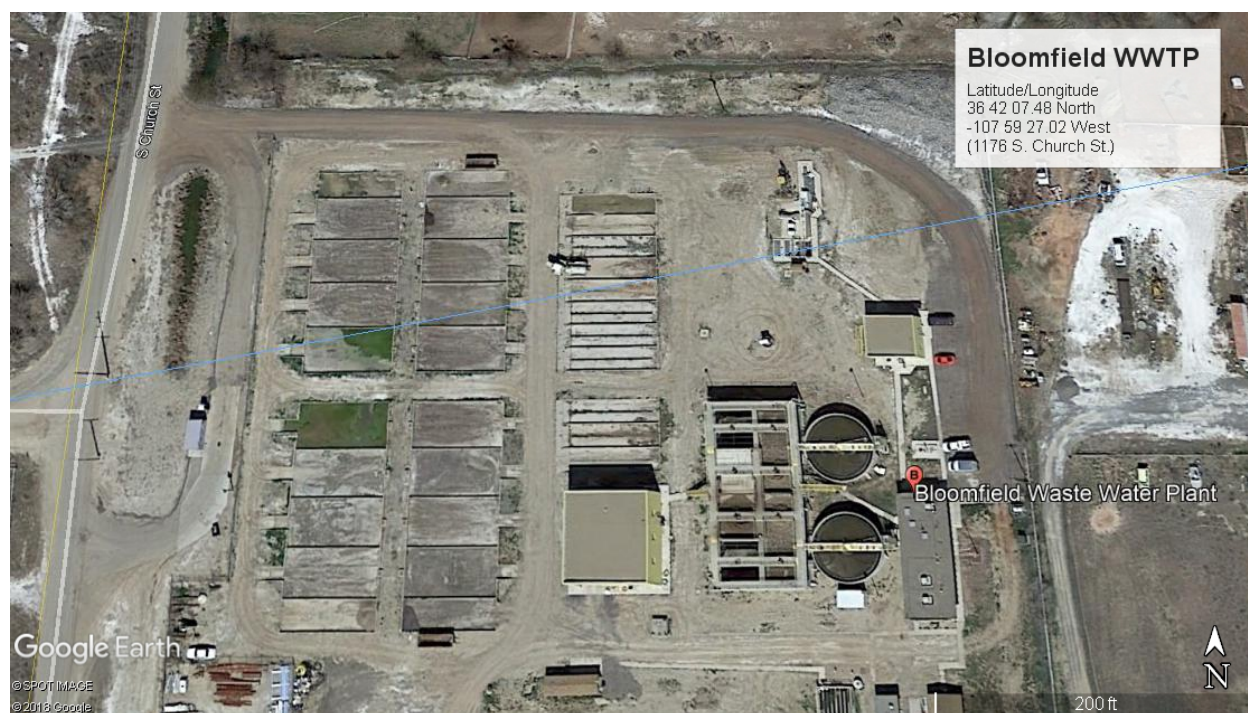
**Aerial Image #1:** Overall view of the City of Bloomfield Wastewater Treatment Plant. Aerial from Google Earth maps.

The WWTP is a major discharger with a design flow of 0.9 million gallons per day (MGD), is located at 1176 S. Church Street, Bloomfield, San Juan County New Mexico (depicted in Aerial Image #1 below). The WWTP facility serves a population of approximately 7,100 (2016 US Census) residents. The WWTP is operated by staff within the Public Works Department and consists of 4 full-time equivalent (FTE) positions, inclusive of administrative support on a Monday through Friday 8-hour per day basis. On-call staff is available on an as needed basis.
