UNITED STATES ENVIRONMENTAL PROTECTION AGENCY, REGION 2  
CARIBBEAN ENVIRONMENTAL PROTECTION DIVISION  
MULTIMEDIA PERMITS AND COMPLIANCE BRANCH

**Industrial Facility**  
**NPDES Compliance Evaluation Inspection**

Commonwealth Oil Refining Company  
Firm Delivery, 600 Road 127, Peñuelas Puerto Rico 00624-7501  
State Road No. 127, Km. 17.3, Tallaboa Poniente Ward Peñuelas, Puerto Rico 00624  
Coordinates: 18° 00' 23.05" N; - 66° 44' 21.82" W  
Telephone Number: (787) 836-1350

**NPDES Permit Number PR0000345**  
Inspection Date: June 7, 2023

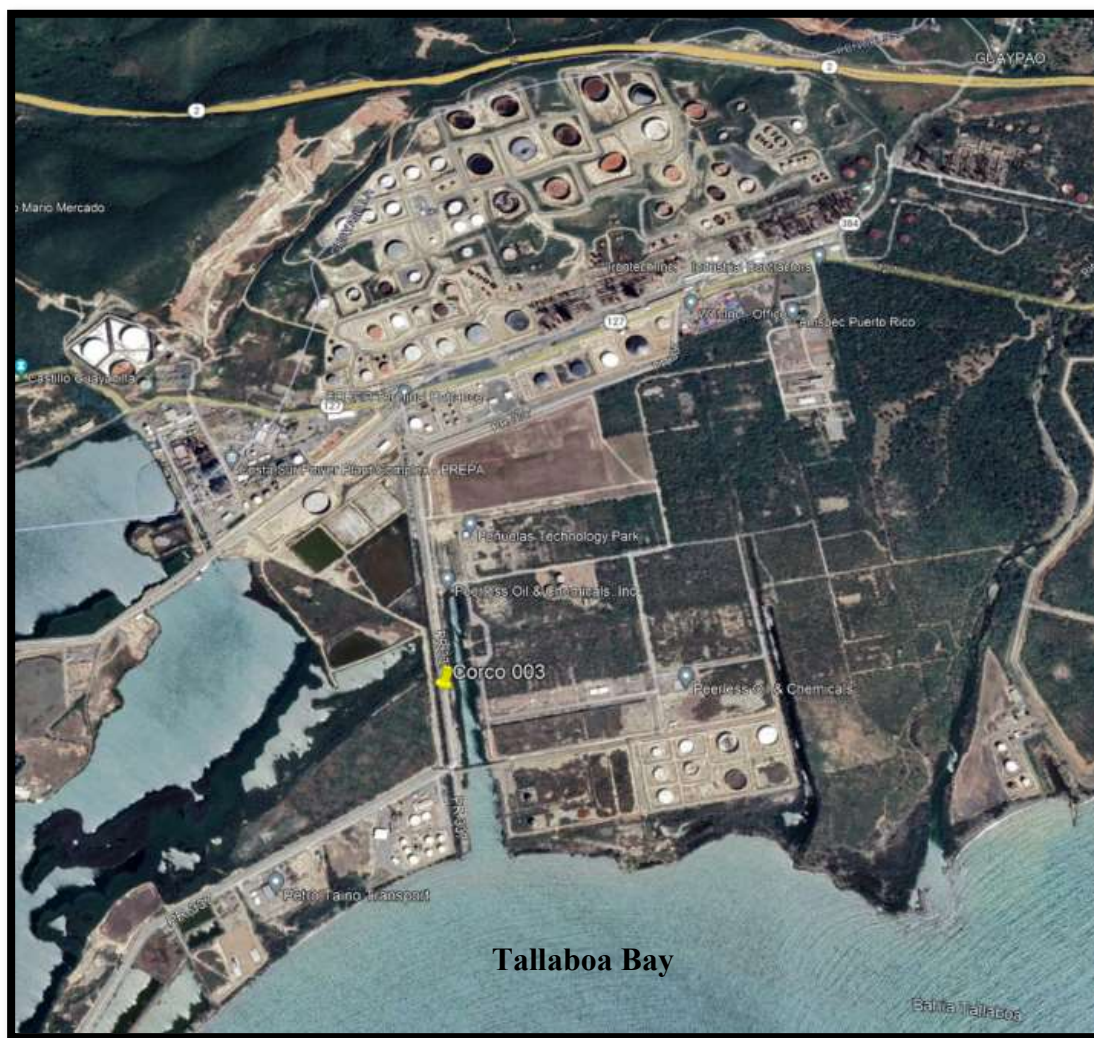
Image 1 below depicts an aerial photograph of the Facility and its surroundings.

Source: Google Earth Pro™, March 2023
