# Asbestos Exposure *VE Slaven* Assessment In Buildings *701-322* Inspection Manual

**ASBESTOS EXPOSURE ASSESSMENT IN BUILDINGS**

**INSPECTION MANUAL**

**Revised: October 1982**

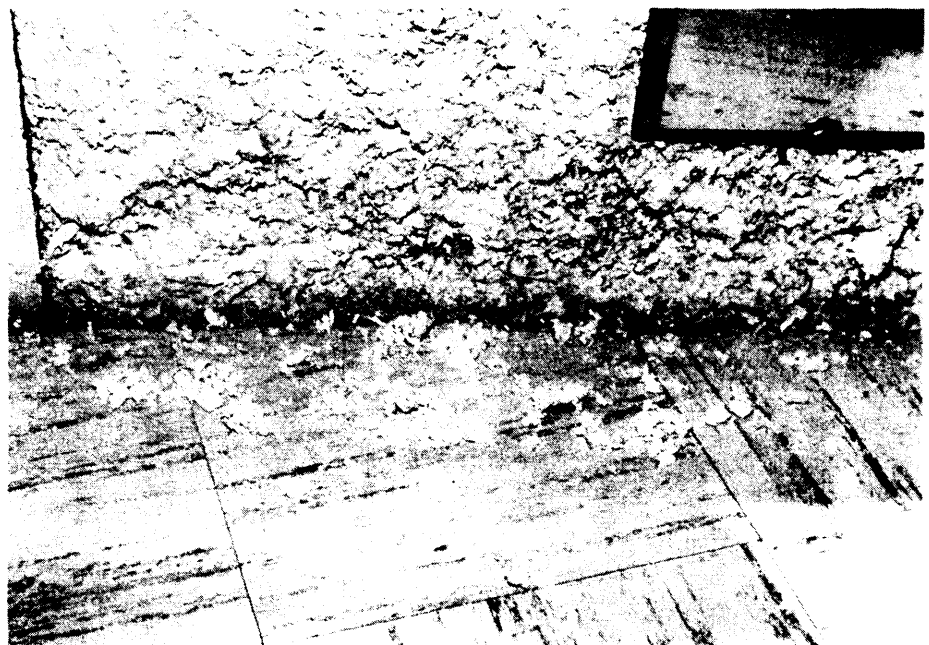
Asbestos-containing wall insulation deteriorated and falling to the floor.

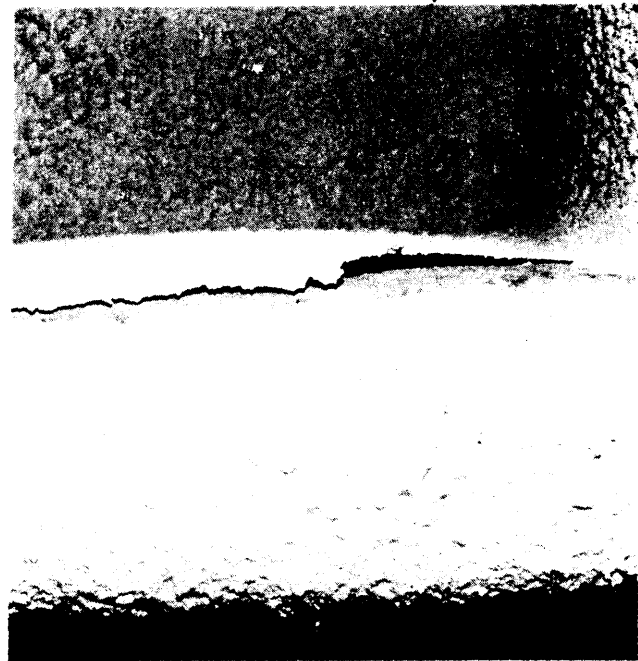
FACTOR TWO. WATER DAMAGE:

C. MODERATE TO MAJOR WATER DAMAGE: Water has dislodged some of the material and caused the material to break away, or has become saturated and has the potential to fall, and/or greater than 10 percent of the material has been affected. Asbestos fibers have been carried from the asbestos-containing material by water, evaporation has occurred, and the fibers have been deposited on other surfaces.

NUMERICAL VALUE: 2

Water has destroyed the bond between the acoustical plaster and the substrate. Note delamination of ceiling coating.

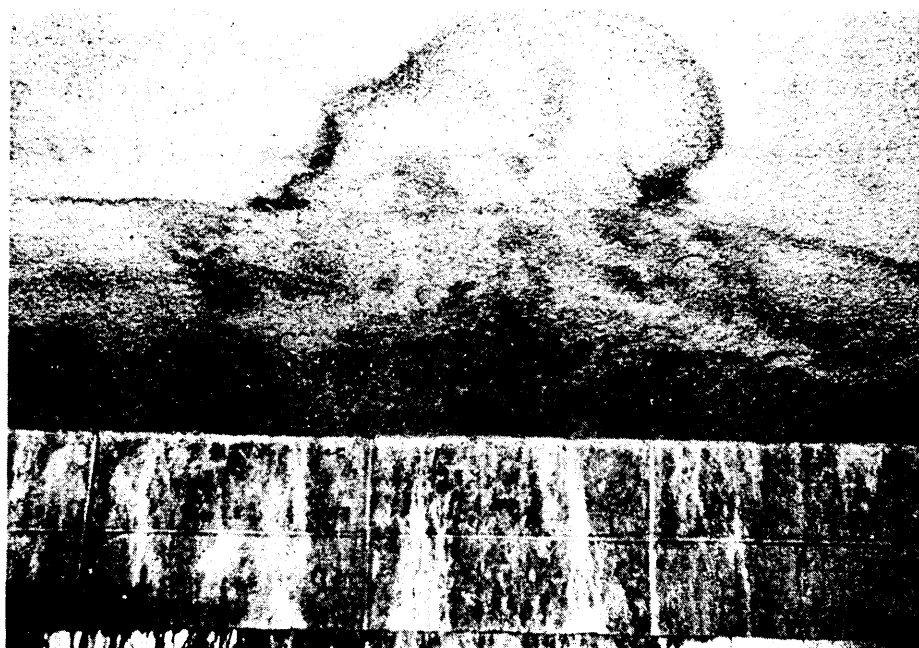
Water has leached asbestos fibers from the acoustical plaster ceiling, carried these fibers down the wall and evaporated leaving a deposit of asbestos fibers on the wall.

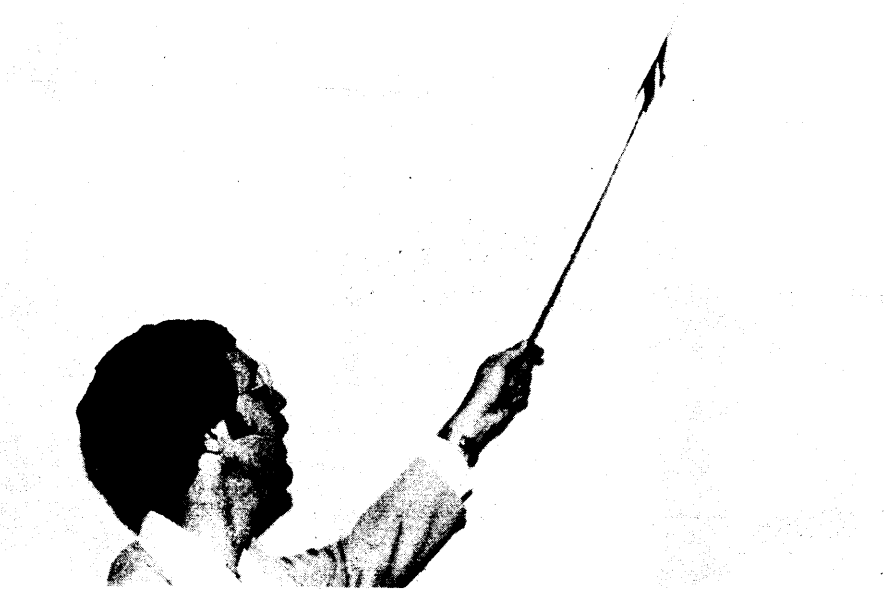
FACTOR THREE. EXPOSED SURFACE AREA:

B. TEN PERCENT OR LESS OF THE MATERIAL IS EXPOSED: A few panels of a suspended ceiling have been removed. Spaces between ceiling tiles exist which would allow fibers to pass through the barrier.

NUMERICAL VALUE: 1

Space between  
suspended ceiling  
panels and wall.  
Asbestos-containing  
insulation above  
suspended ceiling.

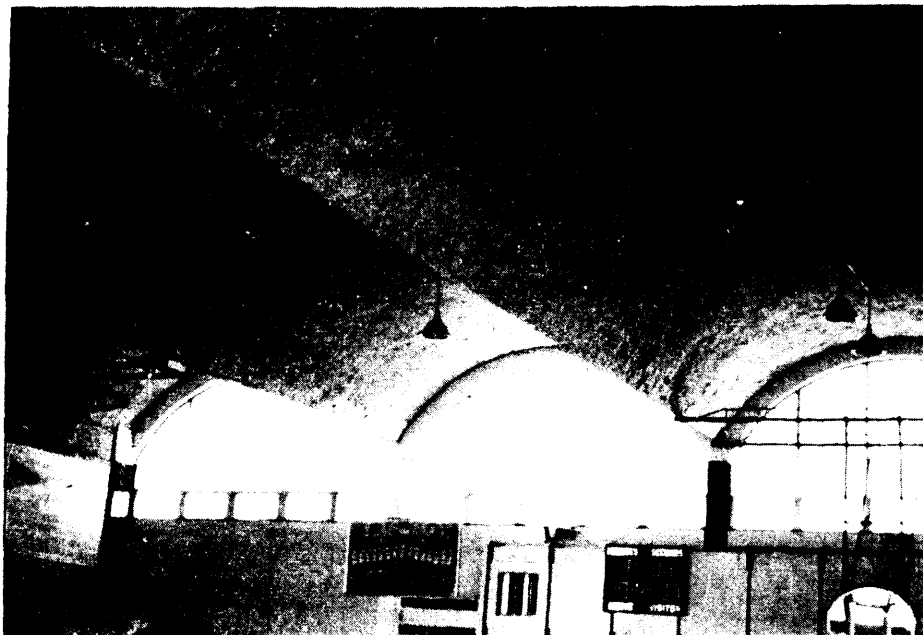
FACTOR THREE. EXPOSED SURFACE AREA:

C. GREATER THAN 10 PERCENT OF THE MATERIAL IS EXPOSED.

NUMERICAL VALUE: 4

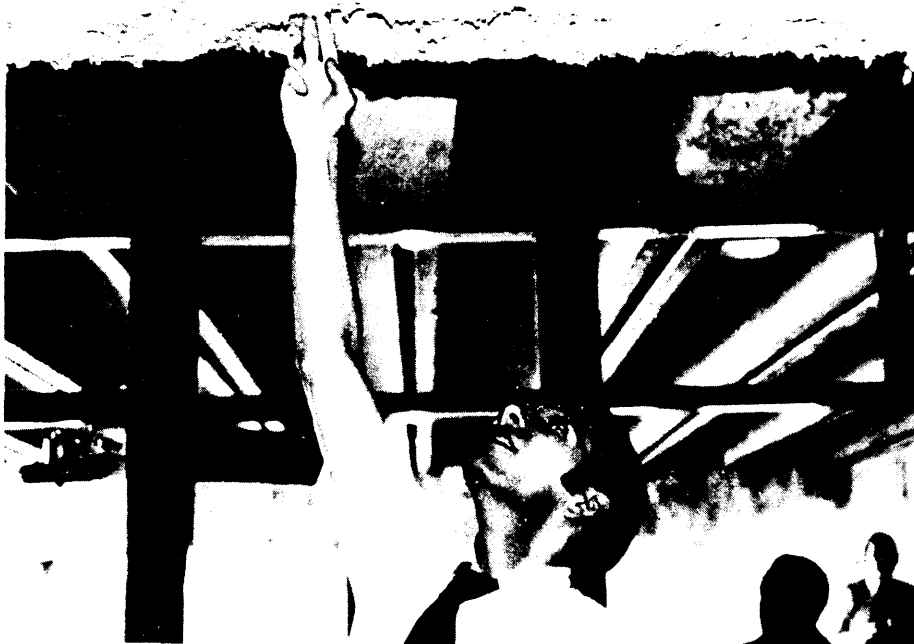
FACTOR FOUR. ACCESSIBILITY:

C. HIGHLY ACCESSIBLE: Material is contacted frequently due to routine maintenance. The building occupants can contact the material during normal activity at which time they routinely touch and dislodge the materials or throw objects against it.

NUMERICAL VALUE: 4

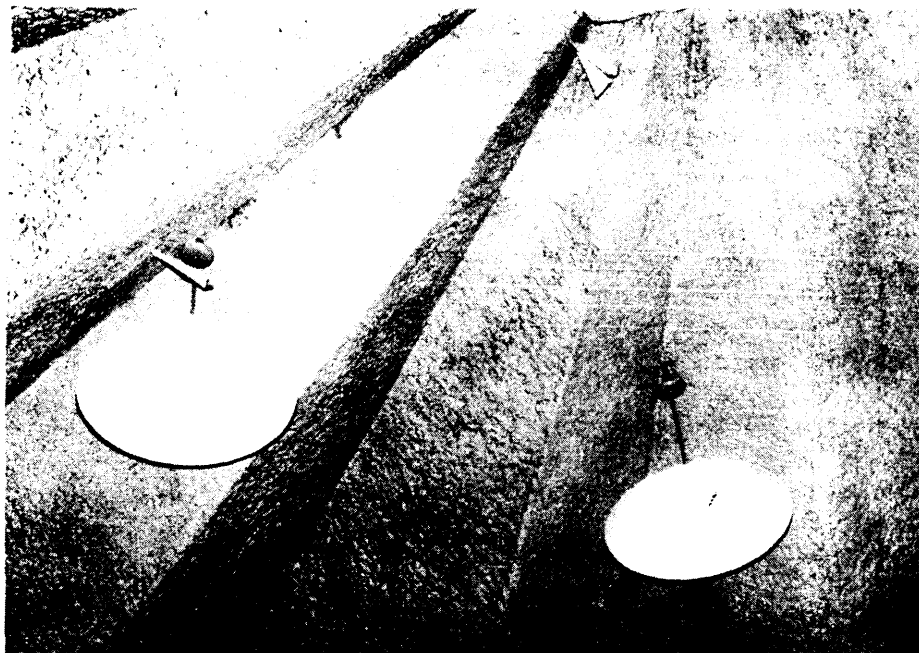
FACTOR FOUR. ACCESSIBILITY:

Although some asbestos-containing ceiling insulation may be out of the reach of building occupants, a ceiling is still considered highly accessible if items have been thrown at it. In many cases such items remain embedded in the insulation, as the paper airplanes in the photograph.

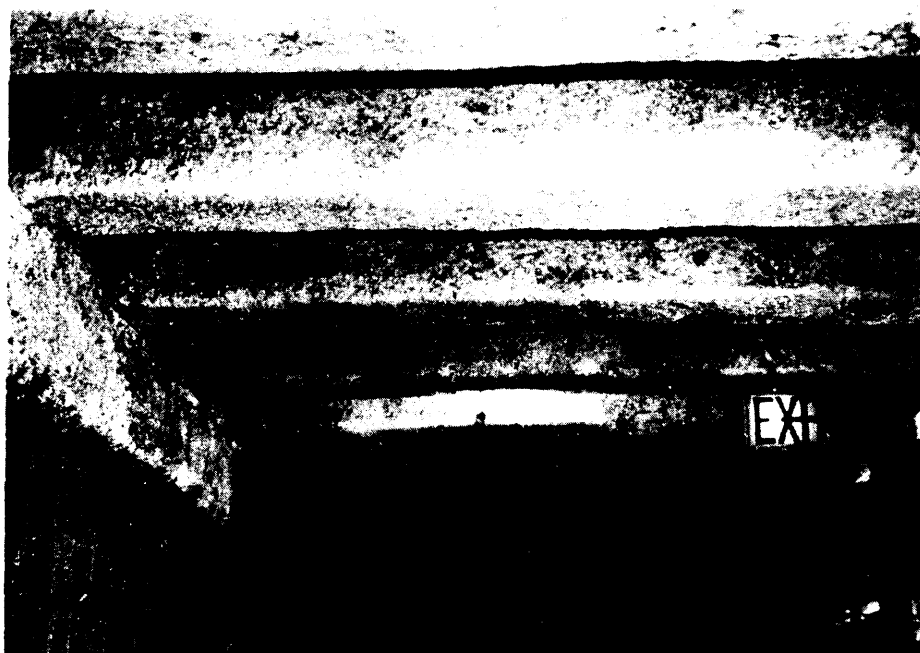
B. MODERATE ACTIVITY: This level describes corridors, classrooms or other areas where activities exist that could create undue vibration. This vibration could result in fibers being released from the material into the immediate area.

NUMERICAL VALUE: 1

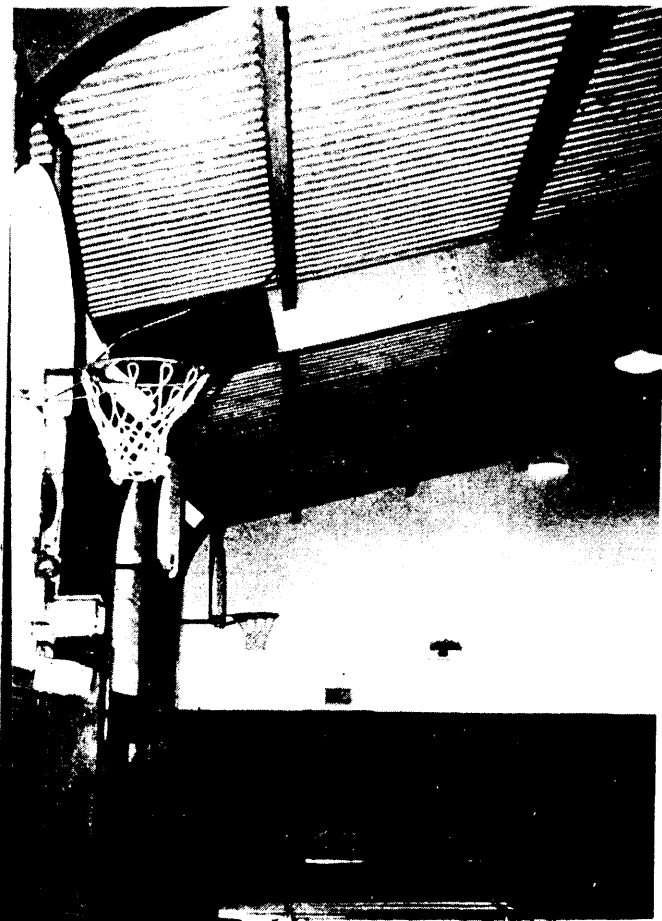
FACTOR FIVE. ACTIVITY AND MOVEMENT:

C. HIGH ACTIVITY LEVEL: This level may be found in cafeterias and corridors whose occupants are vandalous or disruptive in their activities. This also includes all gymnasiums, swimming pools and rooms containing machinery.

NUMERICAL VALUE: 2

Gymnasiums are high activity level areas and ceiling damage is usually evident.

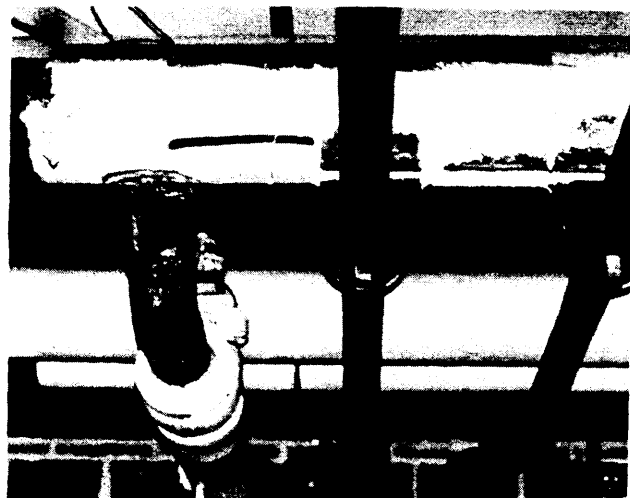
Preformed, asbestos/magnesia, pipe wrapping covered by a protective jacket.

Asbestos-containing pipe and boiler wrapping has been manufactured in various forms, the most common having the appearance of a white, chalky material. Often this material has been preformed to accomodate a certain diameter pipe or molded into bricks for attachment around boilers. Other types of pipe and boiler wrapping have the appearance of mud or an insulating blanket. Some pipe wrapping has been made from corrugated, asbestos-containing paper. Pipe and boiler wrapping is covered on the outside with a protective jacket constructed of such materials as cloth, canvas or metal. Undamaged and intact protective jackets should prevent spontaneous asbestos fiber release. Care must be exercised to prevent the tearing of the fabric jackets and the release of asbestos fibers. Such common practices as laying ladders against pipes and boilers or storing boxes against wrapped pipes may have to be eliminated to prevent destruction of the asbestos-containing insulation and fiber release. Correcting minor damage to pipe and boiler wrapping can often be accomplished with duct tape or re-wrapping torn protective jackets. Replastering of the pipe and boiler wrapping may be required for larger damaged areas. If damage to the protective jacket and wrapping is so extensive that removal is the only option, the same containment and worker protection measures must be implemented as required for safe asbestos removal from ceilings or walls.
