**Region 6 Compliance Assurance and Enforcement Division  
INSPECTION REPORT**

| Facility Name: | <b>Aztec Wastewater Treatment Plant</b> | | |
| Identification/Permit Number: | NM0020168 | | |

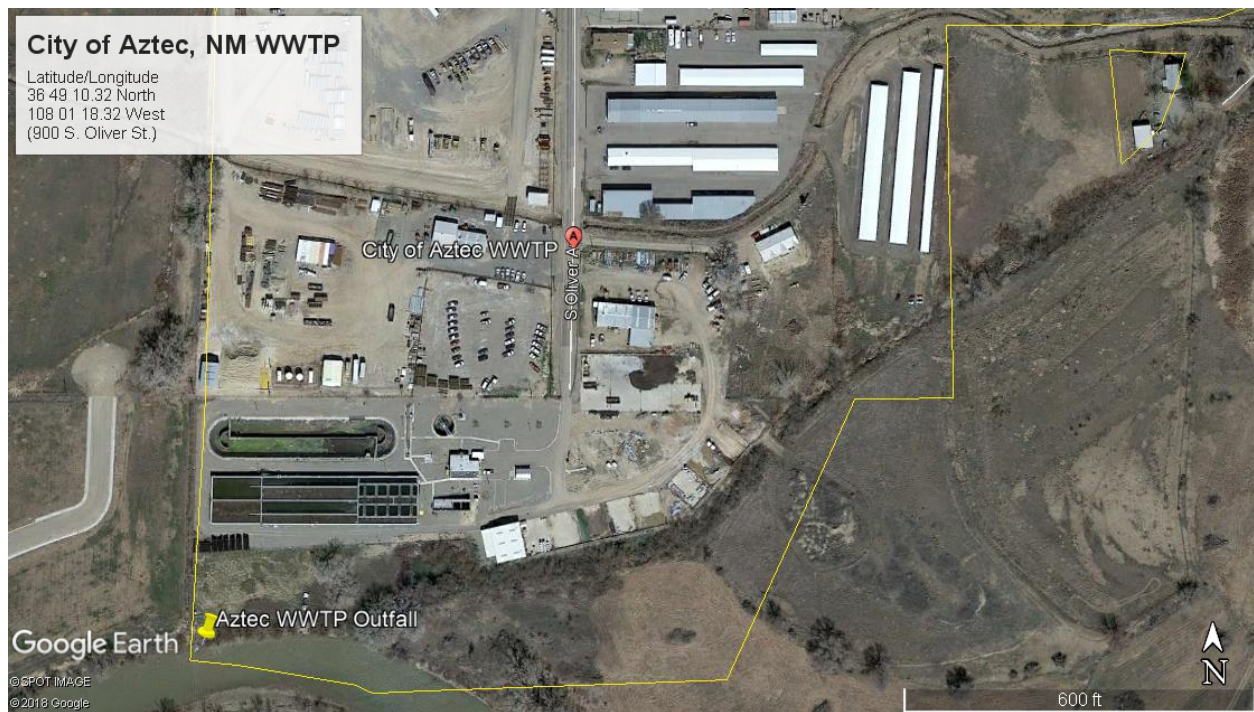
**Aerial Image #1:** Overall view of the City of Aztec's Wastewater Treatment Plant and Outfall 001. Aerial from Google Earth maps.

The WWTP is a major discharger with a design flow of 1.2 million gallons per day (MGD) Aero-Mod activated sludge treatment plant which was commissioned in September 2009. The activated sludge treatment facility is located at 900 South Oliver Street, Aztec, San Juan County New Mexico (depicted in Aerial Image #1 below). The WWTP facility serves a population of approximately 6,000 (2016 US Census) residents. The WWTP is operated by staff within the Public Works Department and consists of 5 full-time equivalent (FTE) positions on a Monday through Friday 7:00 AM to 5:00 PM. On-call staff is available on an as needed basis in addition to "spot-checks" on the weekends.
