E. I. du Pont de Nemours & Company, Inc.

Research Report

AN ACCELERATED TEST FOR THE  
CRACKING OF HOUSE PAINT ON WOOD

Date Issued : September 21, 1959  
 Period Covered : 10/58 to 6/59  
 Project No. : 2191  
 Previous Reports: 6830, 6894  
 Notebook Nos. :

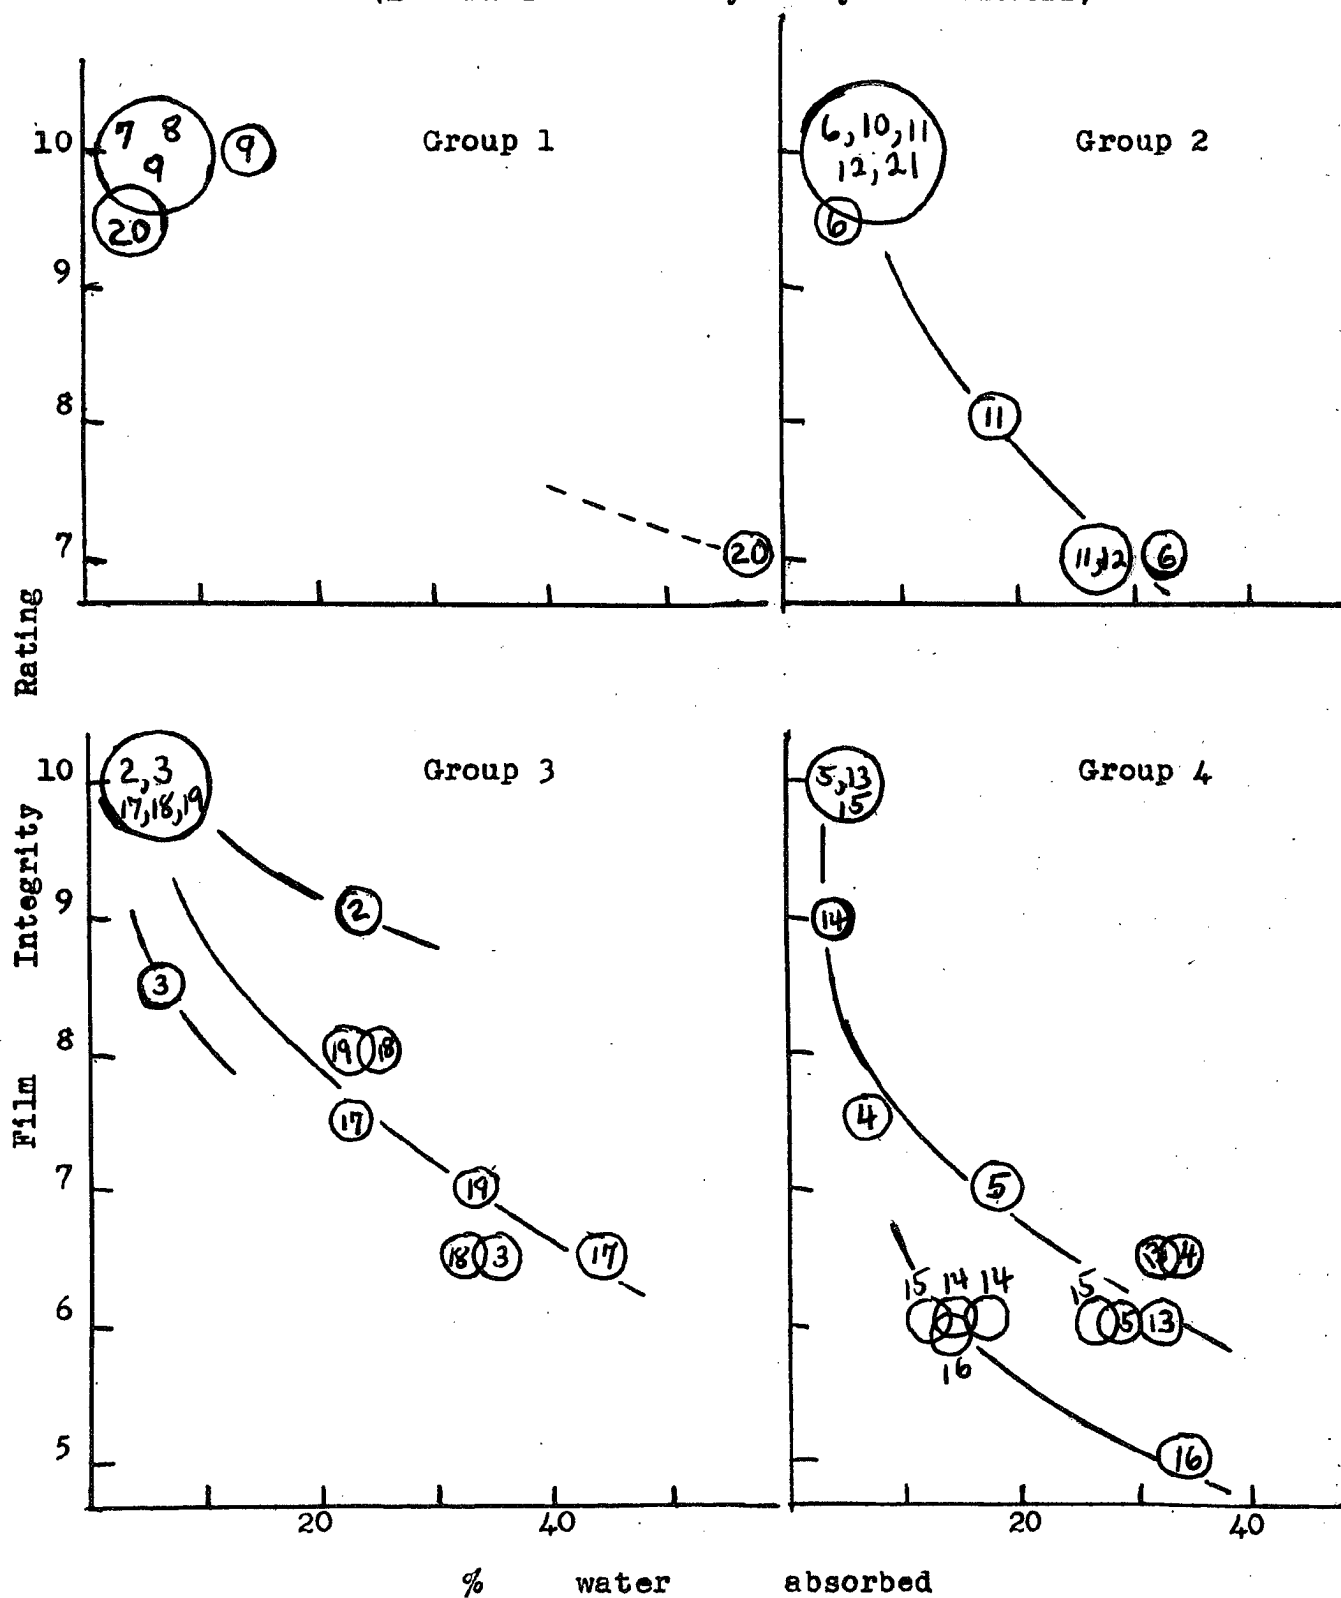
FIGURE I - CRACKING AND WATER ABSORPTION IN SERIES 17867

AT 1000 HOURS IN THE AWC II WEATHERING CYCLE

(See Table V for key to system numbers)
