**Region 6 - Enforcement & Compliance Assurance Division**  
**INSPECTION REPORT**

| <b>Inspection Date(s):</b> | 11/20/2024 | |
| <b>Media Program:</b> | Drinking Water | |
| <b>System Name:</b> | Bentonville Water Utilities | |

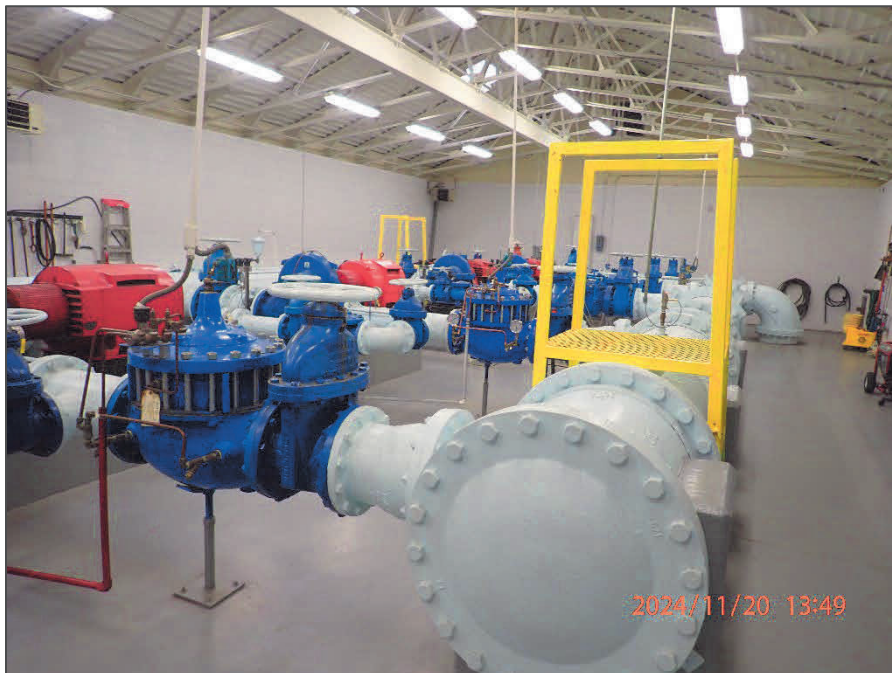
**Photograph 1. 11/20/2024 13:49**

The I Street Pump Station has two 75 horsepower (hp) pumps and two 250 hp pumps with variable frequency drive (VFD) control, which can be run in automatic or manual mode (refer to [Appendix 2, Photograph 1](#)). The pumps draw water from the System's 3 MG and 6 MG I Street Pump Station Tanks (refer to [Appendix 2, Photograph 2](#)) to fill the System's remaining three tanks. The System also monitors chlorine at the pump station (refer to [Appendix 2, Photograph 3](#)). The pump station is equipped with an on-site generator with the capacity to operate the pump station at full capacity for approximately 30 hours (refer to [Appendix 2, Photograph 4](#)).

Description: I Street Pump Station. The pump station has two 75 hp pumps and two 250 hp pumps.

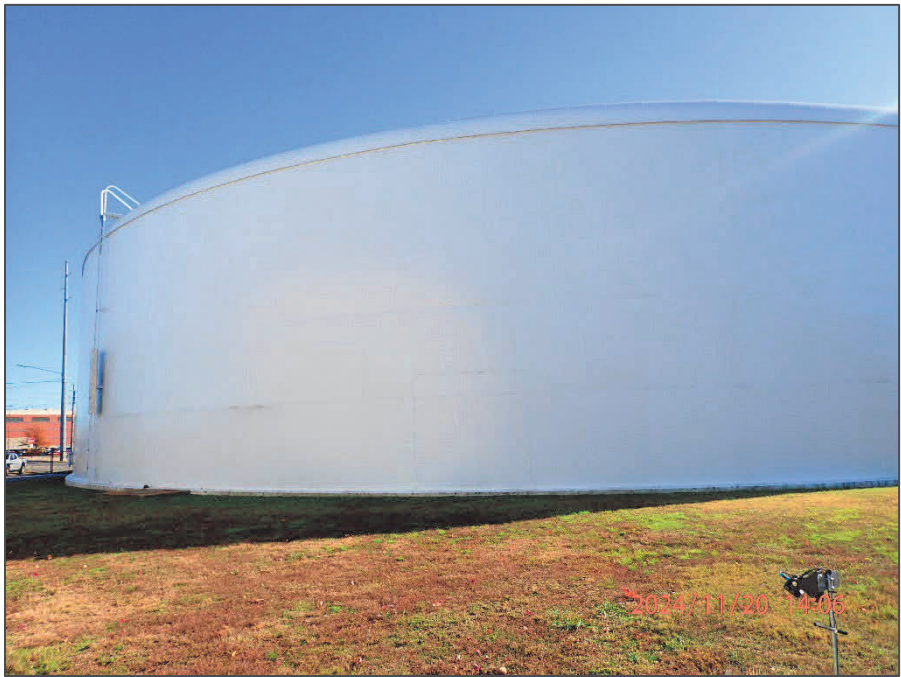
The two I Street Pump Station Tanks (3 MG and 6 MG) are welded steel ground tanks, which are inspected and maintained regularly through a contracted service (Utility Services). The tanks are equipped with acceptable security measures and professionally installed, industry-standard features

such as ladder access, rooftop vents, overflows, and level indication. The 6 MG tank uses passive mixing, and the 3 MG tank is equipped with an active mixer to maintain water quality. The exterior foundations, sidewalls, and coatings appeared to be in good condition.

**Photograph 2. 11/20/2024 14:06**  
Description: I Street 6-MG Tank located on the same site as the I Street Pump Station.

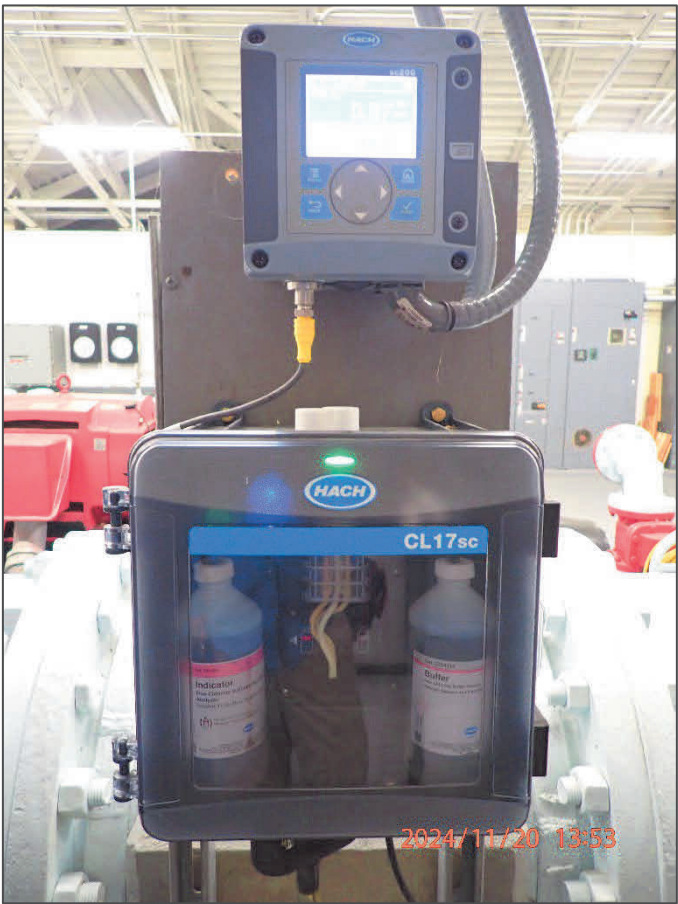
**Photograph 3. 11/20/2024 13:53**  
Description: I Street Pump Station. Chlorine residual is monitored at the pump station to confirm an adequate residual from Beaver Water District.

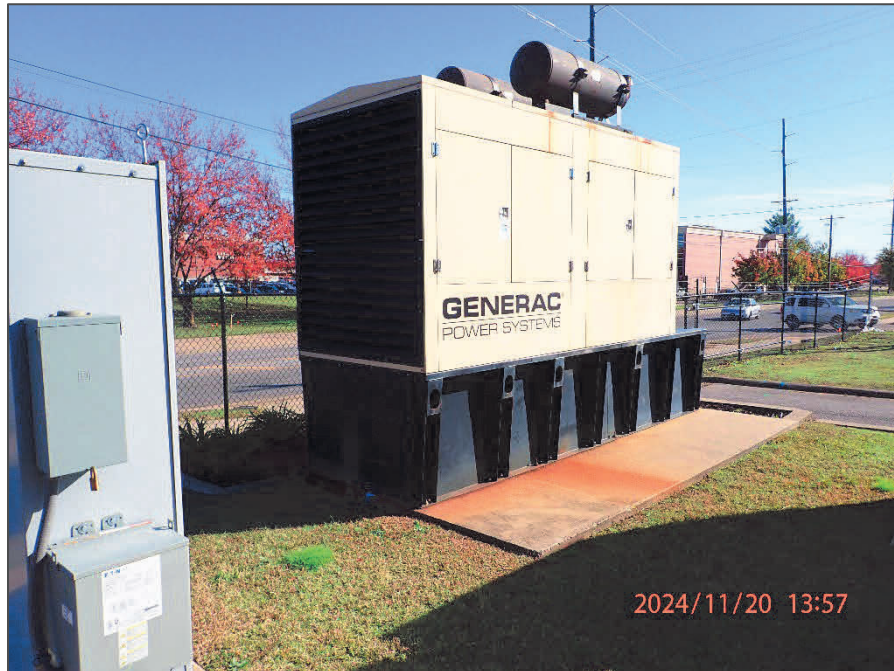
**Photograph 4. 11/20/2024 13:57**

Description: I Street Pump Station. The on-site generator is sized to operate the entire pump station.

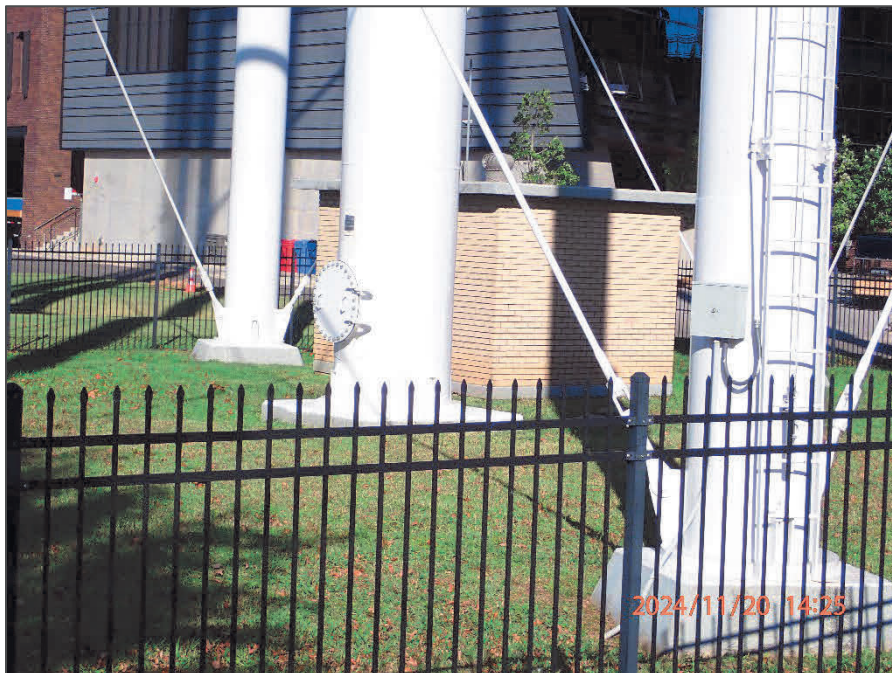
**Photograph 5. 11/20/2024 14:25**

The Downtown Tank is an elevated tank that was constructed in 1953. The tank is fenced with a locked gate (refer to [Appendix 2, Photograph 5](#)). Due to the tank's location and proximity to an elementary school, the city has not installed barbed wire fencing. The tank is gravity-filled and equipped with a control valve to avoid overfilling. The System uses the tank to supply water to the downtown distribution system via pump control at the I Street Pumping Station. The System has not deemed supply and pump operation critical to daily operation, but they operate it daily to turn over the water in the tank and maintain its operation for emergency use. The pump station consists of one low-capacity pump without an alternative power supply.

**Observation 6.** There is no ‘No Trespassing’ signage on the fencing around the tanks.

Description: Downtown Tank. The tank is fenced and locked, does not include barbed wire due to relationship with neighborhood partners, and does not have no trespassing signage.

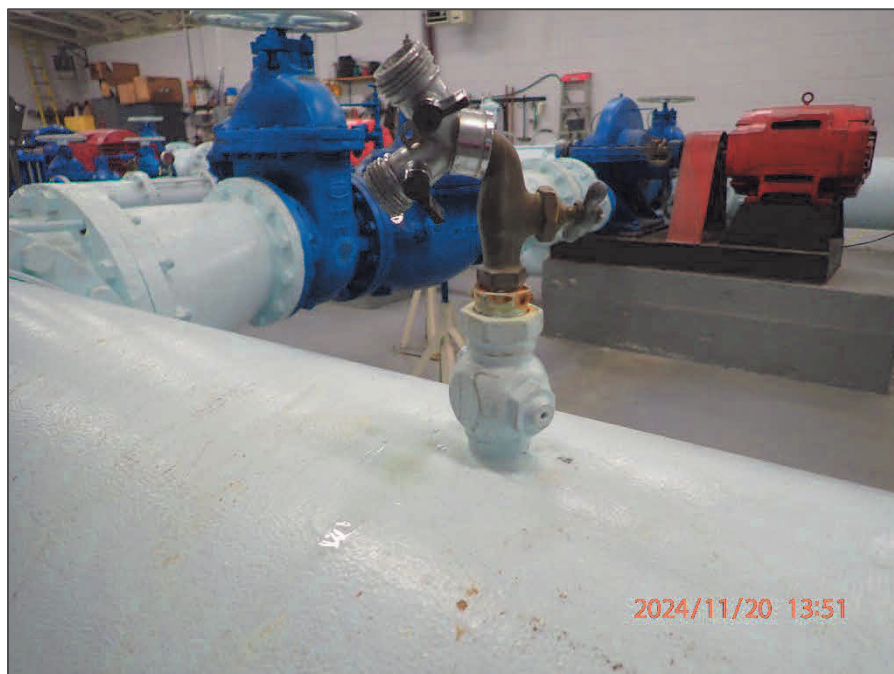
**Photograph 6. 11/20/2024 13:51**

**Observation 8.** The EPA inspection team observed threaded sample taps at the I Street pump station and at the Downtown Tank (refer to Appendix B Photograph 6 and Photograph 7)

Description: I Street Pump Station. Threaded sample tap on a finished water line.

**Recommended Standards for Water Works (Ten States Standards), 2022 Edition, Section 2.11** states, “Sample taps shall be provided so that water samples can be obtained from each water source and from appropriate locations in each unit operation of treatment, and from the finished water. Taps shall be consistent with sampling needs and shall not be of the petcock type. Taps used for obtaining samples for bacteriological analysis shall be of the smooth-nosed type without interior or exterior threads...”

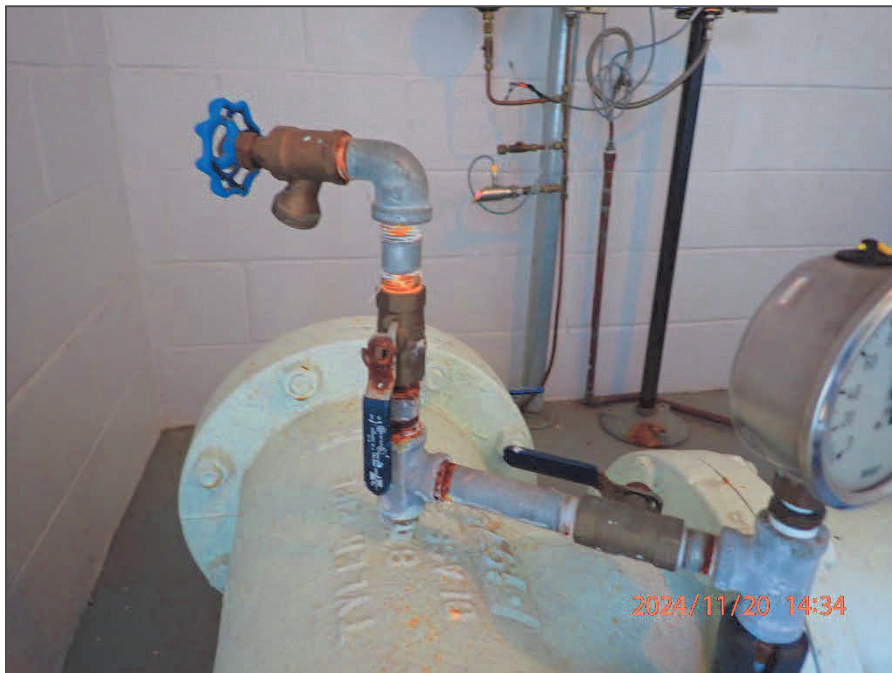
**Photograph 7. 11/20/2024 14:34**

Description: Downtown Tank. Threaded sample tap on a finished water line.
