## NPDES Inspection Report – Pretreatment Categorical Industrial User

| National Database Information | |
|---|---|
| Inspection Date: <b>02/25/2025</b> | Inspection Type: <b>Pretreatment Categorical Industrial User</b> |

| Facility Location Information (Name/Location/ Mailing Address) | |
|---|---|
| Site/Facility Name & Location:<br><b>Colorado Energy Management</b><br><b>1500 South Clayton Ave.</b><br><b>Brush, Colorado 80723</b> | Mail Report (Electronic Delivery) to:<br><b>Drew Moots</b><br><b>EH&amp;S Specialist</b><br><b>dmoots@camsops.com</b> |

INSPECTION REPORT

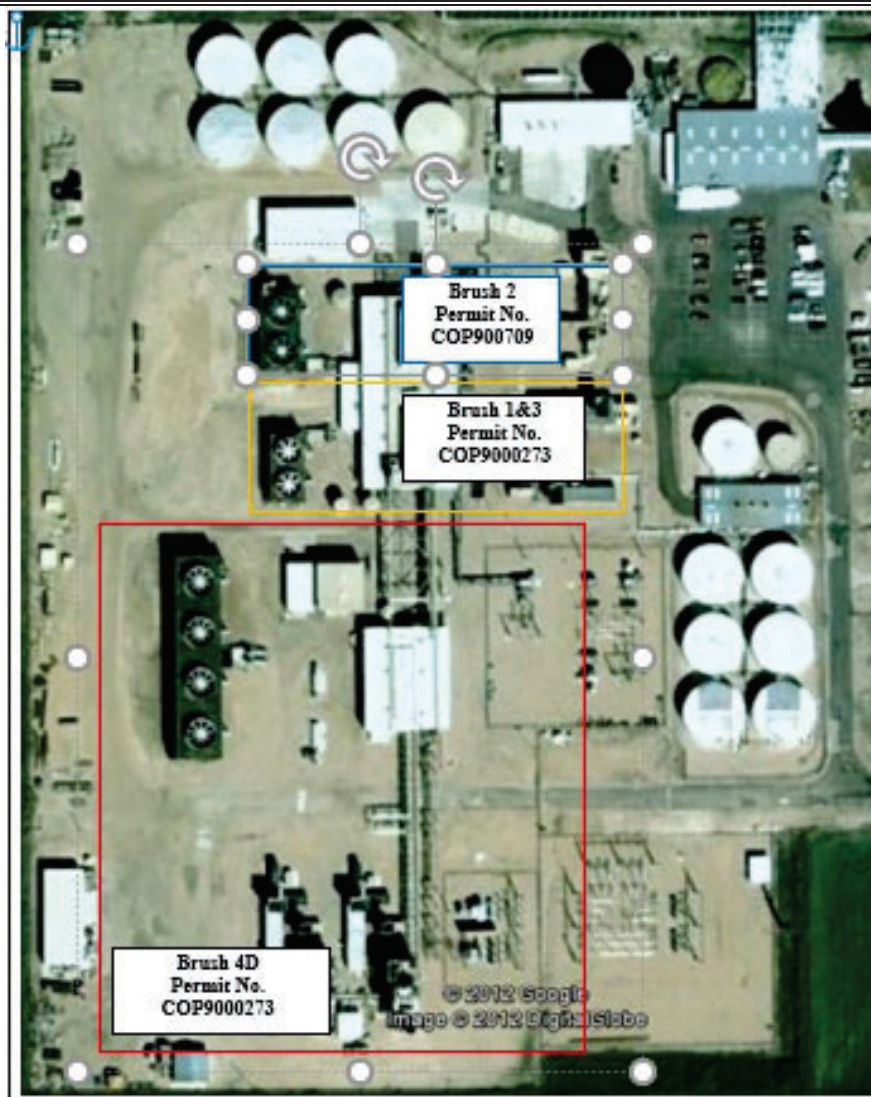
CEM employs twenty-three people and works seven days a week in two 10-hour shifts. Although the facility typically has four generating units—Brush 1, Brush 2, Brush 3, and Brush 4D—at the time of the inspection, Brush 1 and 3 were not operating. In September 2023, Brush 3 had a turbine wreck that stopped Brush 1 and 3 from operating (Photo 17). According to the facility representatives, Brush 3 will not be able to operate again because of the damage. At the time of the inspection, the facility representatives did not know whether Brush 1 will be brought back into operation; the facility was awaiting an air permit for Brush 1. Brush 1, Brush 2, and Brush 4D are combined cycle systems with cooling towers and natural gas combustion turbines. GIP is the owner of Brush 1, Brush 3, and Brush 4D, which share a single discharge point covered under NPDES Permit No. COP900273. Alliance Energy is the owner of Brush 2, which is covered by NPDES Permit No. COP900709. All generating units are operated by CEM. Excel Energy is the sole consumer of energy. See the figure below for the layout of the separate power-generating units.
