ENVIRONMENTAL SURVEY

CAPCO - Ragland Plant

November 20-22, 1974

AMERICAN SMELTING AND REFINING COMPANY  
Department of Environmental Sciences  
Salt Lake City, Utah

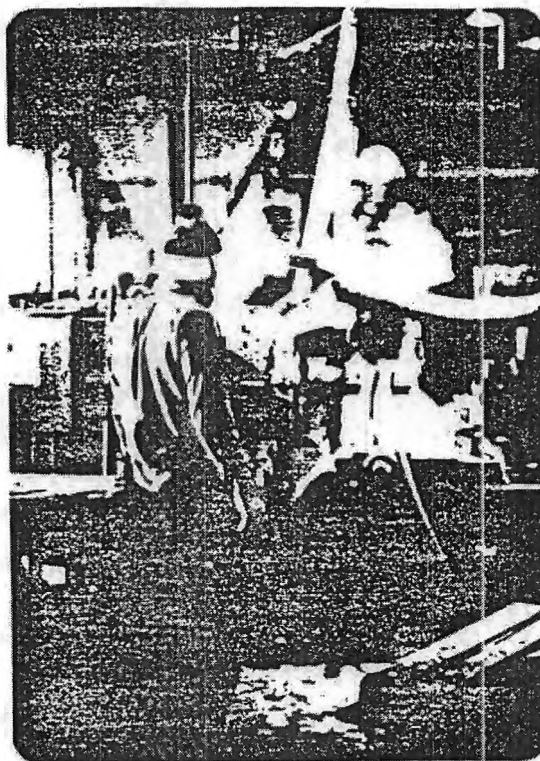
SMALL COUPLING LATHE

Dry couplings are being cut, and ventilation system is not picking up all of the dust produced. Floor around operator is covered with asbestos waste.

- d. Coupling cut-off lathe -- Housekeeping was poor in this area. Employees work on a mound of asbestos cuttings. The operator did not wear a respirator but should be required to do so. Ventilation for the various coupling lathes appeared inadequate and should be improved. One operator was observed to cut very dry couplings on the small coupling lathe resulting in excessive fugitive emissions. The plant has an area with water sprays to keep couplings wet, and the operators should be instructed to return dry couplings to this area and work only with wet couplings.

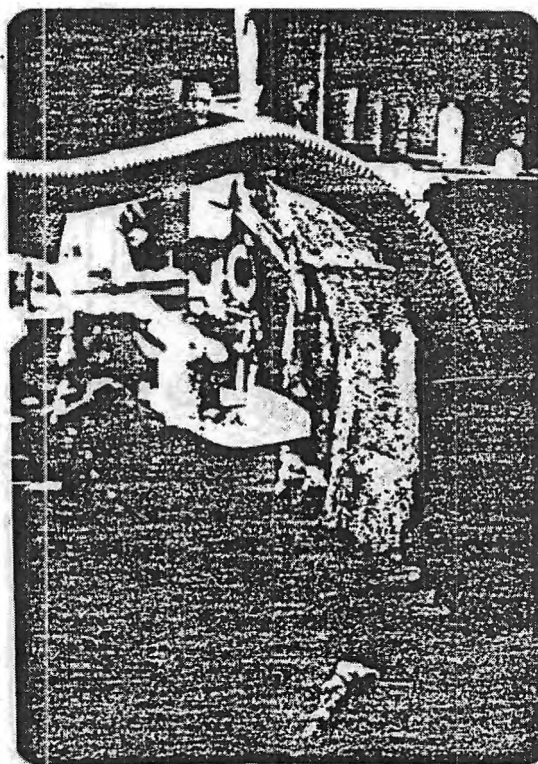
SMALL COUPLING LATHE

Better housekeeping to prevent accumulations of asbestos waste, as shown on the machine and floor, is needed.

- f. Housekeeping needs improvement. OSHA requires that all external surfaces be maintained free of accumulations of asbestos fibers if, with their dispersion, there would be an excessive concentration. The large amounts of asbestos used in the plant combined with the many finishing operations, such as lathing, sawing, and grinding, make compliance with this requirement extremely difficult. Piles of loose asbestos waste were noted on the pipe finishing line and around the lathes. Increasing air velocities at ventilation points (to pick up a greater amount of wastes) by installing the three additional baghouses should help the housekeeping problem. Assignment of more employees to housekeeping may also be necessary.

- K. Housekeeping will need improvement to keep external surfaces free of asbestos fibers.

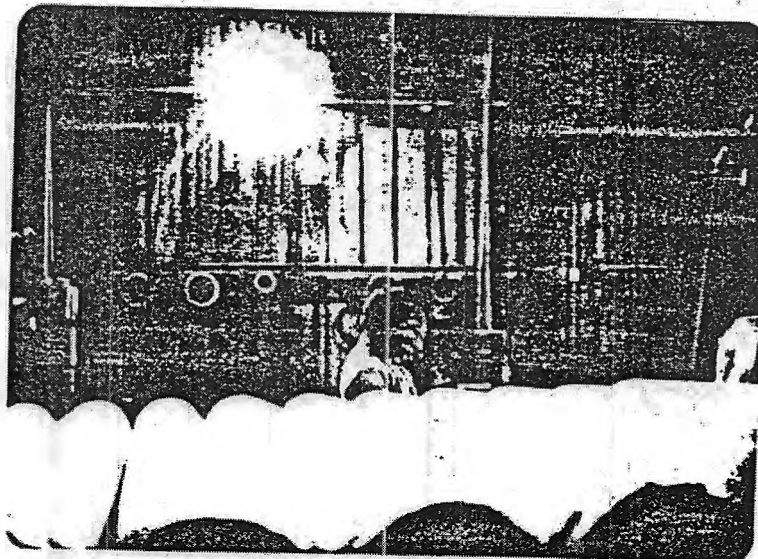
FLEXTESTER

The employee is using a hand-grinder which is not ventilated.

- e. Flextester -- This exposure is probably related to the amount of handgrinding done during the shift. The handgrinder is not presently ventilated. Further sampling is needed.

- e. All hand-operated and power-operated tools, which may produce or release asbestos fibers resulting in an excessive employee exposure, should be provided with local exhaust ventilation. This would apply to the handgrinder used on the pipe finishing line and, possibly, some shop tools. The lathes and other major pipe finishing tools already have exhaust ventilation.

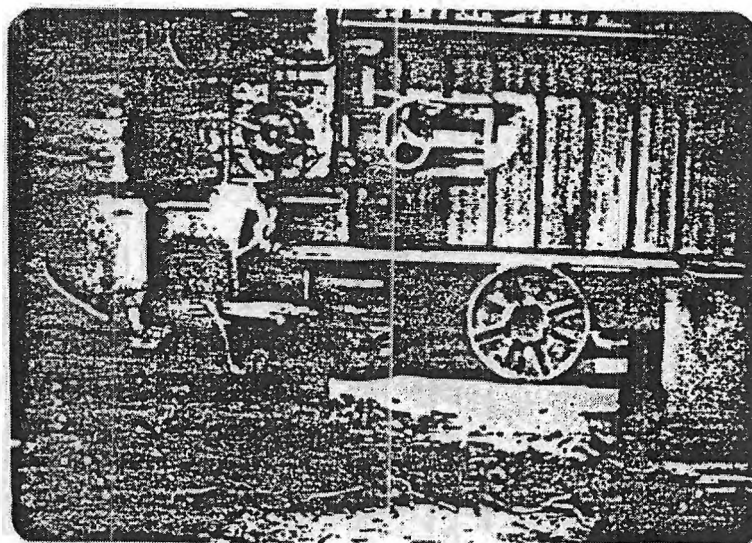
SHOP AREA

Housekeeping around the shops should be improved.

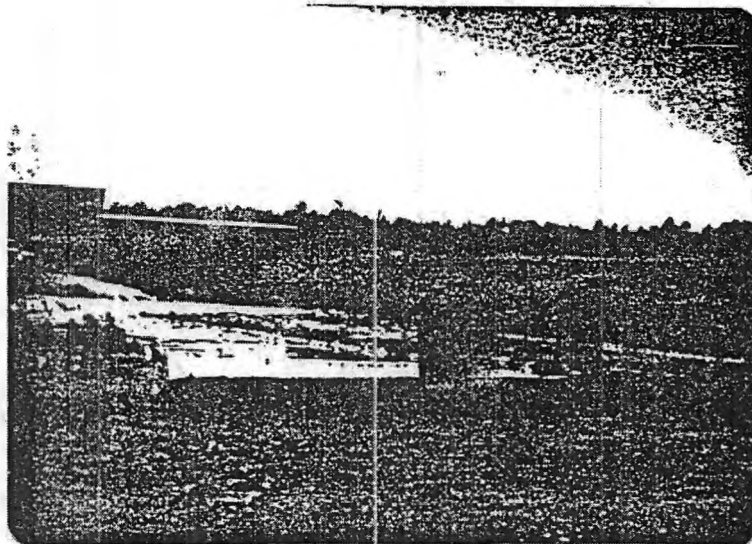
#### WASTEWATER TREATMENT

2. A discharge from the batch mixing area flows into two small concrete settling ponds and thence into Trout Creek via an open ditch. An NPDES permit was sought for this discharge, and a proposed permit was received at the plant during the survey. The permit contained troublesome effluent limitations on oil and grease, total suspended solids content, and pH. Revisions for the permit are being pursued. The plant has plans to recycle this discharge, and construction is underway.

Concrete settling ponds for water discharge from batch mixing area.

The muck removed from the settling ponds is now piled around the ponds. The muck should be buried in a landfill. The recycling program should include provision to cover the existing piles and reclaim the land around the settling ponds.

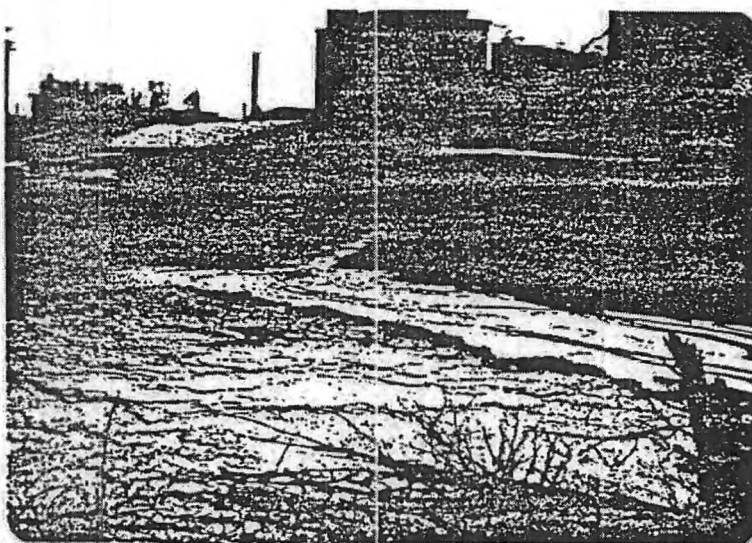
#### WASTEWATER TREATMENT

Natural pond below concrete settling ponds provides additional treatment. Cement plant is in background.

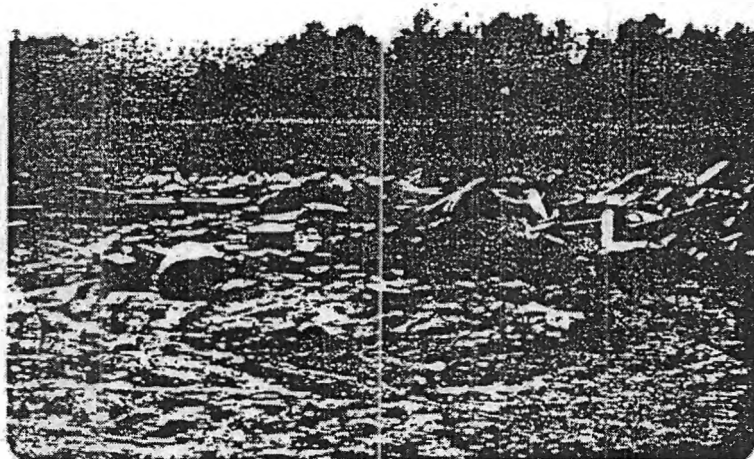
SOLID WASTE DUMP

Solid wastes are disposed of in a semi-landfill operation at a large ravine west of the plant site. This operation should be converted to a sanitary landfill. State agency permits may be necessary.

Pile of loose asbestos waste  
is near center of picture.

- L. Loose asbestos waste should be placed in plastic bags or other containers for disposal. This requirement could be avoided if a sampling program can be instituted which shows that handling of the waste does not result in excessive concentrations of airborne asbestos.
