**Well Inspection**  
**Osage DNR / Environmental Protection Agency**  
**1201 Elm Street, Suite 500**  
**Dallas, Texas 75270**

| | | <b>Lease Name</b> | W Bowring | | |
| | | <b>Well ID</b> | 2-290 | | |

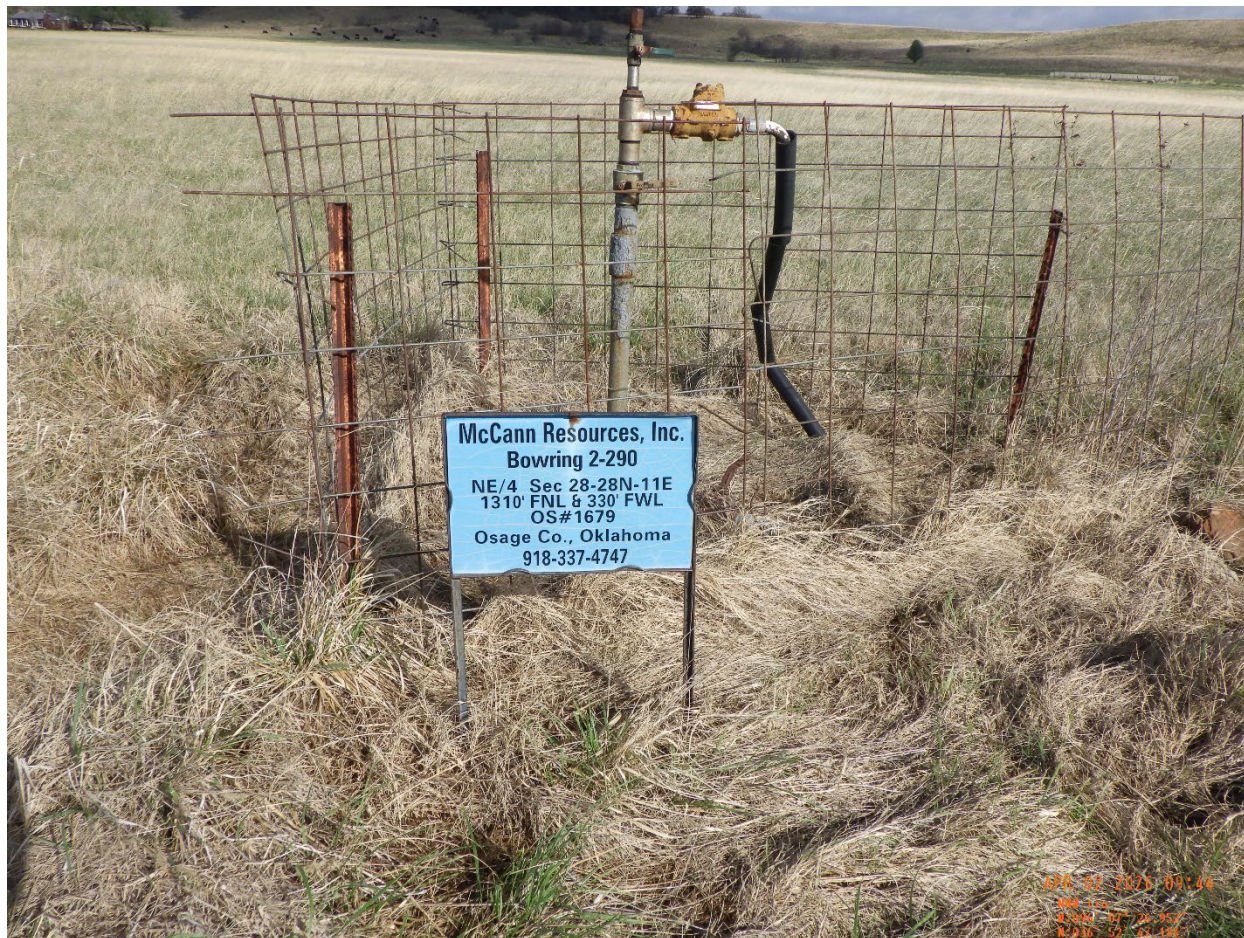
Photo No. 1

| <b>Inspection Comments</b> | At the time of the inspection, well OS1679000 was connected but not injecting. The flowline was hooked up but the tubing cutoff valve was closed preventing injection. The well tubing was reduced to 1" fittings which prevented observance of the fluid level with the EPA echometer which is equipped with standard 2" fittings. The well was overdue for MIT at the time of the inspection. | | | | |

**Description:** This was well OS1679000 at the time of the inspection. The well was overdue for MIT.
