### INSPECTION REPORT

| Inspection Date(s): | 03/27/2025 | |
| Company Name: | <b>Village of Angel Fire</b> | |
| Facility Name: | <b>Angel Fire WWTP</b> | |

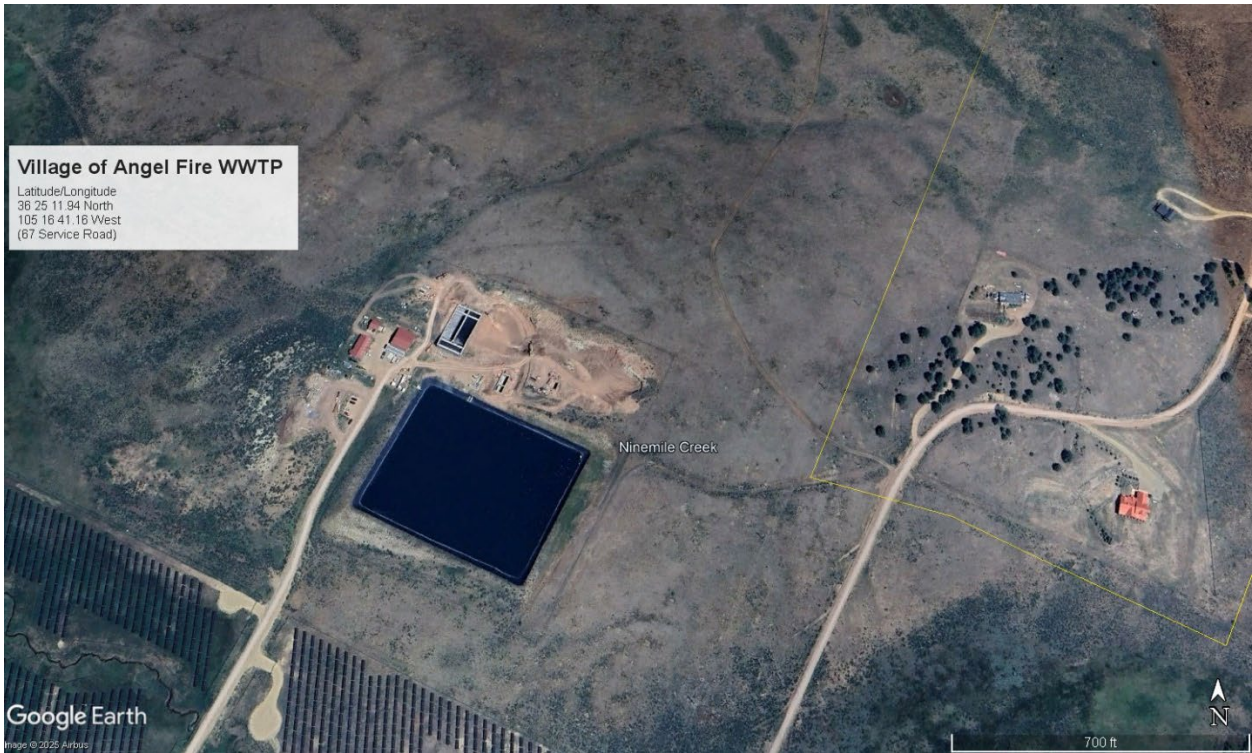
**Aerial Image #1:** Overall view of the Village of Angel Fire’s Wastewater Treatment Plant. Aerial from Google Earth maps.
