Magazine Article - "Asbestos Fibers in Drinking Water With Special Reference to Asbestos-Cement Pipe Usage"

# Asbestos fibres in drinking water with special reference to asbestos-cement pipe usage\*

B.T. Commins, BSc, MSc, PhD, CChem, FRSC

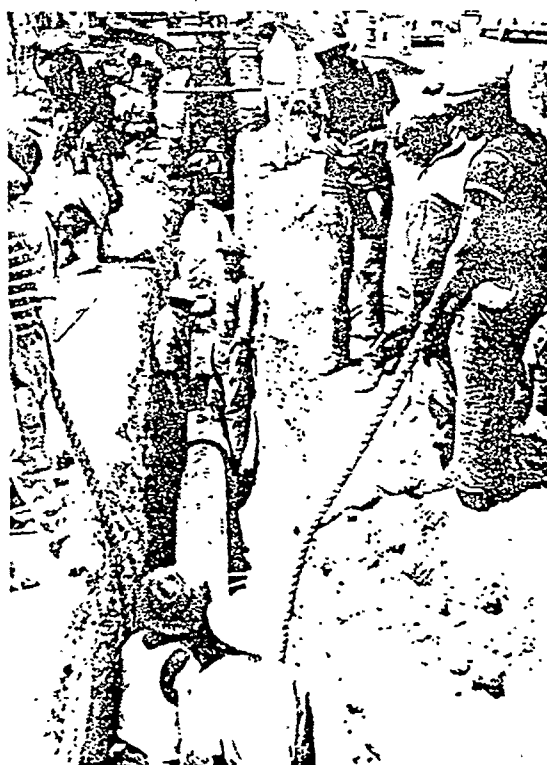
Fig. 1. 300-mm diameter asbestos-cement pipe being laid in the city centre of Durban, South Africa.
