### INSPECTION REPORT

| Regulatory Program: | Water (CWA) Brine Program (Oil & Gas inspection) | |
| Company Name: | <b>RCP Production, LLC</b> | |
| Facility Name: | <b>Emodell Murphy #1, 2, 3, 4 (Emodell Murphy Lease) Tank Battery</b> | |

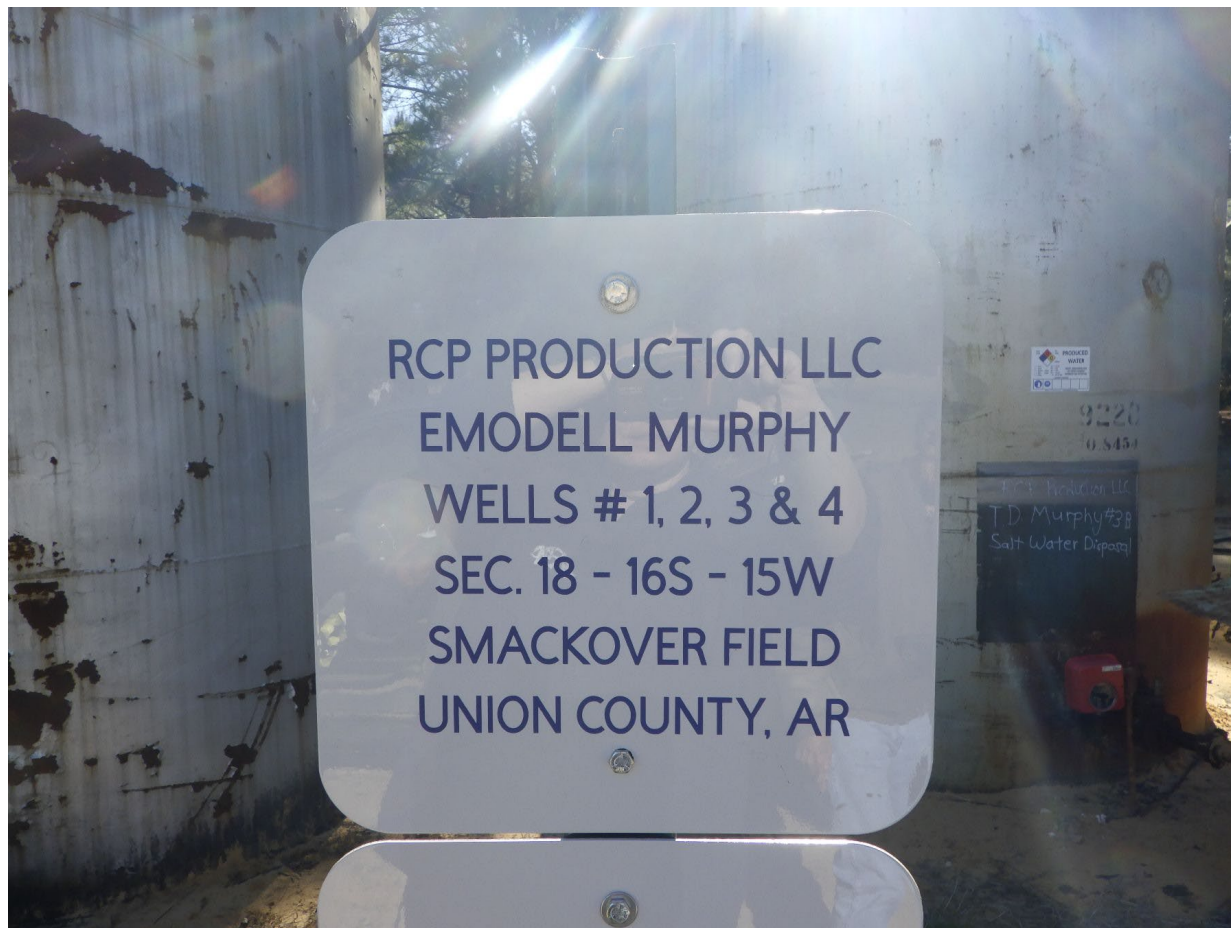
Photo No. 1

I observed the facility sign, secondary containment, oil-water separators, pipes and valves, and storage tanks located at the facility; see Appendix 1 (Photographs Log), Photos No. 1 and No. 2. For additional GPS location and photo metadata, see Appendix 1.

| Description: | Looking SSW, this photo shows the signage for the Emodell Murphy Lease Tank Battery ("facility"). | | |

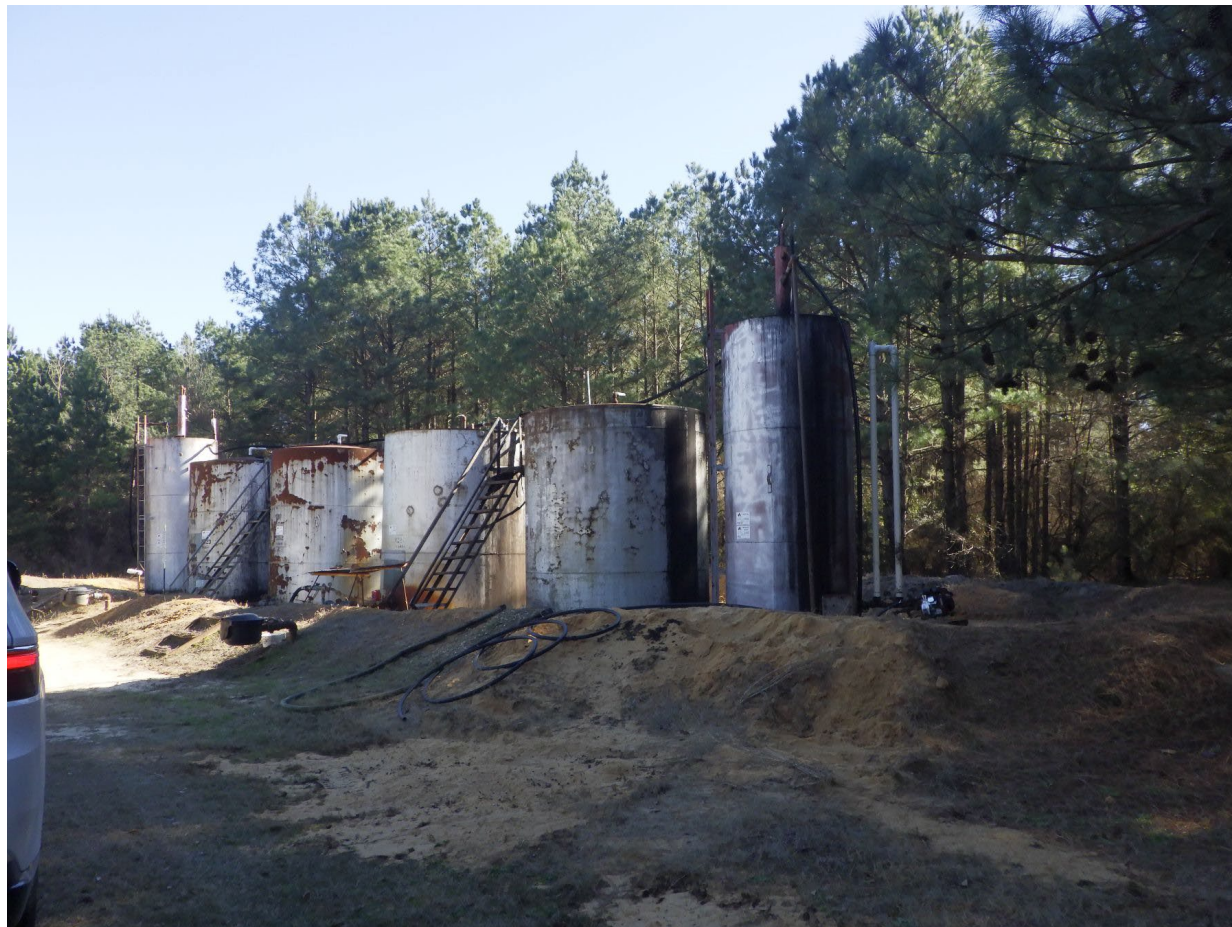
Photo No. 2

| Description: | Looking S, this photo shows an overview of the facility. | | |

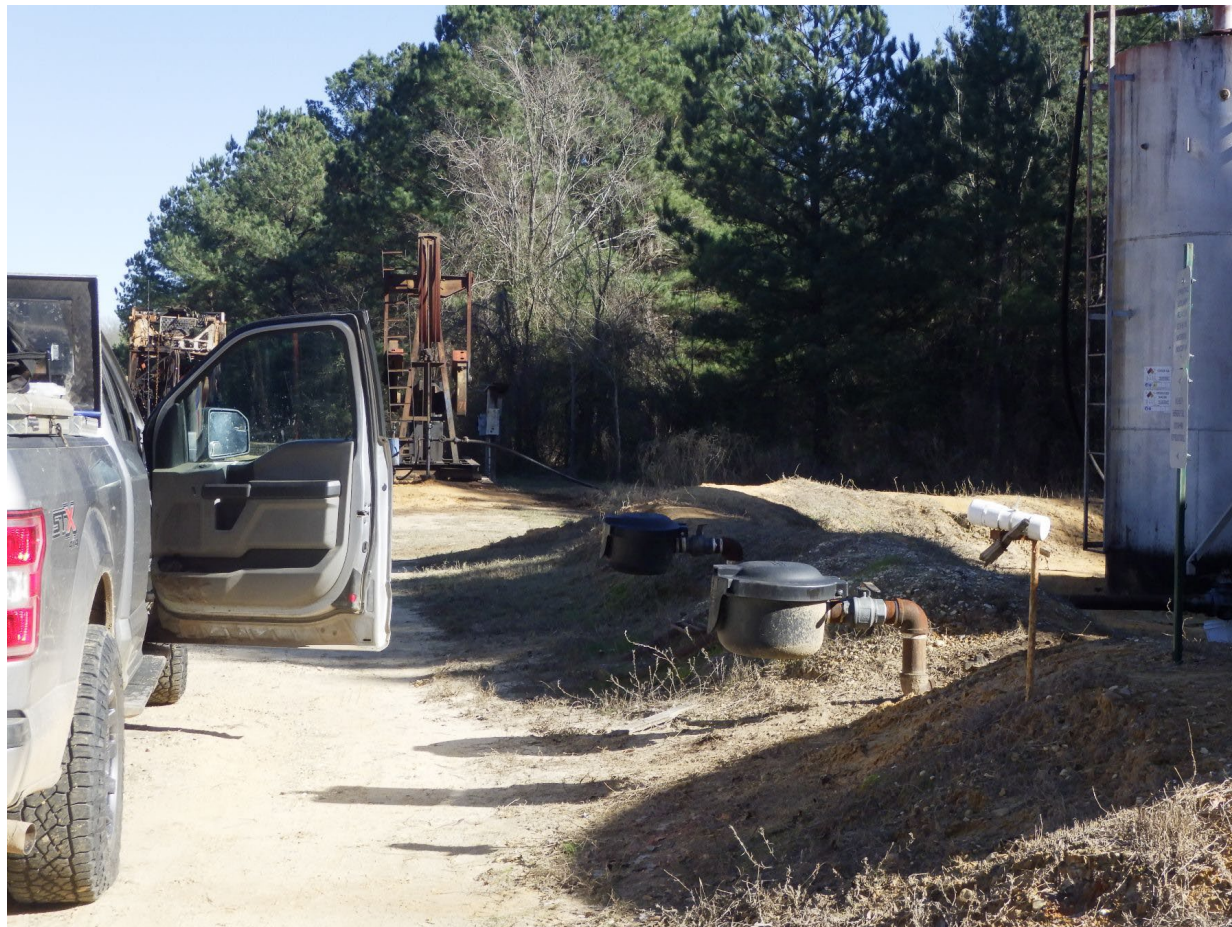
Photo No. 3

I observed the load lines with catchment buckets, see Photo No. 3.

| Description: | Looking S, this photo shows transfer lines with secondary containment. | | |

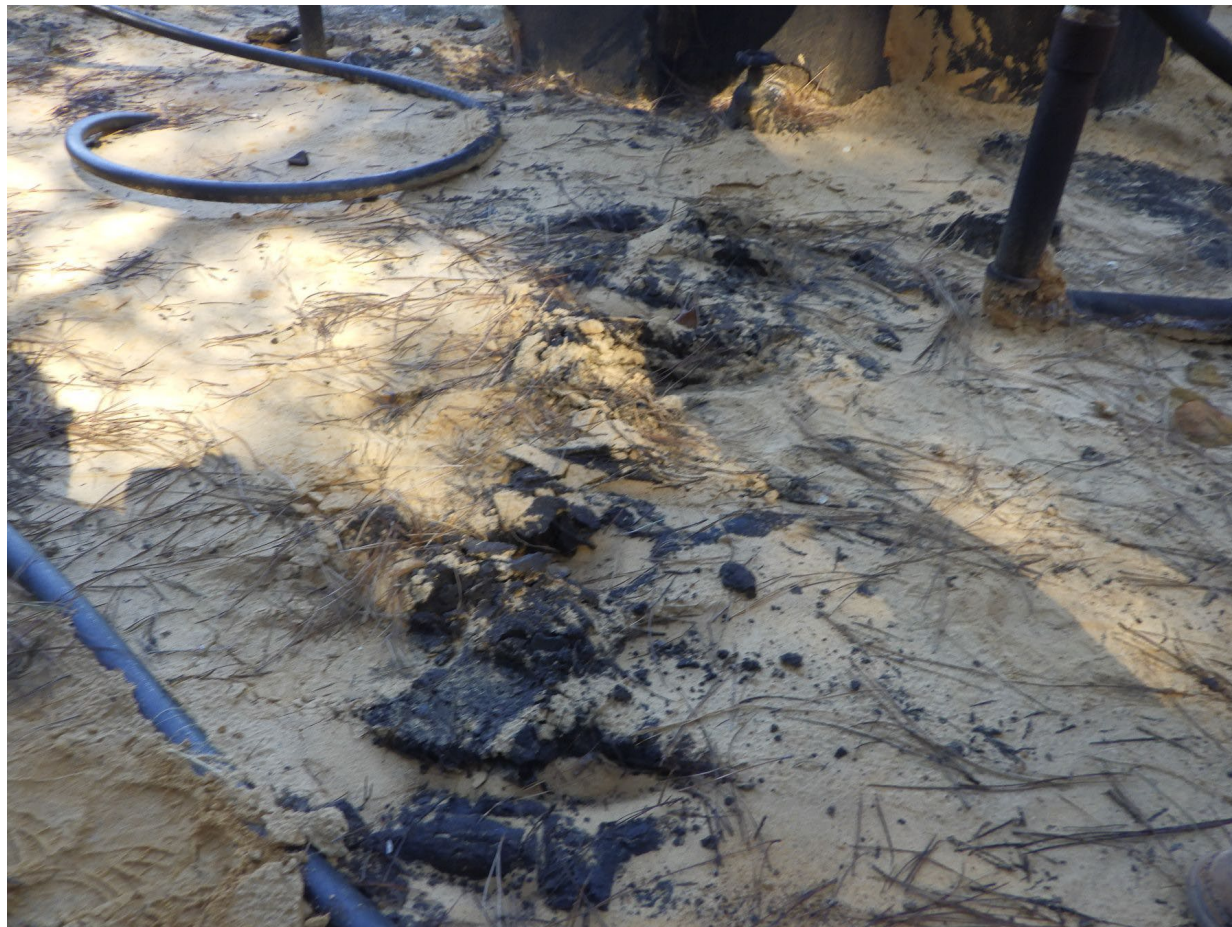
Photo No. 4

I observed loose oil inside the tank battery, see Photos No. 4 and No. 5.

- Loose oil inside and outside the facility tank battery, 40 CFR 112.9(b)(1) and 112.9(b)(2) (Photos No. 4, No. 5, and No. 7).

| Description: | Looking SSW, this photo shows loose oil inside the tank battery. | | |

Inspector will conduct follow-up phone calls with the company representative(s) over the coming weeks and months to ensure areas of concern are properly addressed. SEE Inspector Tom McKay will address SPCC rule concerns.

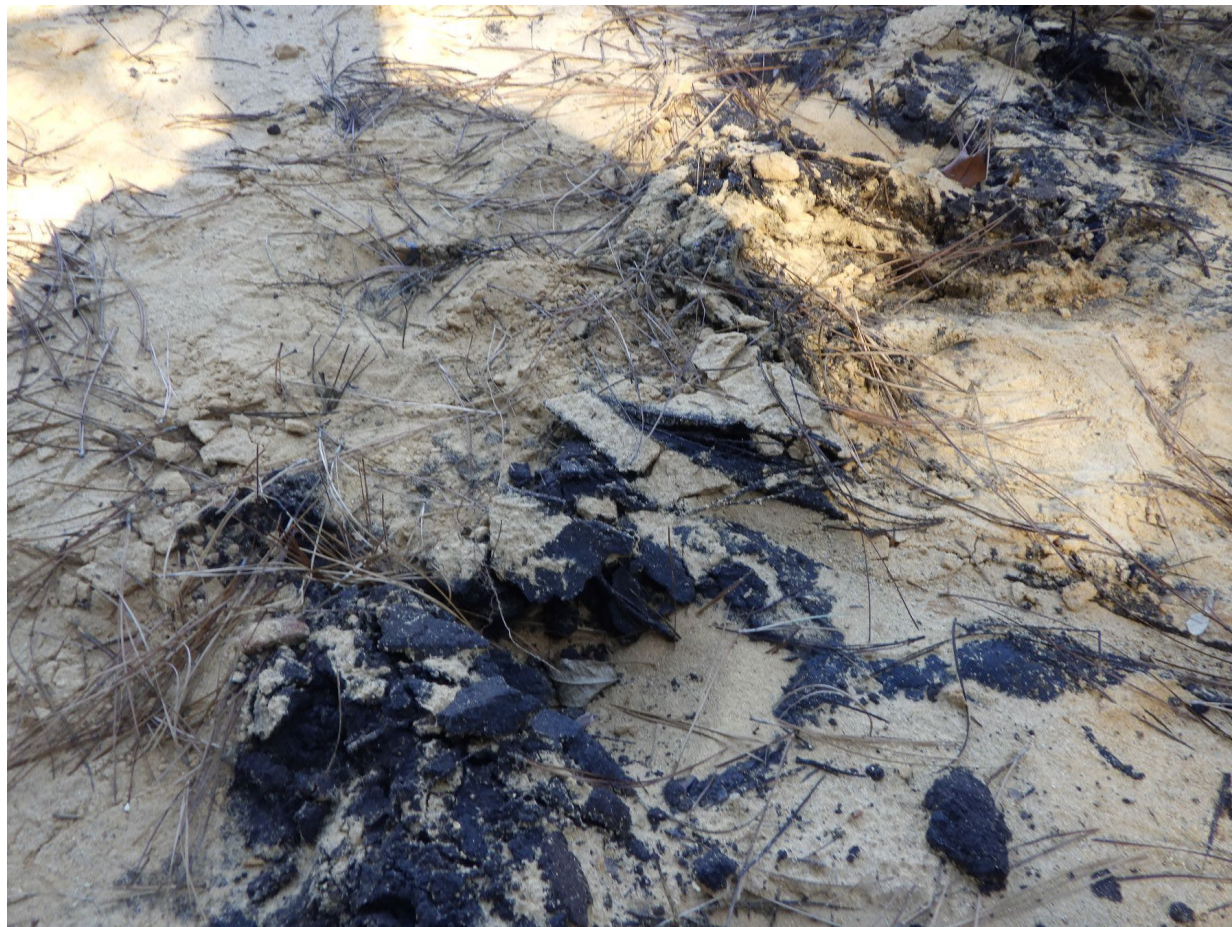
Photo No. 5

| Description: | Looking SSW, this photo shows a closeup of the loose oil from Photo No. 4. | | |

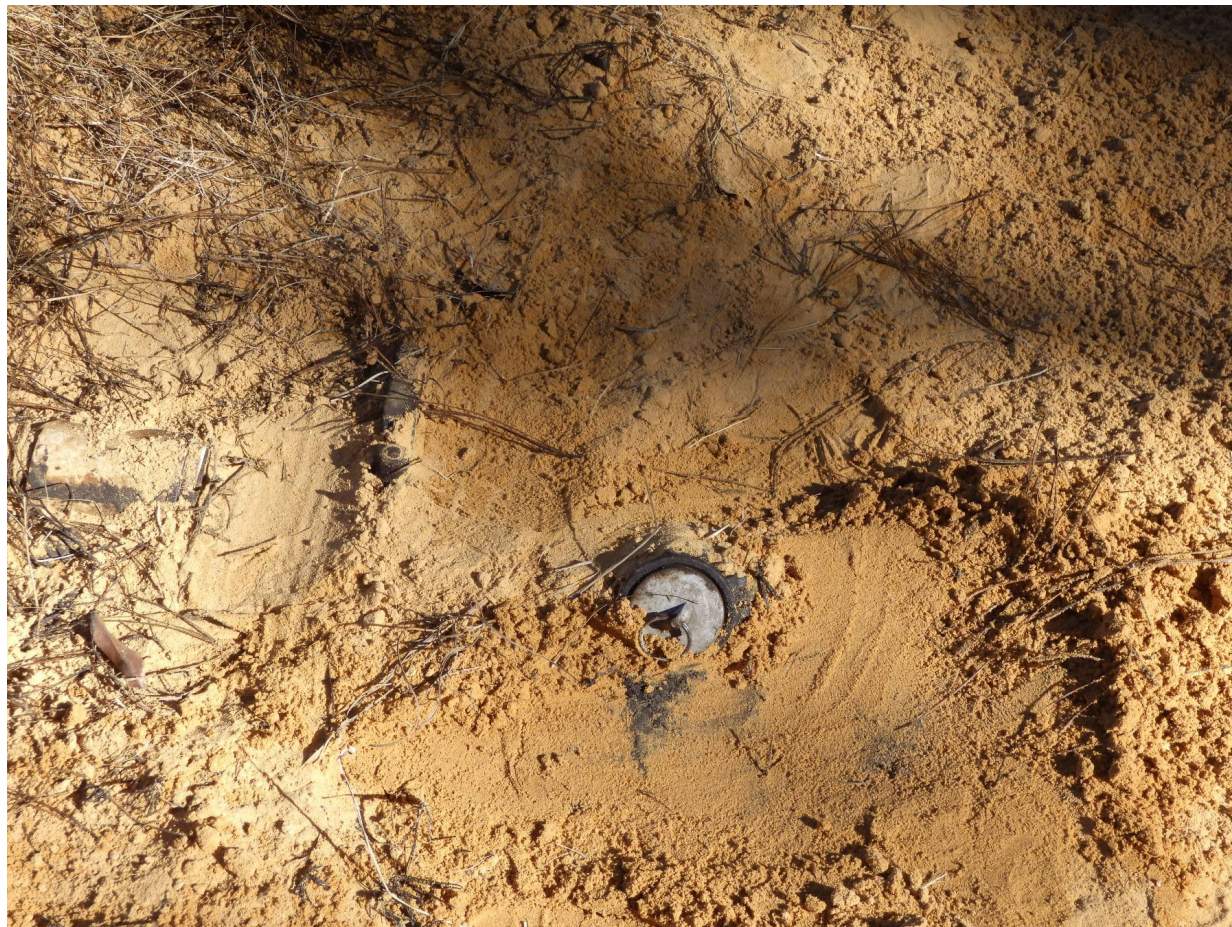
Photo No. 6

I observed the drainpipe for the tank battery with an attachment to connect to a vacuum truck, see Photo No. 6.

| Description: | Looking S, this photo shows a closeup of the drainpipe for the tank battery. | | |

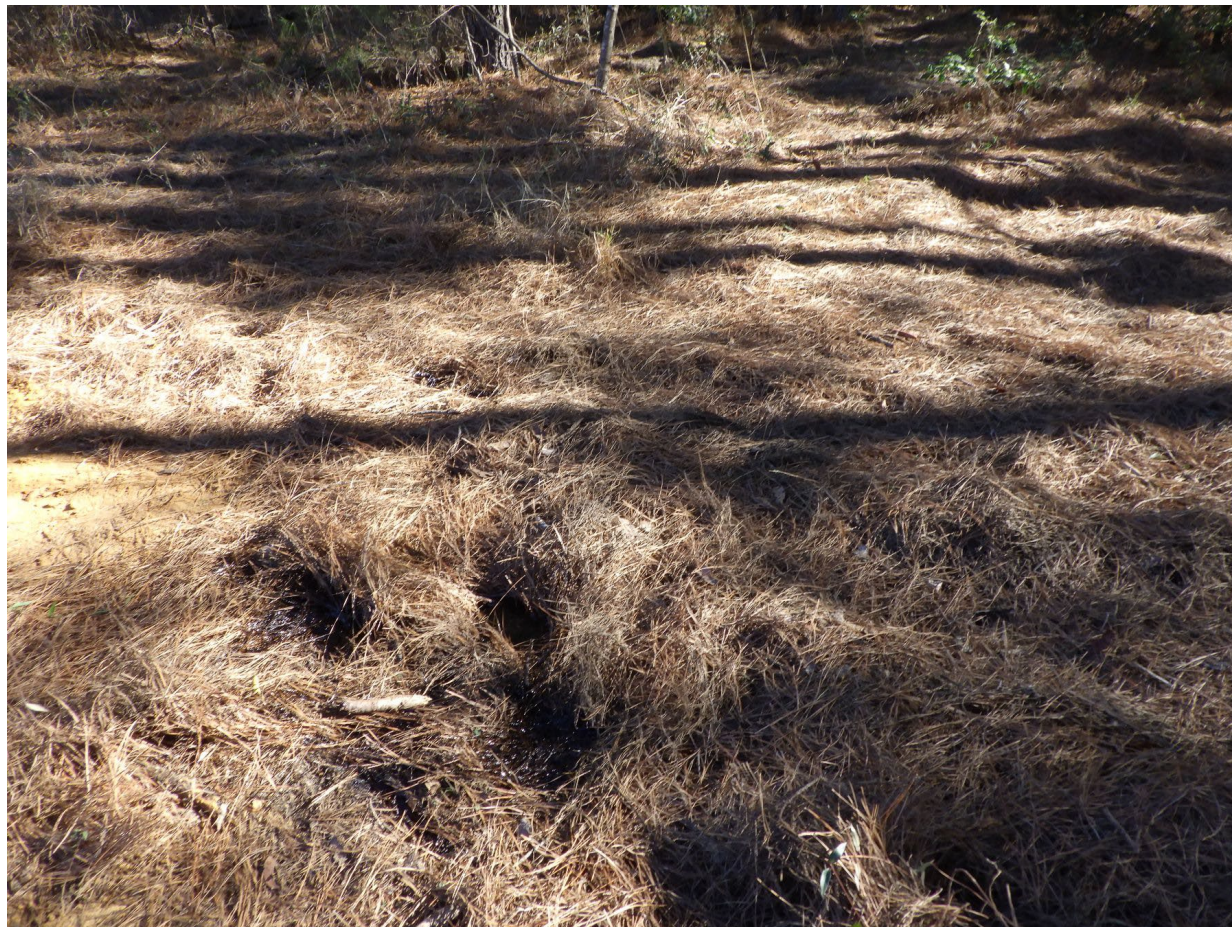
Photo No. 7

I observed loose oil outside the tank battery from the drainpipe, see Photo No. 7.

| Description: | Looking S, this photo shows loose oil outside secondary containment. | | |
