SITE NO. 8  
3M COMPANY  
WOODBURY, MINNESOTA

INTRODUCTION

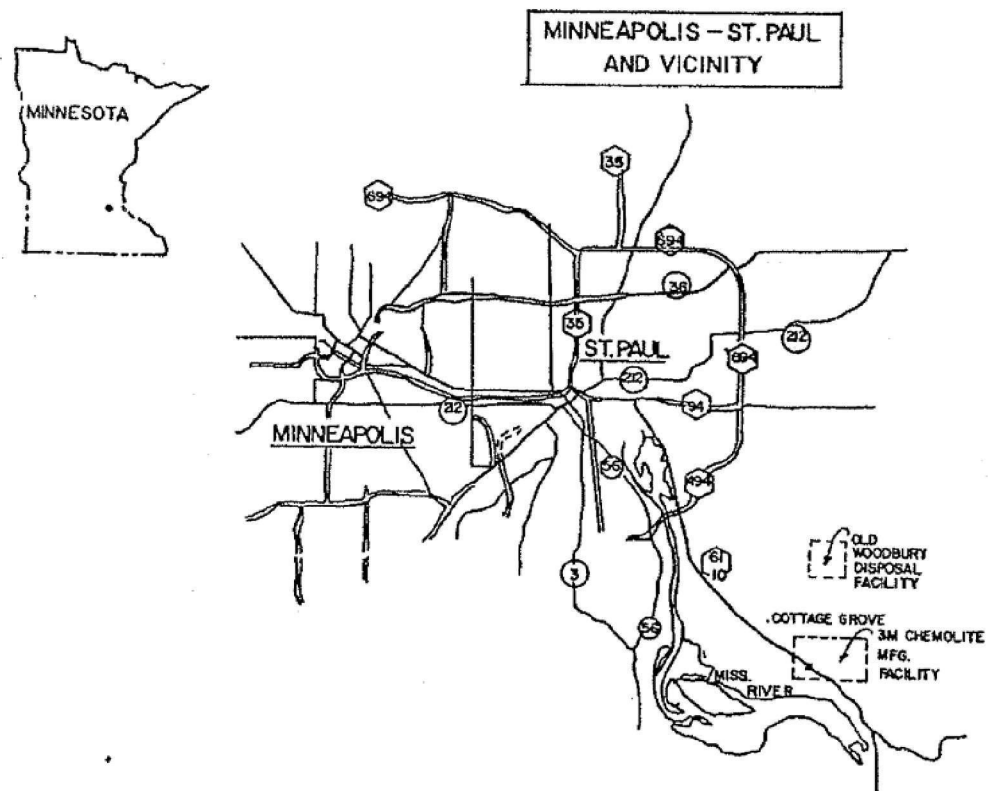
Figure 8-1. Location of 3M Woodbury Disposal Site  
Woodbury, Minnesota.

Figure 8-1 shows the directional relationship of Minnesota Mining and Manufacturing's (hereafter called 3M) Woodbury disposal site to Chemolite, the Twin Cities, and to the Mississippi River. The 3M Woodbury disposal facility is located on the eastern side of the Twin Cities (Minneapolis-St. Paul) metropolitan area. The Chemolite Manufacturing facility of 3M, which provided a major portion of the waste disposed at the Woodbury site, is located about 5.6 km (3.5 mi) south of the Woodbury disposal facility.

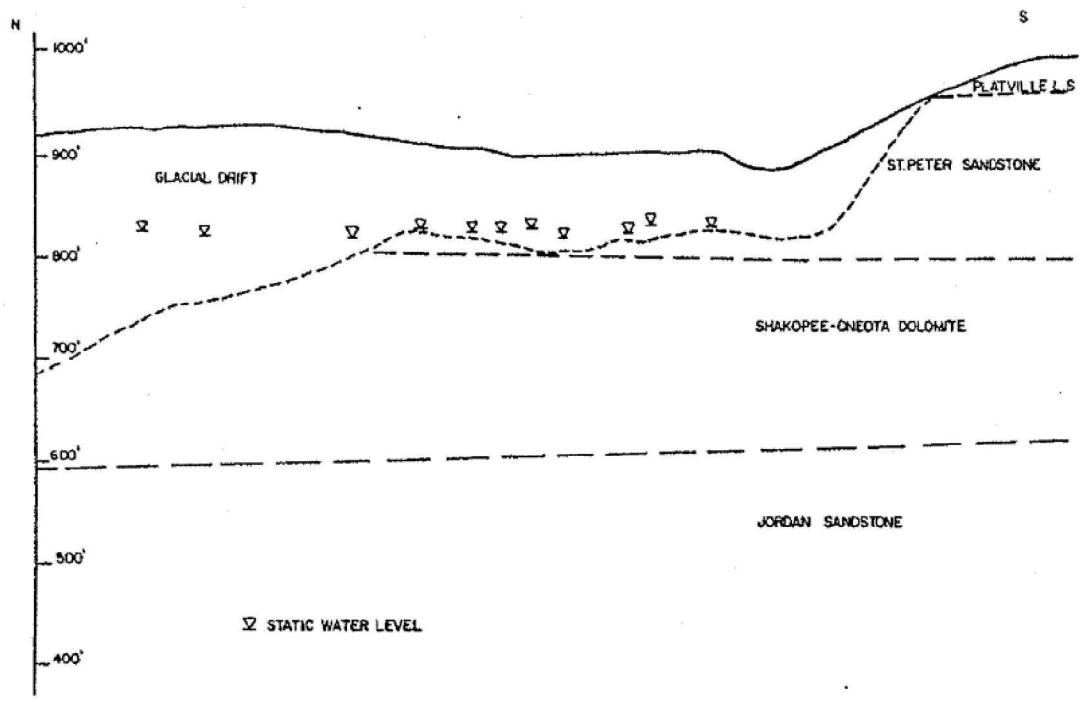
Figure 8-2. Geological cross section of area beneath Woodbury site.<sup>1</sup>

The geology in the area consists of Paleozoic bedrock overlain by glacial drift averaging 15.2 to 30.5 m (50 to 100 ft) thick. The site appears to lie in a buried glacial valley. During an earlier time period, the valley (channel) apparently was cut by a tributary which fed into the nearby Mississippi River. The channel was subsequently filled with sand and gravel from more recent glaciation. The buried bedrock channel trends toward a northwest to southeast direction and was carved out of the Prairie du Chien-Jordan Aquifer.

Beneath the glacial outwash, Platteville limestone, a medium dense gray shaley limestone, overlays the St. Peter Sandstone. The St. Peter Sandstone in turn overlays the Shakopee-Oneota dolomite, which overlies the Jordan Sandstone. The Shakopee

dolomite is not a tight formation and contains fractures created by previous glacial loadings. The pits at the Woodbury disposal site are located in the glacial outwash over the Shakopee dolomite. Therefore, it is speculated that if any contaminants reached the Shakopee, easy access would be provided to the underlying Jordon aquifer.

Prior to installation of barrier wells, two ground water bodies were located beneath the pits in Woodbury: a perched water table and the Jordon aquifer. Figure 8-2 displays a generalized geological cross section of the area beneath the site.

The perched water table which was located in the glacial drift material immediately below the pits supplied water to shallow wells in the immediate vicinity. Three years after 3M's installation of barrier wells, the perched ground water in the glacial till had dissipated. Therefore, presently the only ground water body located beneath the old pit area is the Jordon aquifer. The glacial drift ground water tended to flow southward to south toward the Mississippi River. The Jordon aquifer flows generally northwestward from the site area toward Minneapolis and St. Paul.

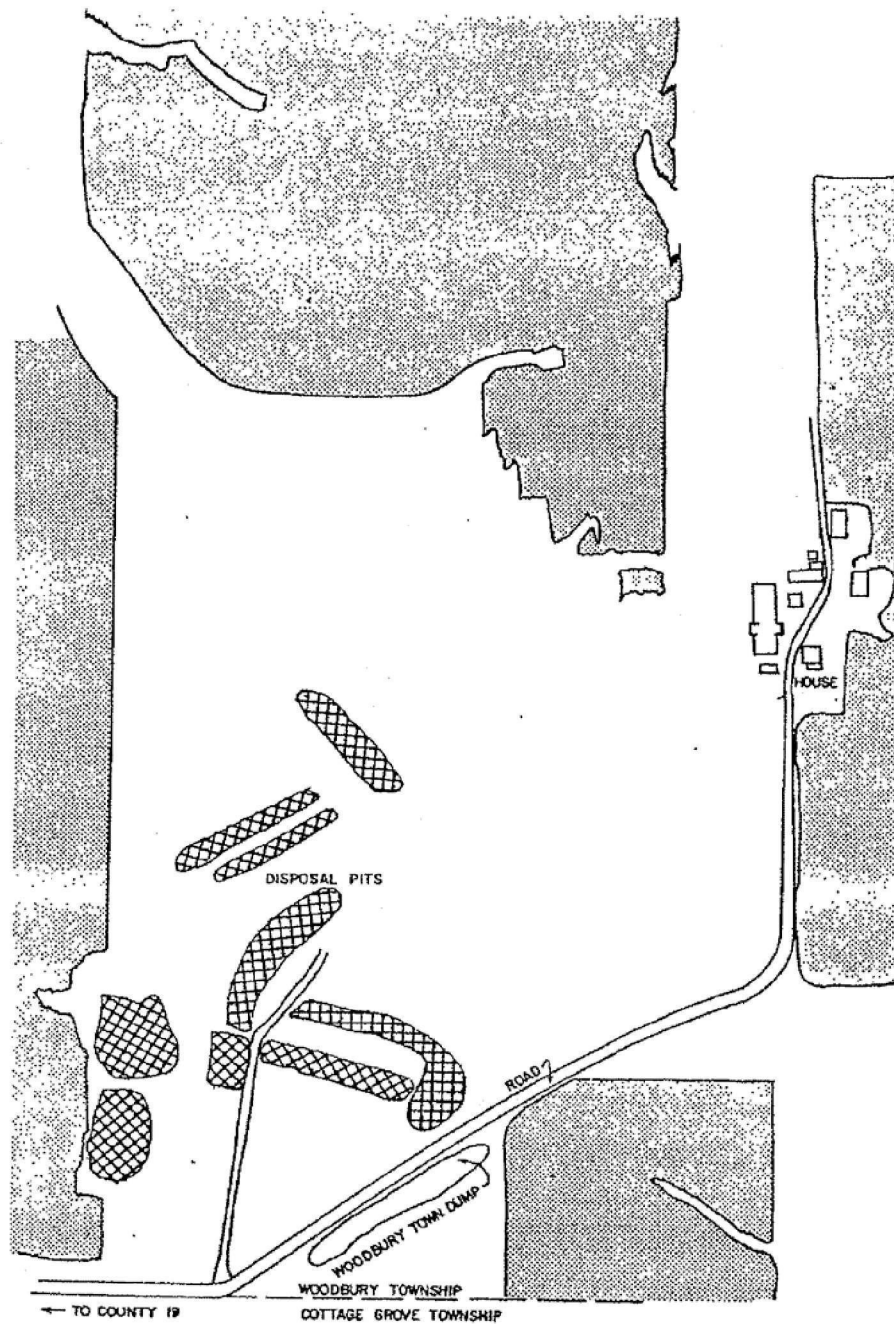
Figure 8-3. Pit location at 3M Woodbury disposal site.<sup>2</sup>

dispose their municipal waste in the southeast corner of the property. Figure 8-3 shows the location of the pits at the Woodbury site. The municipal waste was segregated and kept outside the pit areas used for solvent, acid, and facility waste of 3M. Only a minor amount of Woodbury municipal waste was disposed at the site in relationship to the 3M waste. This was one of the factors which prompted 3M to purchase the property in 1961 and to haul their own wastes to the site. Presently 3M owns some 101 to 113 ha (250 to 280 ac) in the immediate vicinity of the disposal area.

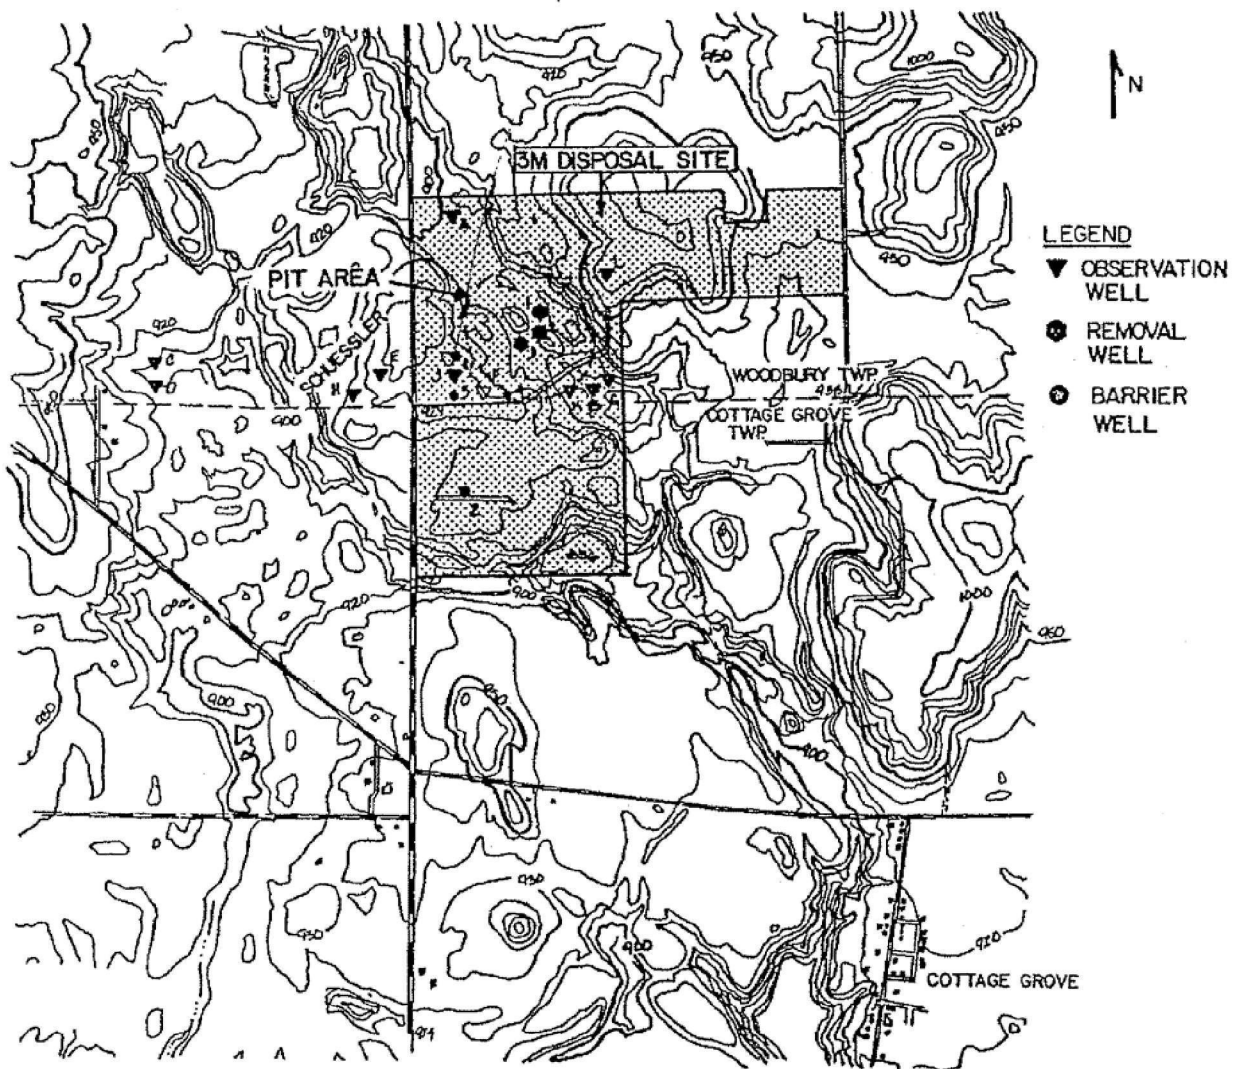
Figure 8-4. Location of contaminated well (Schuessler well) and barrier wells.<sup>1,3</sup>

By August 1966, all the wells in the area had been sampled and use of the disposal site had been discontinued. Eugene A. Hickok and Associates was retained by 3M to determine the extent of the problem and to make recommendations regarding its solution. A 61 m (200 ft) 30 cm (12 in.) test well was drilled on the site on September 13, 1966. Resistivity test equipment was used to determine the best location of the test hole, and the resistivity of the glacial drift between the contaminated resident's (Schuessler's) well and the dumping area. Figure 8-4 exhibits the location of Schuessler's well in relationship to the disposal site and to the test hole (later called Observation Well A).

Drilling of the test well stopped at two levels in the glacial drift, three levels in the Shakopee-Oneota limestone, and one level in the Jordon Sandstone. Water samples were collected from each level for analysis. Additionally, water samples were collected from two 3M existing 5 cm (2 in.) observation wells and the caretaker's well located on the disposal site. One observation well is located in the northwest

corner of the site, one in the southwest corner, and the caretaker's well is located east of the disposal area equi-distant between the two observation wells. The observation wells finish in the St. Peter sandstone and are open to both glacial drift and sandstone.

Table 8-1 shows the horsepower of the barrier well motors and the average discharge quantity per barrier well. Figure 8-4 exhibits the location of the barrier wells. Figure 8-6 shows that a decrease in concentration of isopropyl ether has been experienced since the introduction of the barrier wells. Table 8-2 displays 19 priority pollutants which were found in the discharge water. The discharge system consists of a 9.7 to 10 km (6 to 7 mi) discharge underground forcemain privately owned by

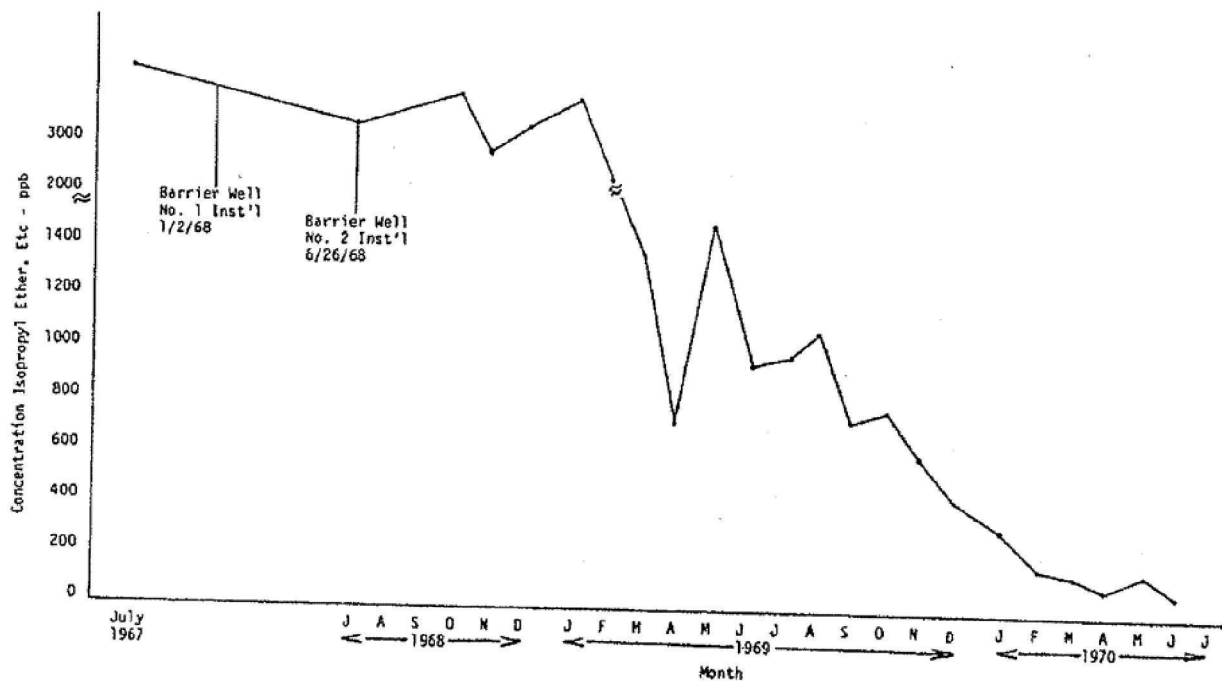
Figure 8-5. Sum of the Concentration of isopropyl ether, isopropanol, and dichloromethane for Schussler well Woodsbury Township

Analysis on the above wells showed that the glacial drift and upper levels of the Shakopee-Oneota limestone at a depth of about 61 m (200 ft) were chemically contaminated. The concentration decreased substantially with an increase in depth. Only insignificant trace concentrations of chemicals were detected in the Jordan sandstone. Isopropyl ether was the dominant pollutant with concentrations varying from 4 to 5 ppm in the shallow drift to less than 0.1 ppm at 47.5 to 61 m (156 to 200 ft). Isopropyl ether was identified as being the contaminant causing the odor problem at the Schuessler's residence. Isopropyl ether is very mobile and has a low odor threshold in the ppm range.

Since confirmation of contamination of upper ground water aquifer, regular monitoring has been conducted at the nearby residential wells. Ten area wells are now sampled bi-monthly by the Department of Health and by 3M. Previously, 3M had sampled 52 wells in the surrounding neighborhood on a bi-monthly schedule. The 10 wells presently sampled are located in glacial material and have shown no chemical contamination except for barnyard runoff. Schuessler's well was the only well ever found to be contaminated with organics. As a result of barrier well water withdrawal, the glacial perched water table was dissipated and Schuessler's well went dry around 1970. A new well was installed for Schuessler which retrieves ground water from the Jordan aquifer. The Jordan was never found to be contaminated with isopropyl ether. Figure 8-5 exhibits the combined concentration of isopropyl ether and other compounds at the Schuessler well. The new well installed for Schuessler in 1970 was never found to be contaminated with isopropyl ether.
