## **RCRA Inspection Report**

Chemical Products Corporation (CPC)    EPA ID# GAD003275468  
102 Old Mill Road  
Cartersville, Georgia 30120

The purpose of this inspection was to conduct an unannounced compliance evaluation inspection to determine CPC’s compliance with the conditions of its RCRA Hazardous Waste Facility Operating Permit HW-26(T&CA)-3, the applicable requirements of RCRA and the corresponding Georgia Environmental Protection Division (GA EPD) regulations. This was an EPA lead inspection.

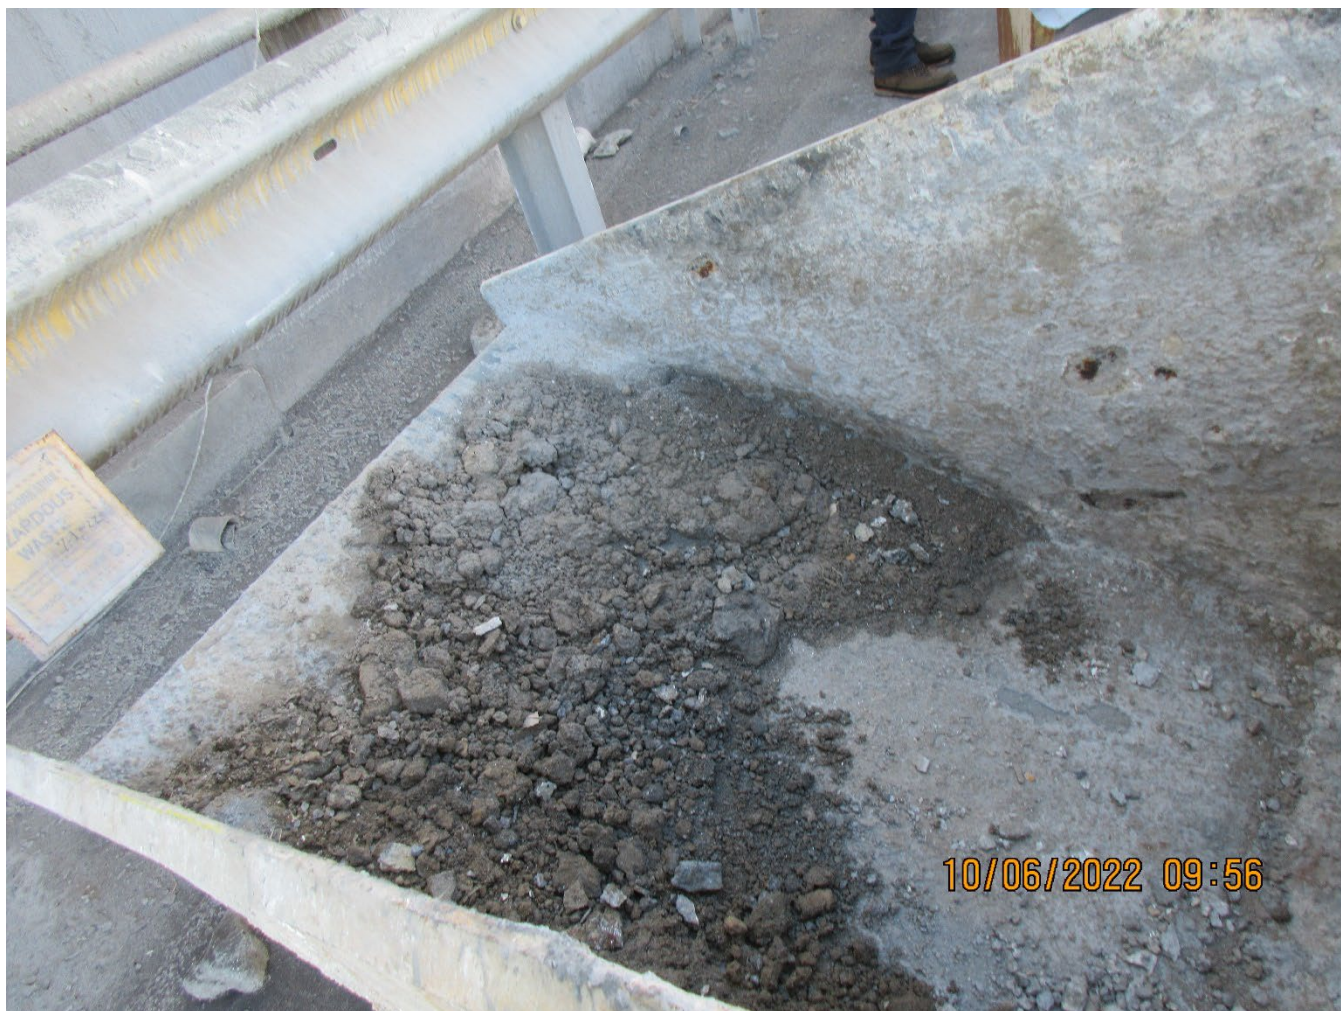
Small amounts of cleanout material were observed within two of the metal cubic yard containers at the time of the inspection which appeared to meet the definition of "RCRA" empty (Photos 1 and 2).

Photo 1 – Material in one of the metal cubic yard boxes in the CAA

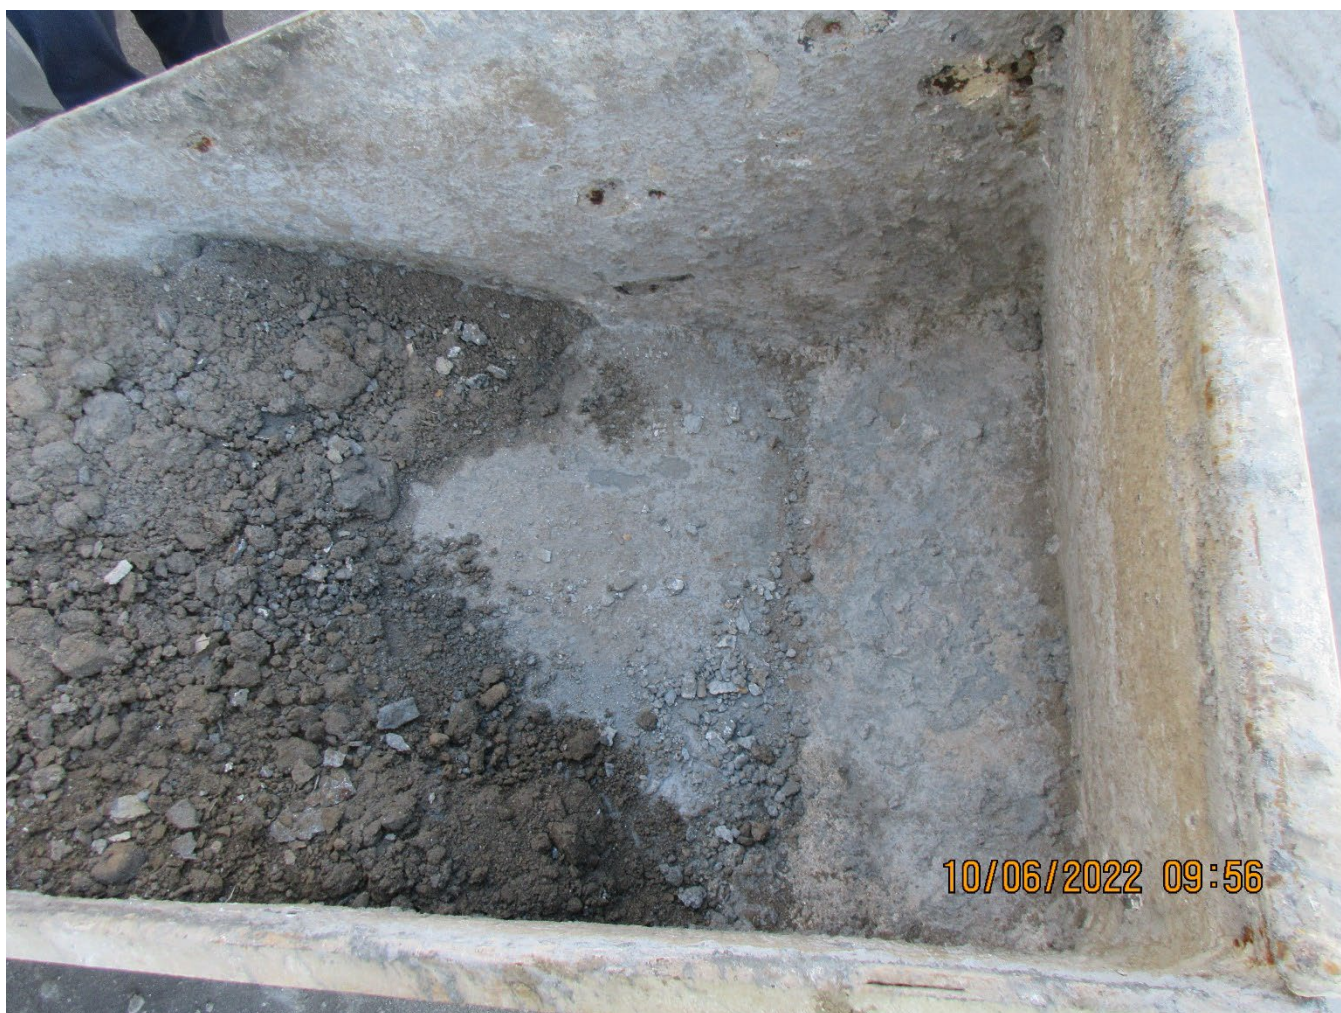
Photo 2 - Material in one of the metal cubic yard boxes in the CAA

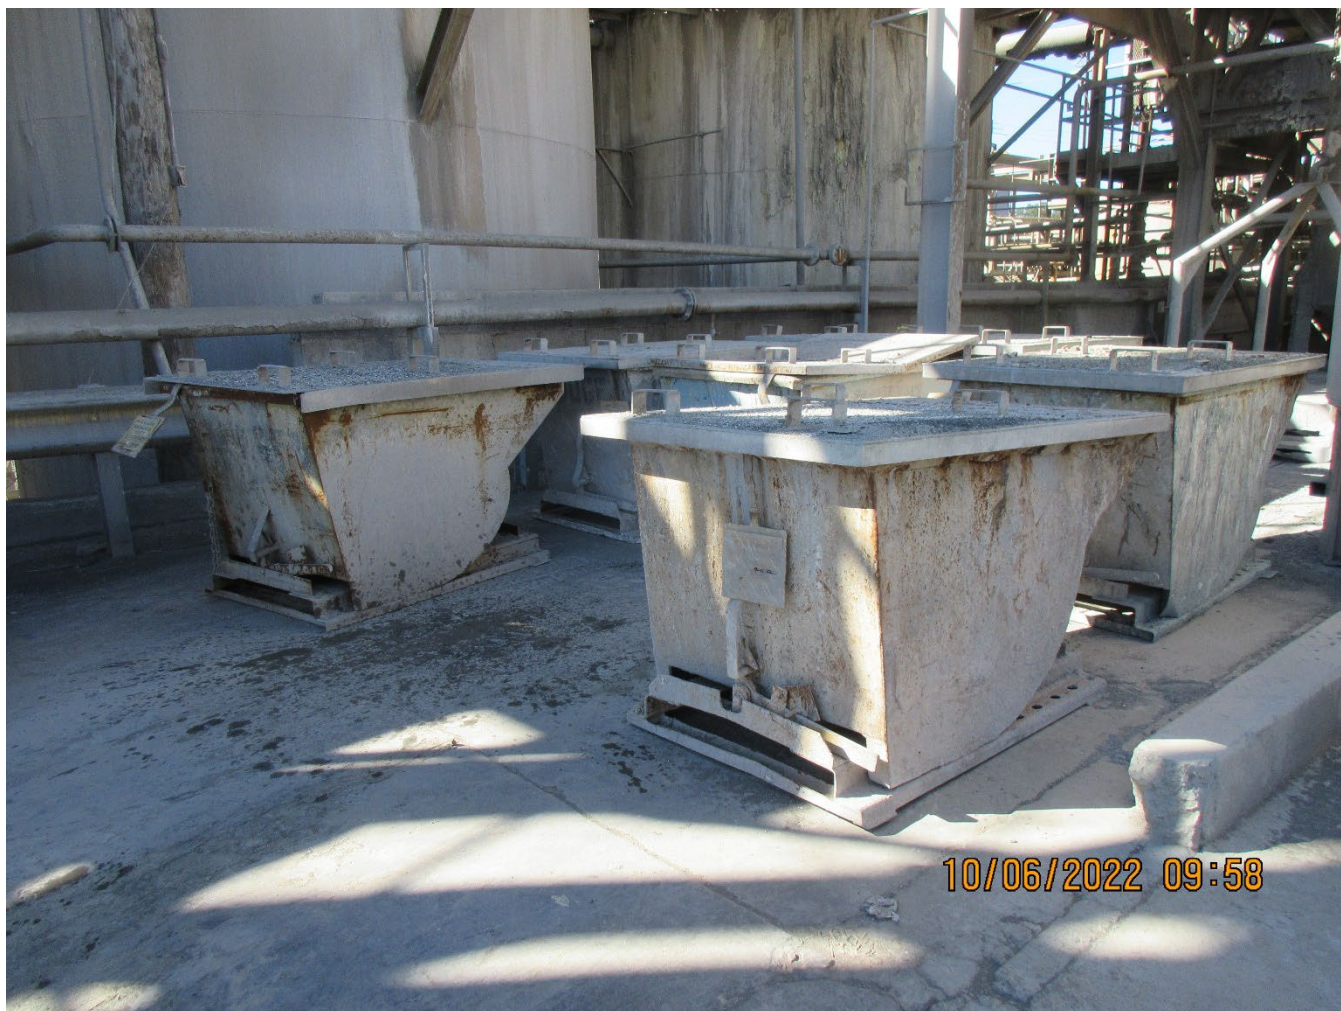
Eight of the metal cubic yard containers, described above, containing hazardous waste were observed in this area at the time of the inspection. The containers were closed with metal lids, labeled with the words "Hazardous Waste" and marked with accumulation start dates of less than 90-days. The containers were not labeled with markings which identified the hazard contents of the waste.

Photo 3 – Metal cubic yard boxes of hazardous waste in CAA

**Pursuant to Ga. Comp. R. and Regs. 391-3-11-.08(1) [40 C.F.R. § 262.17(a)(5)(i)], which is a condition of the LQG Permit Exemption, a generator must mark or label its containers with the following: the words “Hazardous Waste”; an indication of the hazards of the contents; and the date upon which each period of accumulation begins clearly visible for inspection on each container.**

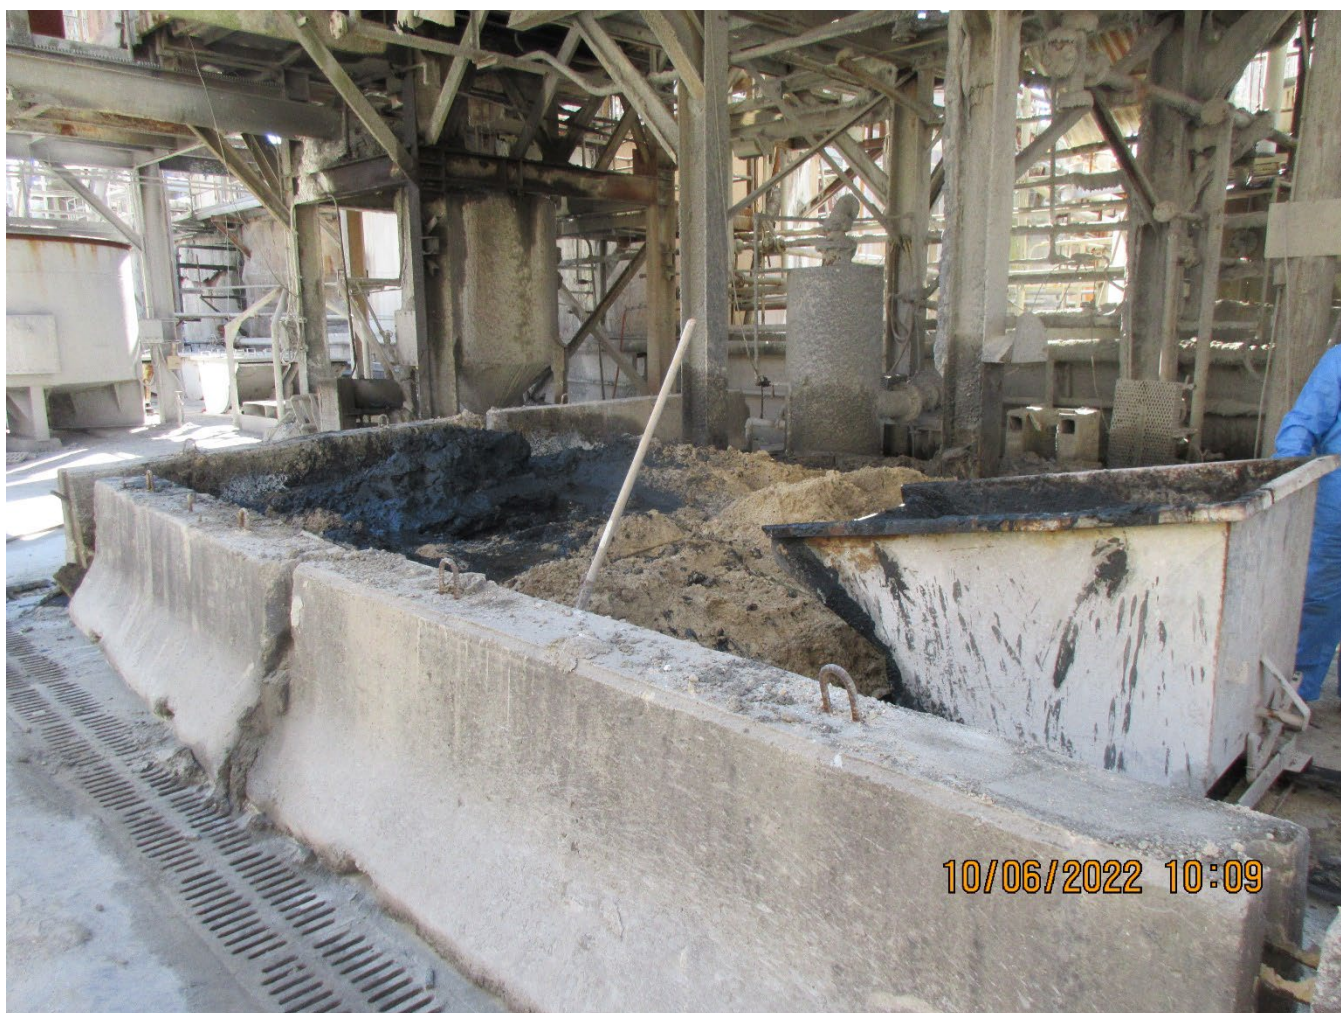
In an area adjacent to where the containers identified above were located, the facility was managing sludges from its barium chloride settler tank which were deemed by the facility to be nonhazardous (Photos 4 and 5). The sludges were maintained behind concrete road barriers. On October 13, 2022, EPA’s Laboratory Services and Applied Science Division (LSAD) took a sample of the materials present in this area. The toxicity characteristic leaching procedure (TCLP) levels present for barium in the sample taken was less than 20 micrograms per liter and was deemed to be nonhazardous as shown in the report forwarded to Joshua Parr via electronic message on January 30, 2023.

Photo 4 – Barium chloride settler sludge

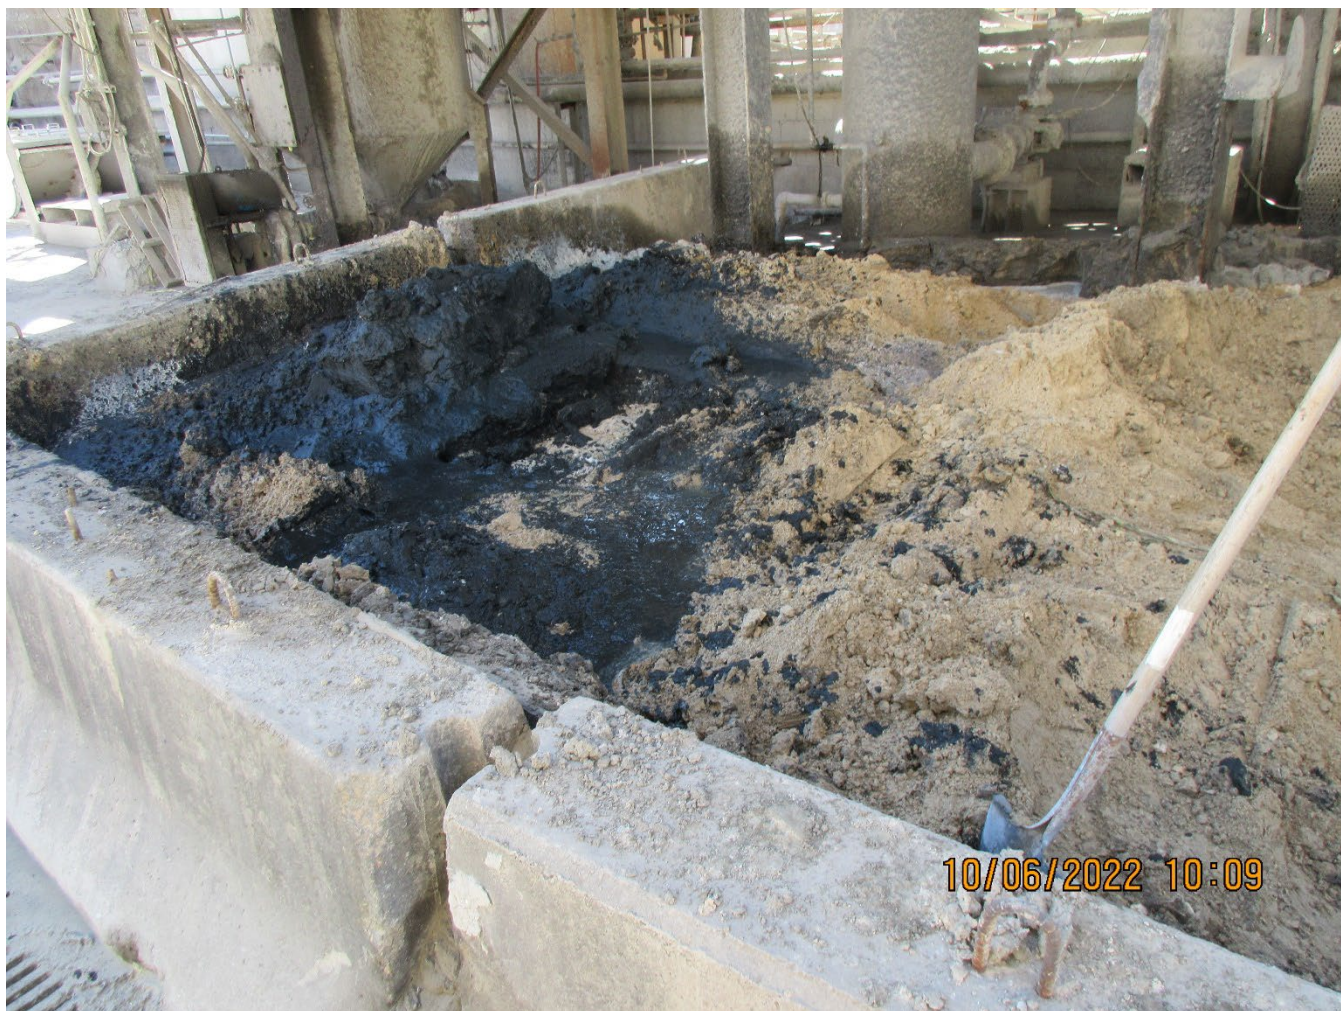
Photo 5 – Barium chloride settler sludge

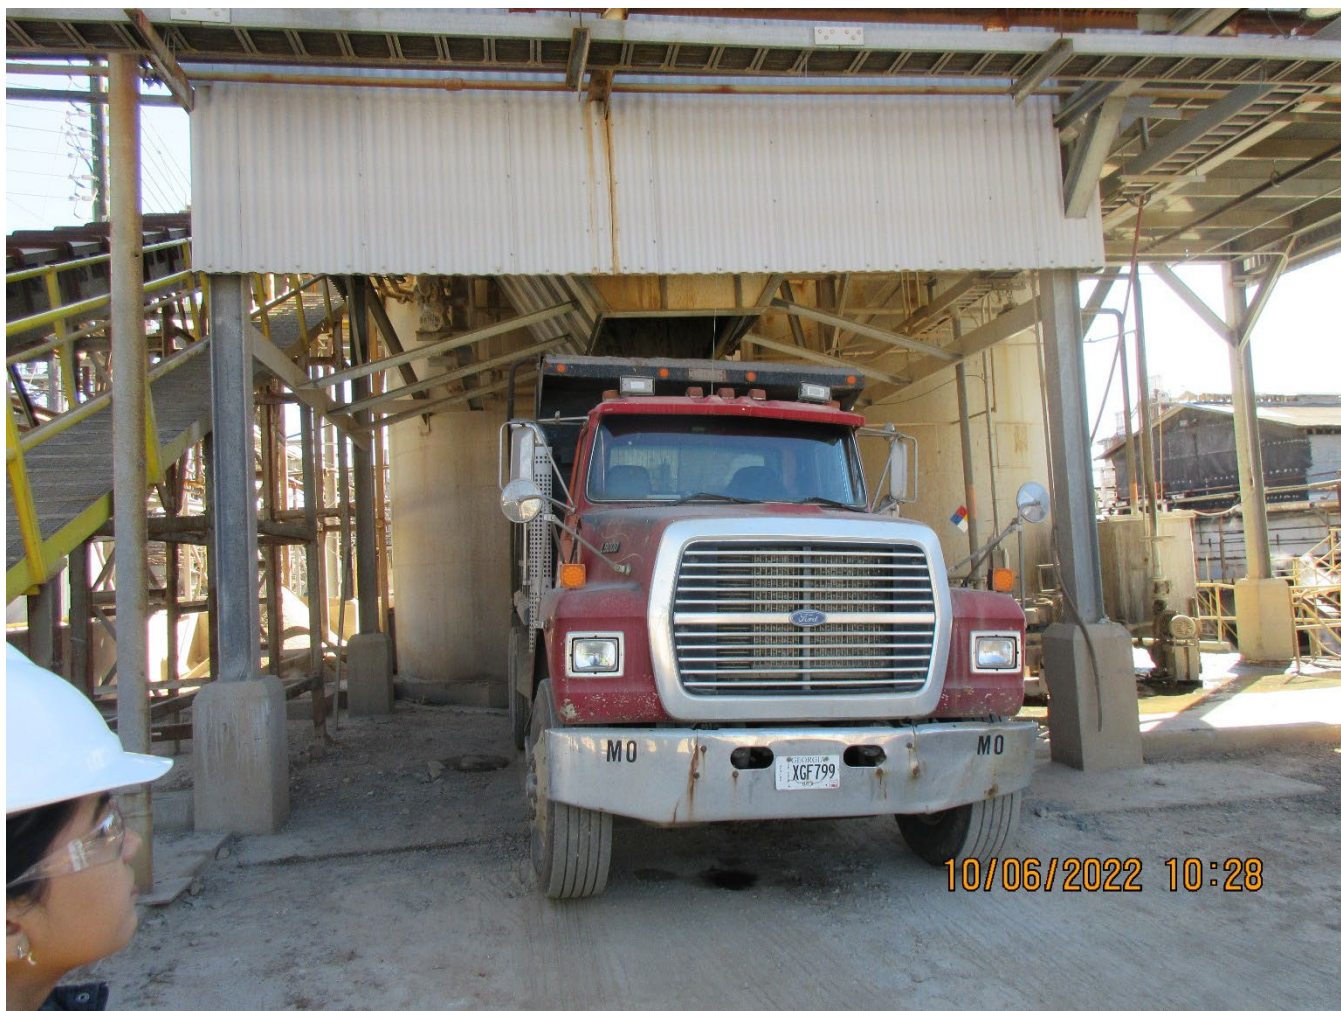
At the time of this inspection, the facility had transitioned from treating its hazardous waste in seven cement mixers in accordance with Section D of its hazardous waste permit and was now treating its wastes in a tank system. The facility is currently in the process of a permit modification with GA EPD to document this transition. The wastes treated in the tanks are deposited into dump trucks (Photo 6) and transported to the facility’s on-site solid waste landfill. No evidence of spillage of material was observed in the area where the wastes are deposited into the dump trucks.

Photo 6 – Dump truck fill area for treated wastes

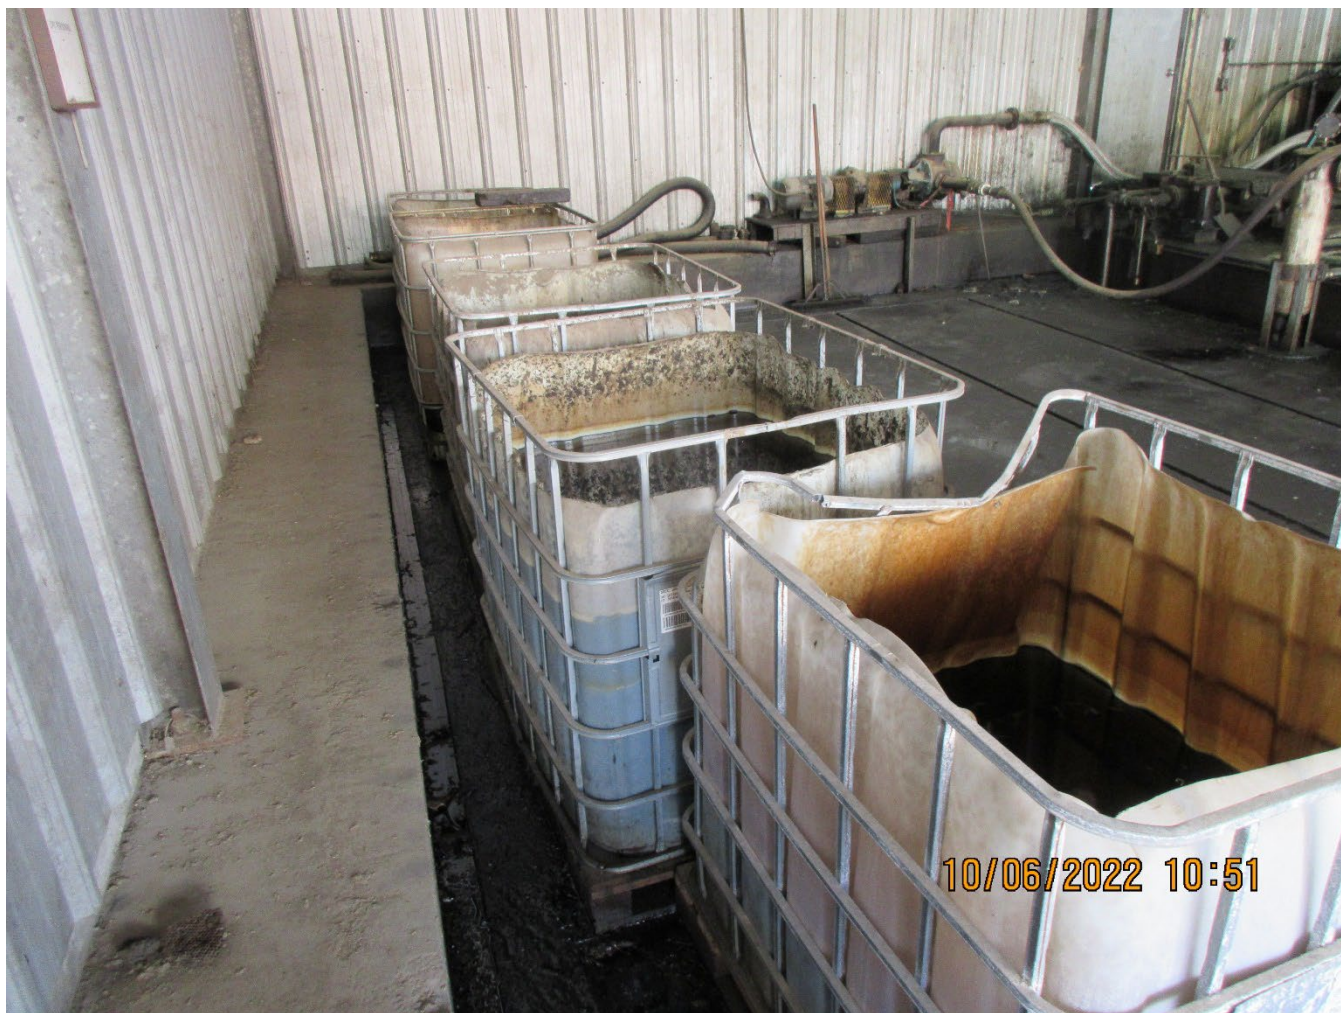
Used oil generated by facility equipment is collected within 275-gallon totes in this area. Six 275-gallon totes were in this area at the time of the inspection (Photos 7–9). Four of the totes

Photo 7 – Use oil collection area

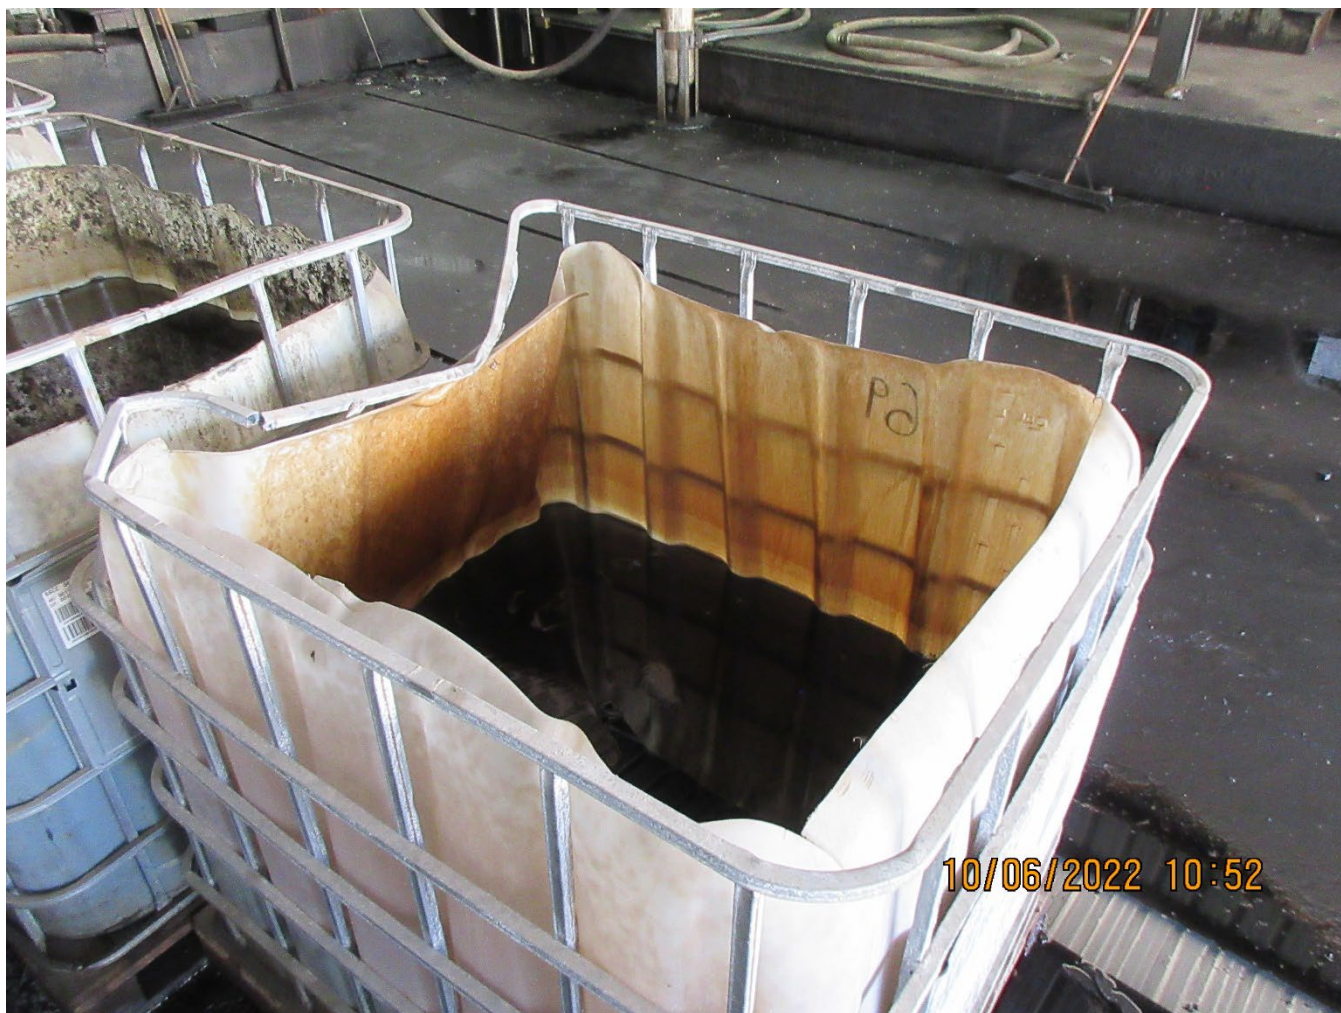
Photo 8 – Used oil collection area

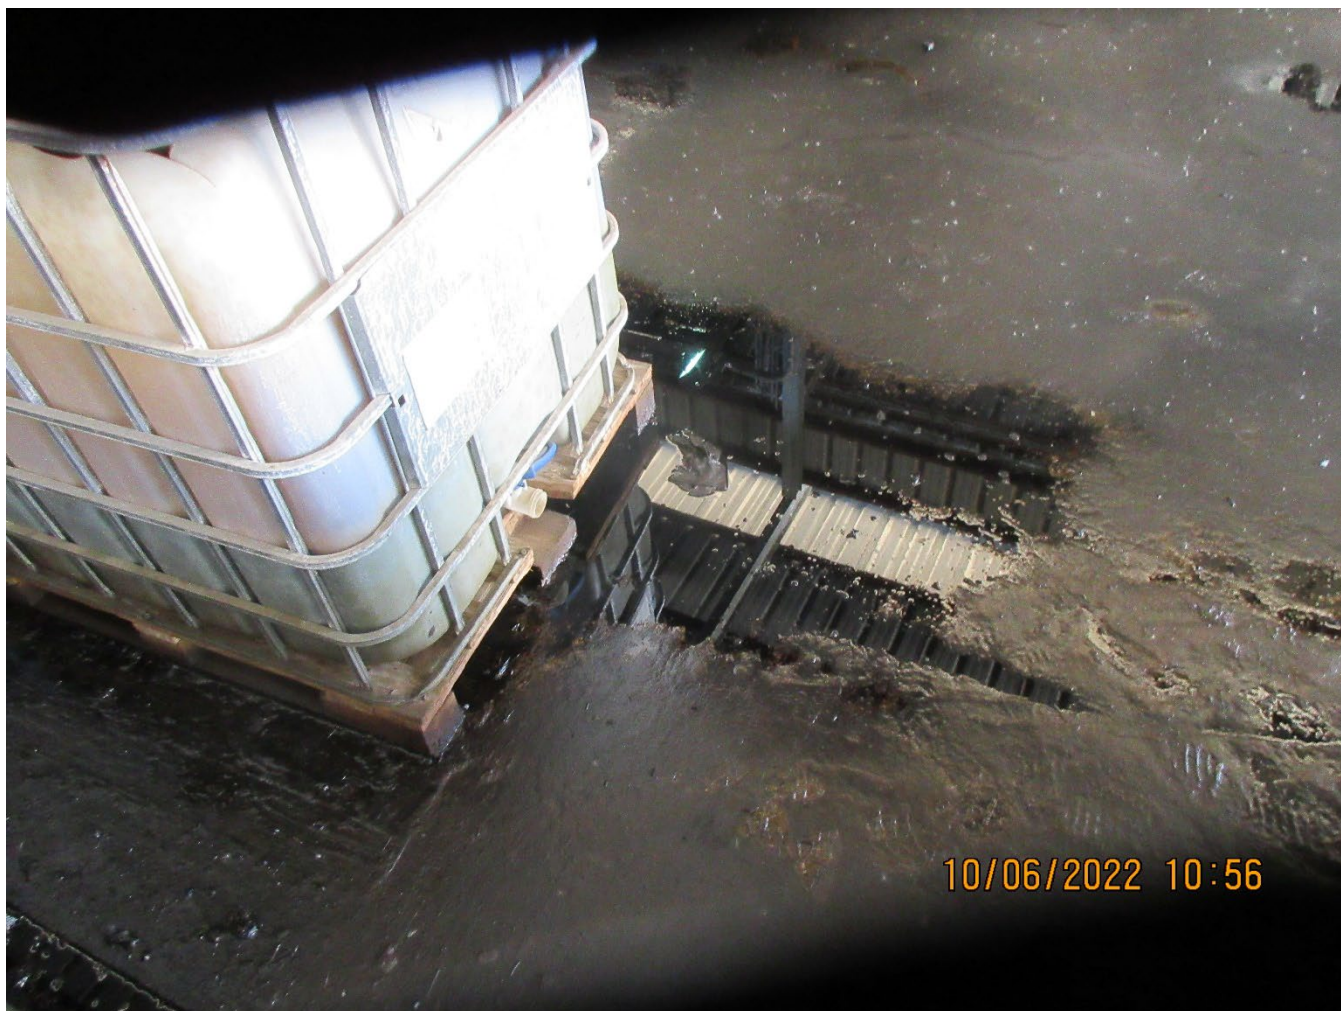
contained used oil. Each of these totes was labeled with the words “Used Oil.” Oil had been spilled or released onto the concrete floor in the area where the totes were situated (Photo 9).

Photo 9 – Floor with used oil release in collection area

**Pursuant to Ga. Comp. R. and Regs. 391-3-11-.17(1) [40 C.F.R. § 279.22(d)], upon detection of a release of used oil to the environment, the facility must clean up and manage properly the released used oil and other materials.**

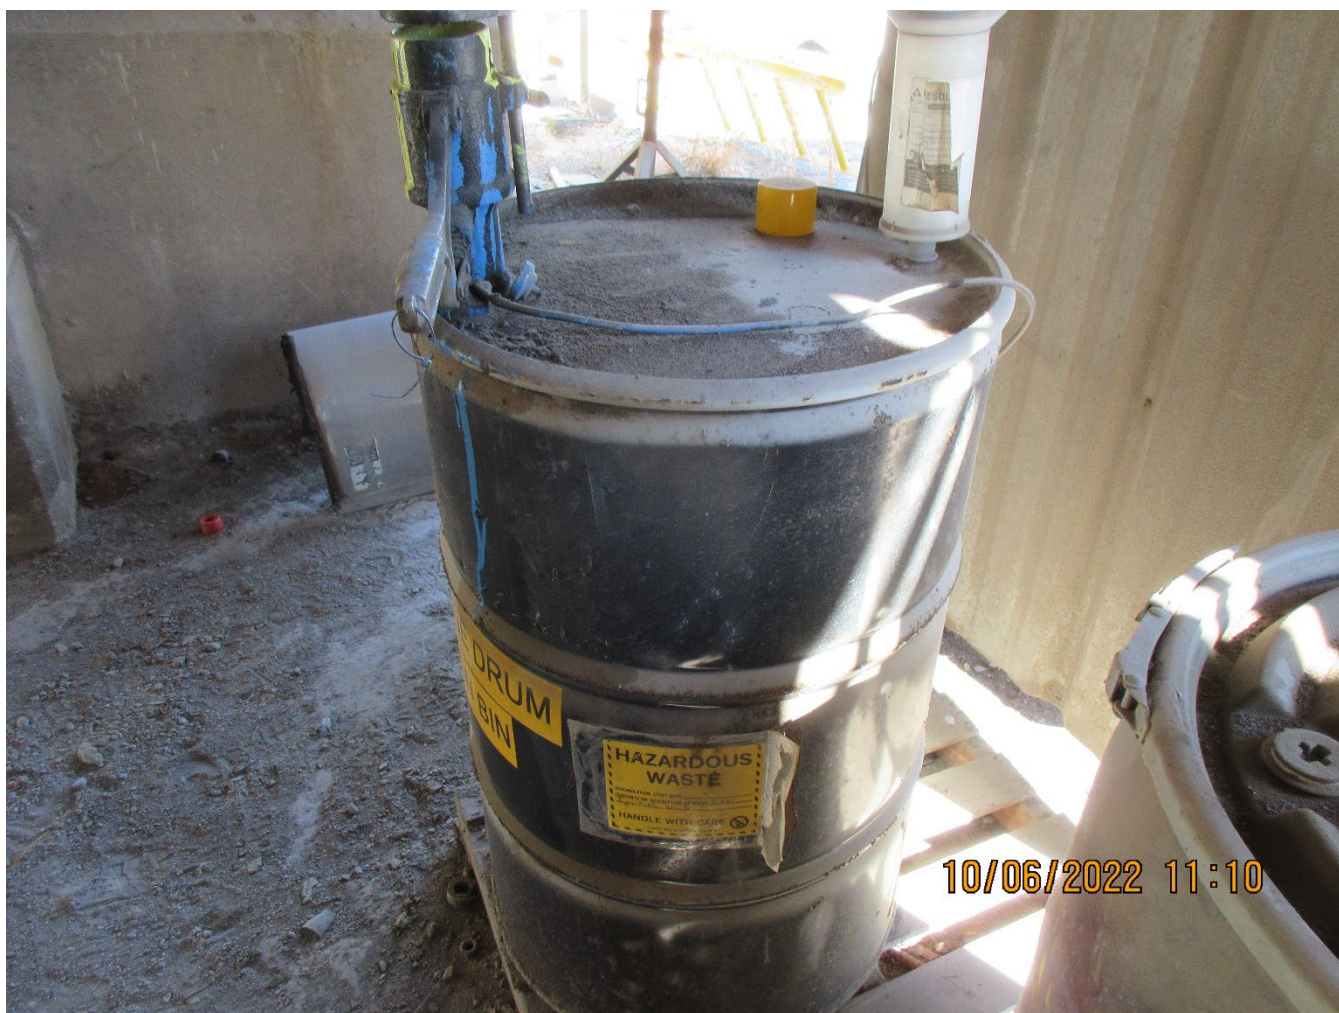
One 55-gallon drum of liquid aerosol can hazardous waste (Photo 10) was observed within a satellite accumulation area (SAA). The container was labeled with the words “Hazardous Waste” and a placard indicating the hazards associated with the contents of the container.

Photo 10 – SAA for the collection of aerosol can waste

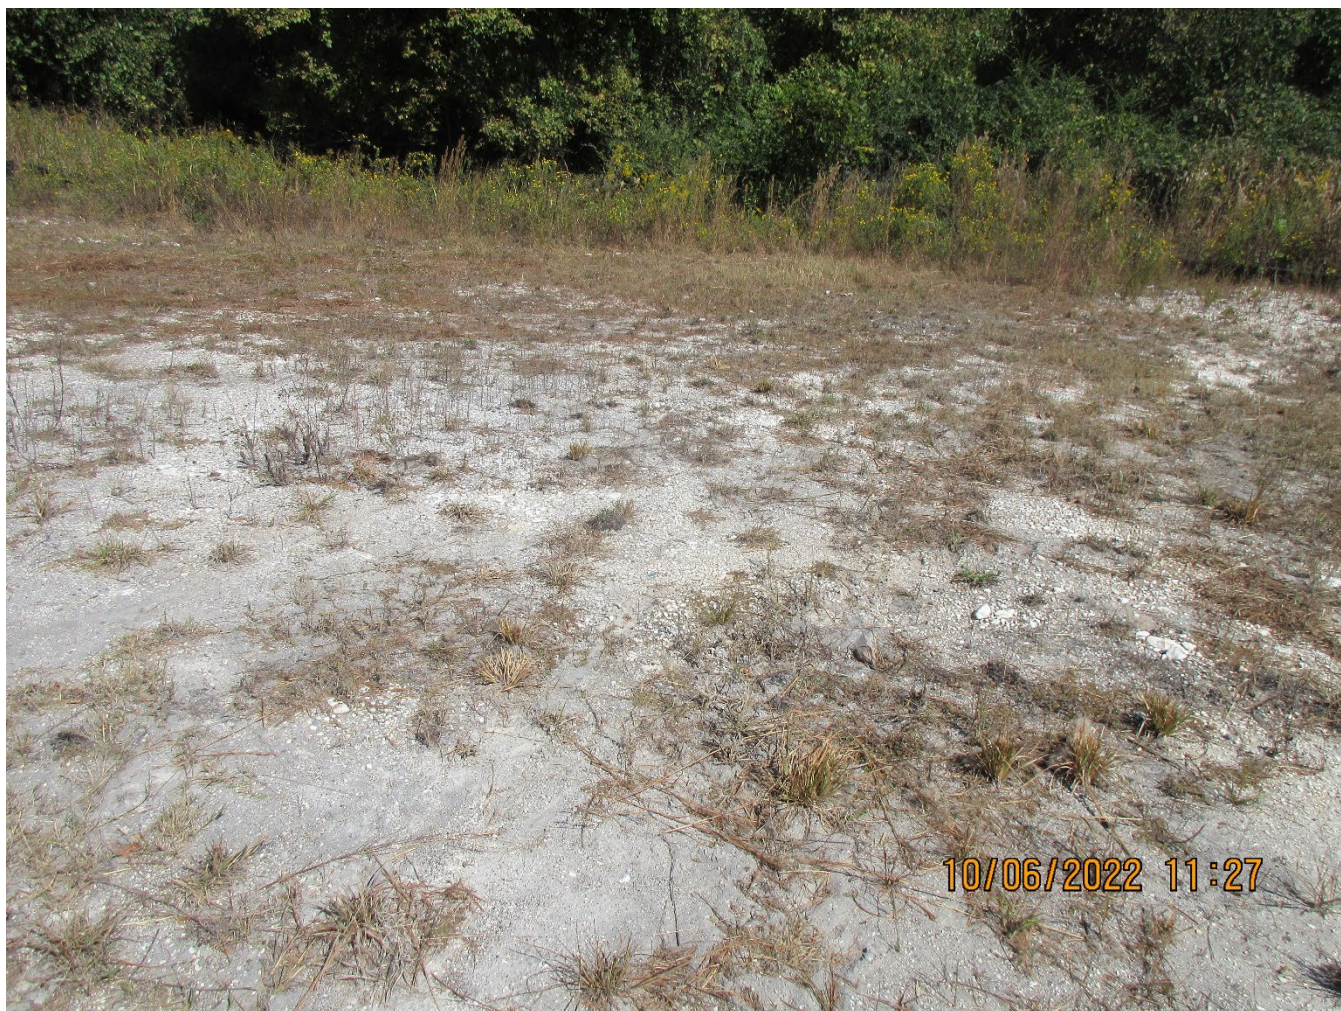
In 2016, a fire damaged the AQ Building which was located on the Chemical Products Corporation facility. A contractor operated within this building manufacturing chemicals for the pulp and paper industry. A bead blast operation was operated in area on the ground outside of the former AQ Building for cleaning debris from equipment (Photos 11 & 12).

On October 13, 2022, EPA’s LSASD sampling team took a soil sample in the area of the former bead blast operation. The results for total barium in the soil sample were found to be 6600 parts per million. The results of TCLP analysis performed on the sample indicated a barium level of 110 parts per million. This level is in excess of the TCLP level for barium of 100 parts per million. In comparison to the totals level of barium detected, a background threshold value for barium in silt/sands surface soils, an acceptable value of 6030 ppm was observed. *As the totals value for barium found by EPA in its sample of 6600 parts per million is not significantly greater than acceptable levels of barium for this area, EPA is recommending that Georgia EPD, address the barium levels found in this area in accordance with the corrective action requirements of the facility’s permit.*

Photo 11 – Area outside of AQ Building

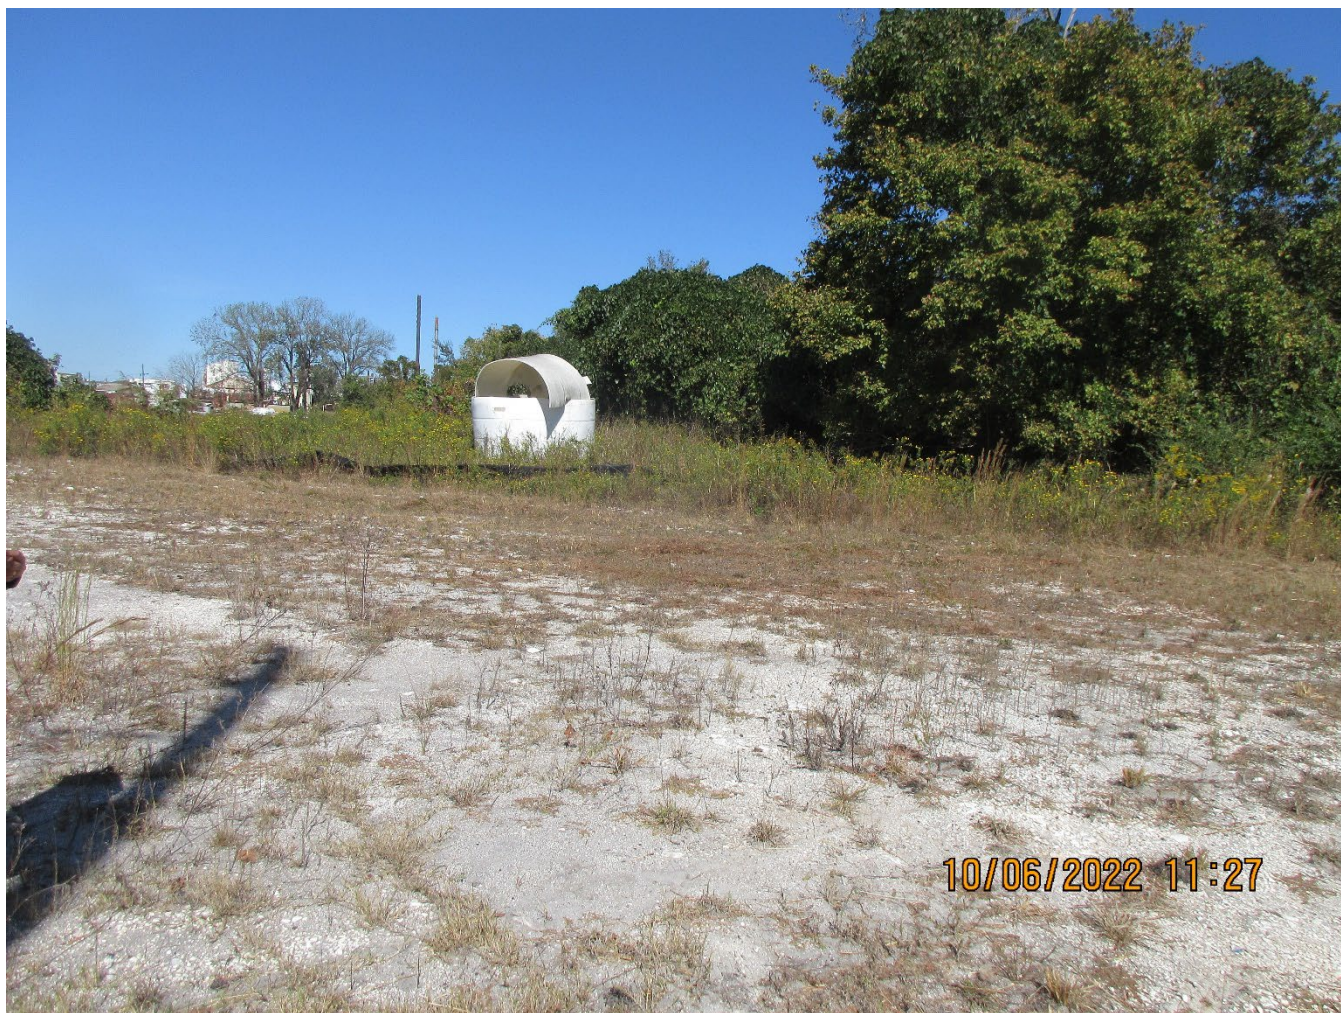
Photo 12 - Area outside of AQ Building
