## CAA112(r) INSPECTION REPORT

| <b>Name:</b> Scout Energy Group V, LP dba Scout Energy Partners – Jayhawk Gas Plant | |
| <b>Process:</b> NAICS 21113, Natural Gas Extraction | |

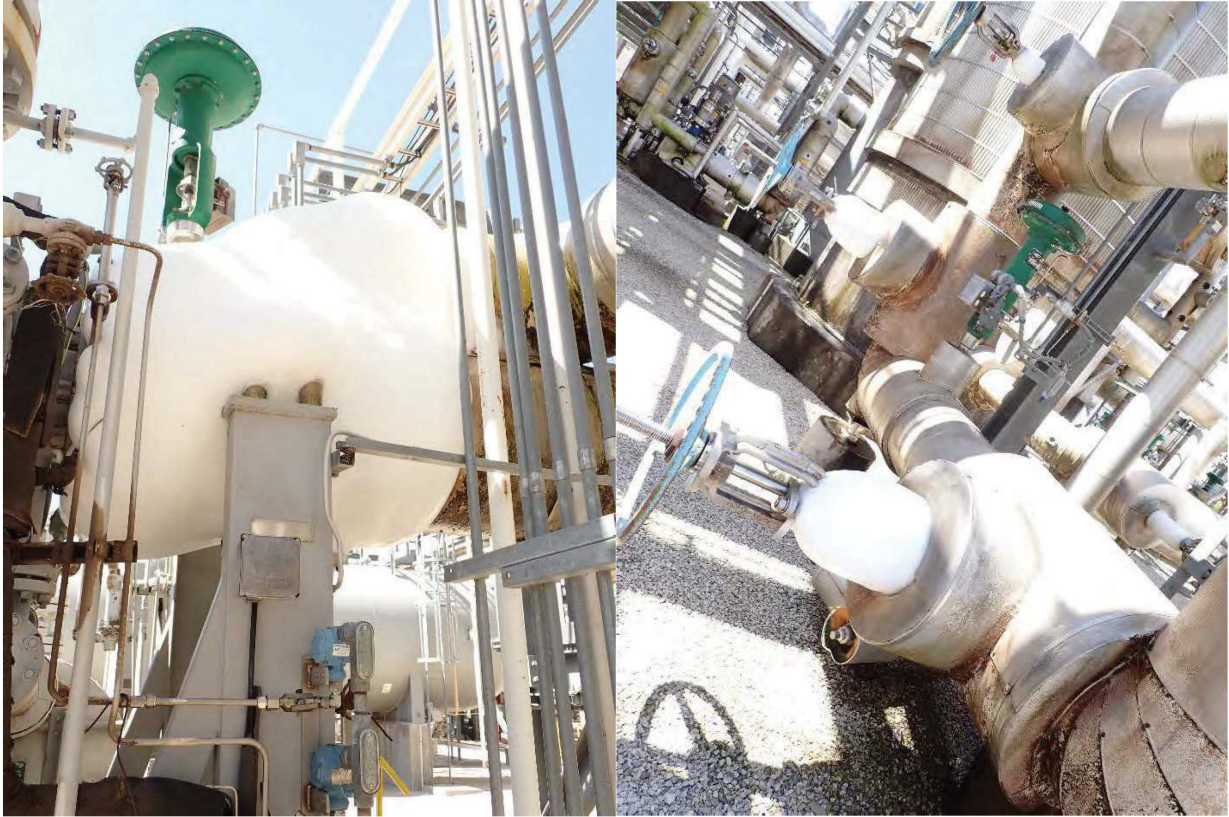
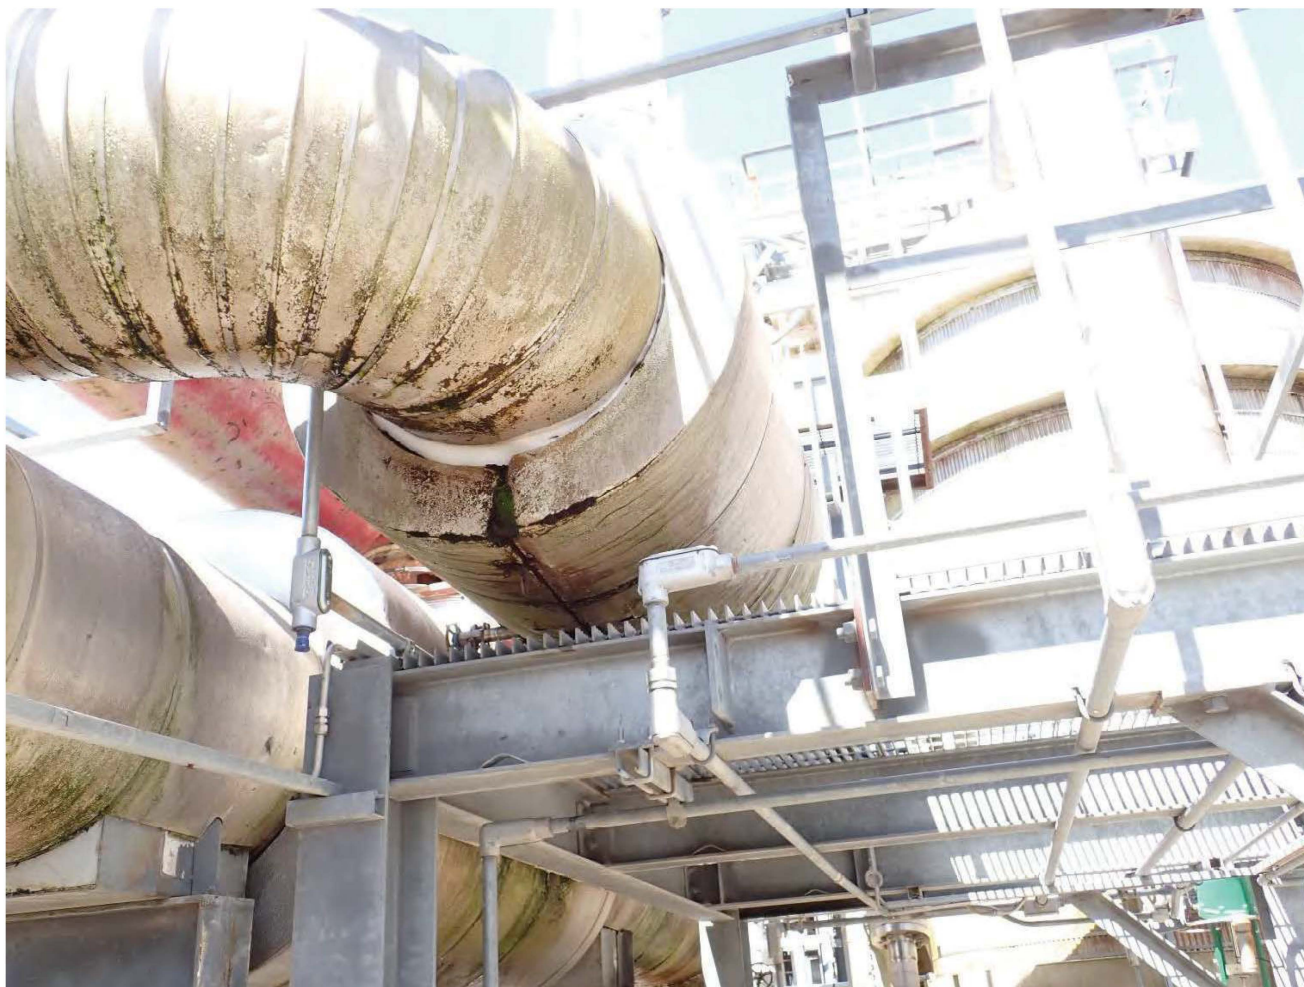
I observed several pipes and valve stems that were significantly iced over (Appendix 1, photos 55 – 74). I took images of ice accumulation on piping under insulation that has caused metal covering to bulge and separate (Appendix 1, photos 58-59).

During the inspection I took photos that show ice accumulation in areas of the cryogenic process. As discussed in the Field Tour section of this report, I documented separation and expansion of the metal casing covering pipe insulation caused by ice buildup. I also documented corrosion to the metal casing around pipes, as well as icing on valve stems and around valves. (Photos 55, 58 and 71)

Poor maintenance of insulation materials or failures to identify the causes of insulation failures, as seen in photo 58 of Appendix 1, exposes the equipment beneath the metal casing to moisture accumulation, corrosion and potentially stress cracking. Ice accumulation, as observed in photo 55 of Appendix 1, can overload pipe supports and damage pipe and equipment. Ice accumulation on valve stems (Appendix 1, photos 63 – 71) may impede the ability to close the valves easily in an emergency. Ice accumulations can also be a hazard to employees working in the area if large chunks were to breakoff and fall onto employees.

I sent an email (Appendix 33a) to Messrs. Harrold, Anderson, and Graber to request documentation on how they manage ice accumulation, such as the accumulation observed in photo 55 of Appendix 1, of an ice buildup on piping and a valve below an actuator.

Due to the uncertainty around the accuracy of inspection intervals and retirement dates, as well as the observed icing and damage to metal casing that covers insulation and lubricant-leaking pump, I identified the following deficiency:

- 4. Scout Energy failed to ensure frequency of inspections is consistent with manufacturer's recommendations and good engineering practices as is required by 40 CFR 68.73(d)(3).**
