**Compliance Evaluation Inspection Report**

Project No.: CV-MS0053503-6-4-2024

Pearl River Wastewater Treatment Plant

NPDES Permit No.: MS0053503

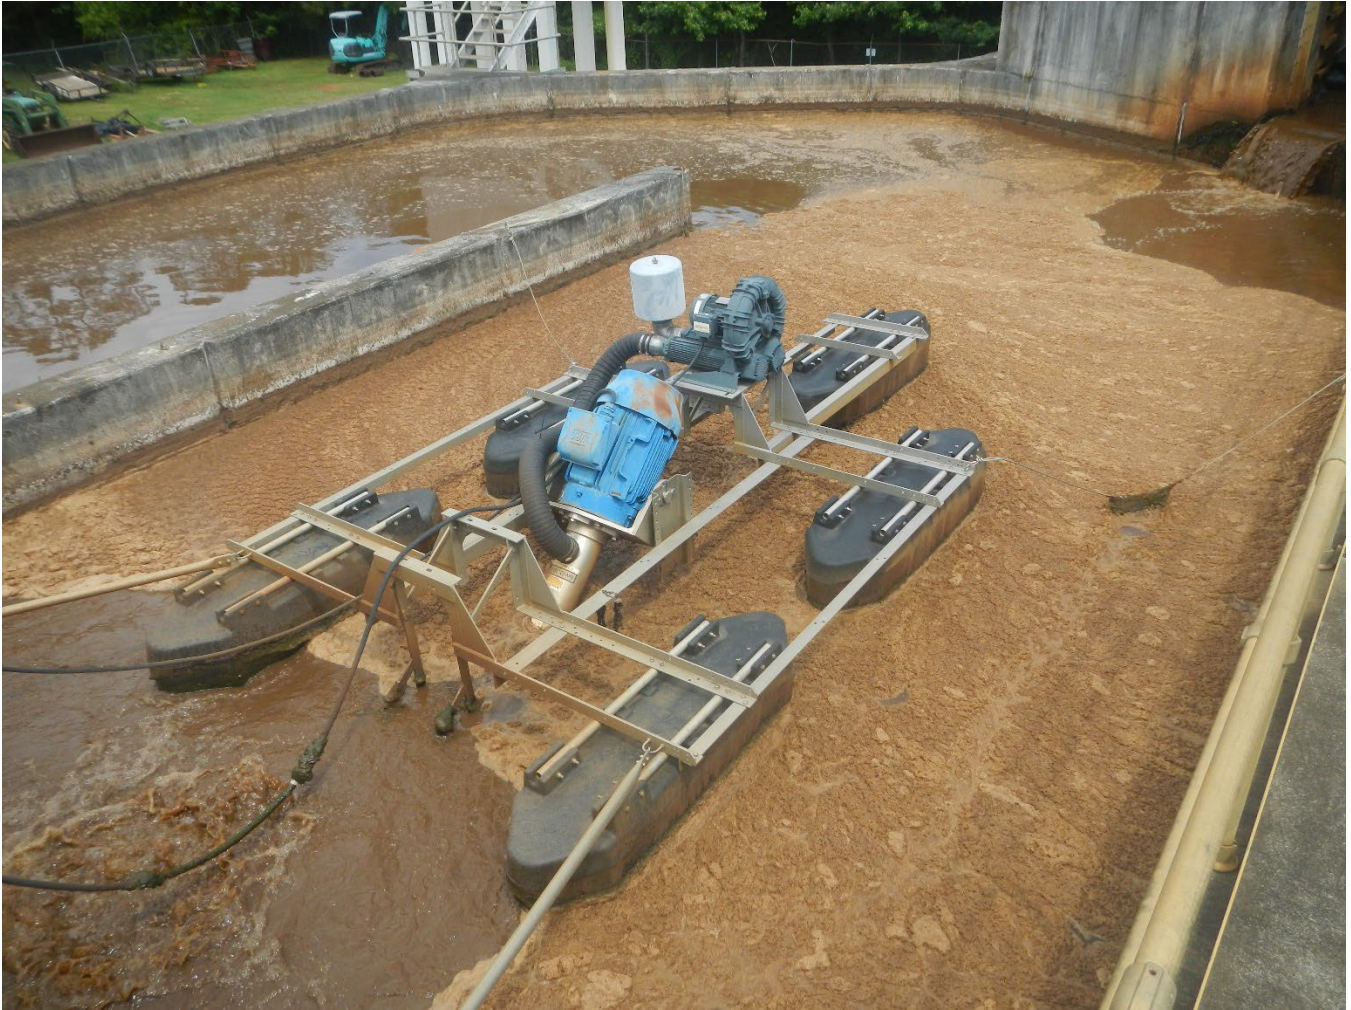
- The headworks comminutor was non-operational.
- Facility personnel stated that the headworks flow measurement was inaccurate.
- The composite sampler located at the headworks did not have a functioning thermometer.
- Heavy persistent foaming was observed in the aeration chamber (Photo 1).
- Empty barrels that previously held sludge conditioning polymers were stored outside without caps.
- Dried sludge was stored in an exposed, albeit tarp lined, dumpster. This would allow rainwater to enter the dried sludge.

Photo 1: Thick foam observed in aeration basin.

- a. The permittee should have a functioning headworks to effectively remove larger solids from the treatment processes.
- b. The influent flow meter should be regularly calibrated to reflect accurate flow readings.
- c. The influent composite sampler should have a functioning thermometer and climate control system to ensure proper storage of samples.
- d. Barrels that contain or have contained chemicals should be stored with lids on where rainwater cannot enter them.
- e. The permittee should monitor the mixed liquor suspended solids (MLSS) levels in the aeration basin to adequately control foaming and solids content.
- f. Dried sludge should not come into contact with rainwater.

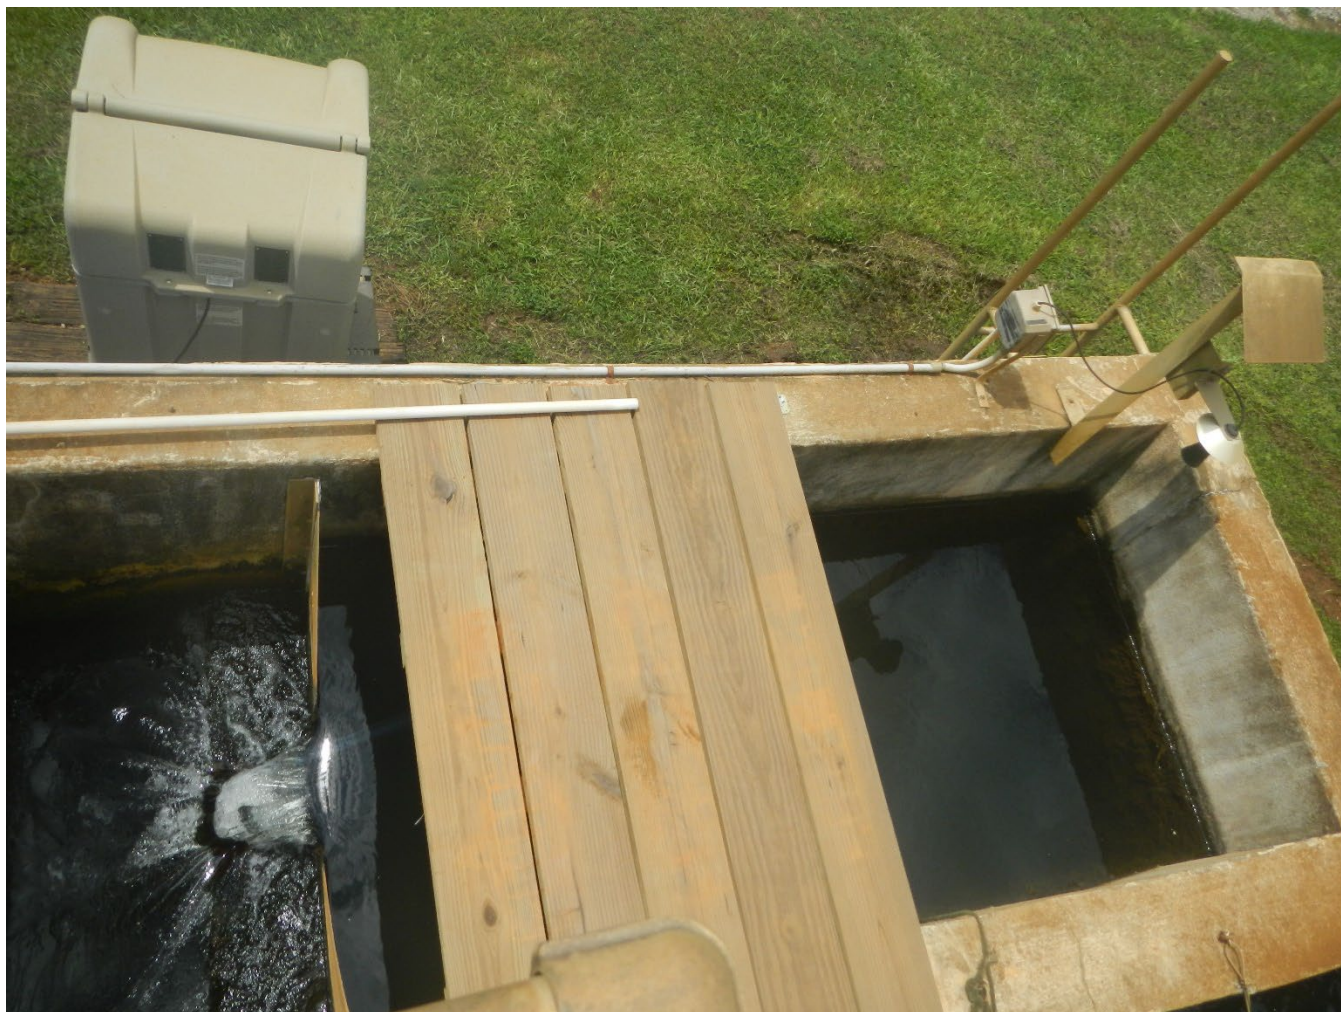
Final effluent flow is measured by an ultrasonic flow meter at a V-notch weir (Photo 2). The flow meter was calibrated on 3/6/2024.

Photo 2: flow measurement (90 degrees V notch Weir) following clarification and disinfection.
