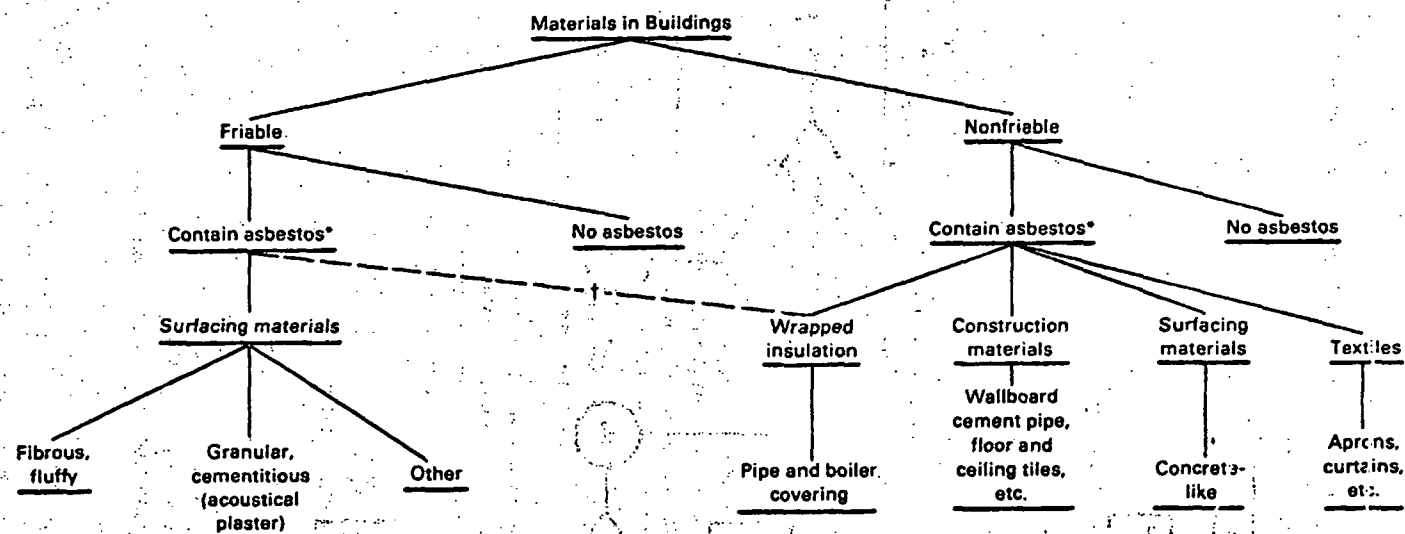
Figure 5. Types of building materials which could contain asbestos.

\*See Appendix C for a more complete description of asbestos-containing materials.  
 †Wrapped insulation that is damaged may be friable.
