# White Lead for Many Purposes Gives Lasting Service

*Inside and Out, on Wood and Metal, White Lead Paint Performs Remarkably*

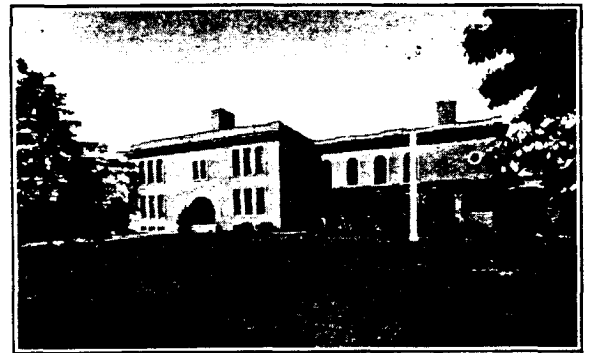
*Havemeyer School, Greenwich, Conn., in which flat white lead paint did not require repainting for fifteen years.*

Another Greenwich building wherein pure white lead paint has given an excellent account of itself, but for an entirely different purpose, is the Havemeyer School. Seventeen years ago the entire interior was painted with pure white lead, mostly flat finish. It was not repainted until two years ago. This demonstrates the economy of using the best paint for interiors, for white lead can be repeatedly washed and its good appearance maintained for years, whereas cheap flat paint washes off and can not be washed clean, for dirt imbeds in its surface and the paint becomes streaky. The fifteen years of service

of this white lead interior is more remarkable when it is considered that it is in a school, where wear and tear on painted walls is generally great.

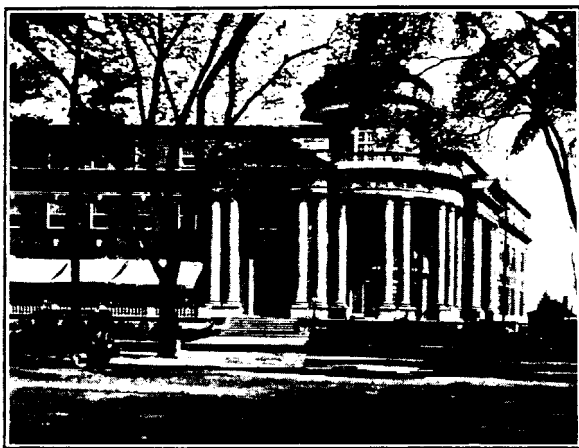
*The wood trim of the Greenwich, Conn., Y.M.C.A., shown here, was last painted in 1929 with pure white lead.*

White lead was put to still another use on the Greenwich Trust Co. building, where it has again proven both its versatility and durability. Metal sash was the only exterior work requiring paint. It was painted with pure white lead for all coats in 1926 and has not been repainted in the eight ensuing years. Wood sash and trim in the Greenwich Y.M.C.A. was also painted with pure white lead, in 1929, and is not yet in need of repainting.

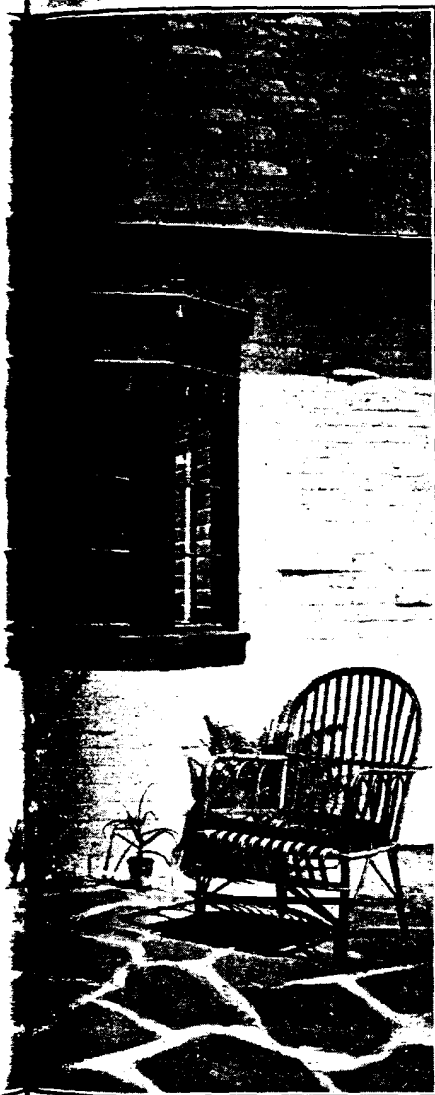
*Here over a bay window on a house in a New York suburb.*

*Hand wrought ornamental lead gutters, downspout and window flashing add to the attractiveness of this lovely home.*
