## RCRA COMPLIANCE EVALUATION INSPECTION REPORT

Tradebe Treatment and Recycling of Tennessee, LLC (Tradebe)  
5485 Victory Lane  
Millington, Tennessee 38053

EPA ID: TND000772186

March 8 & 9, 2022

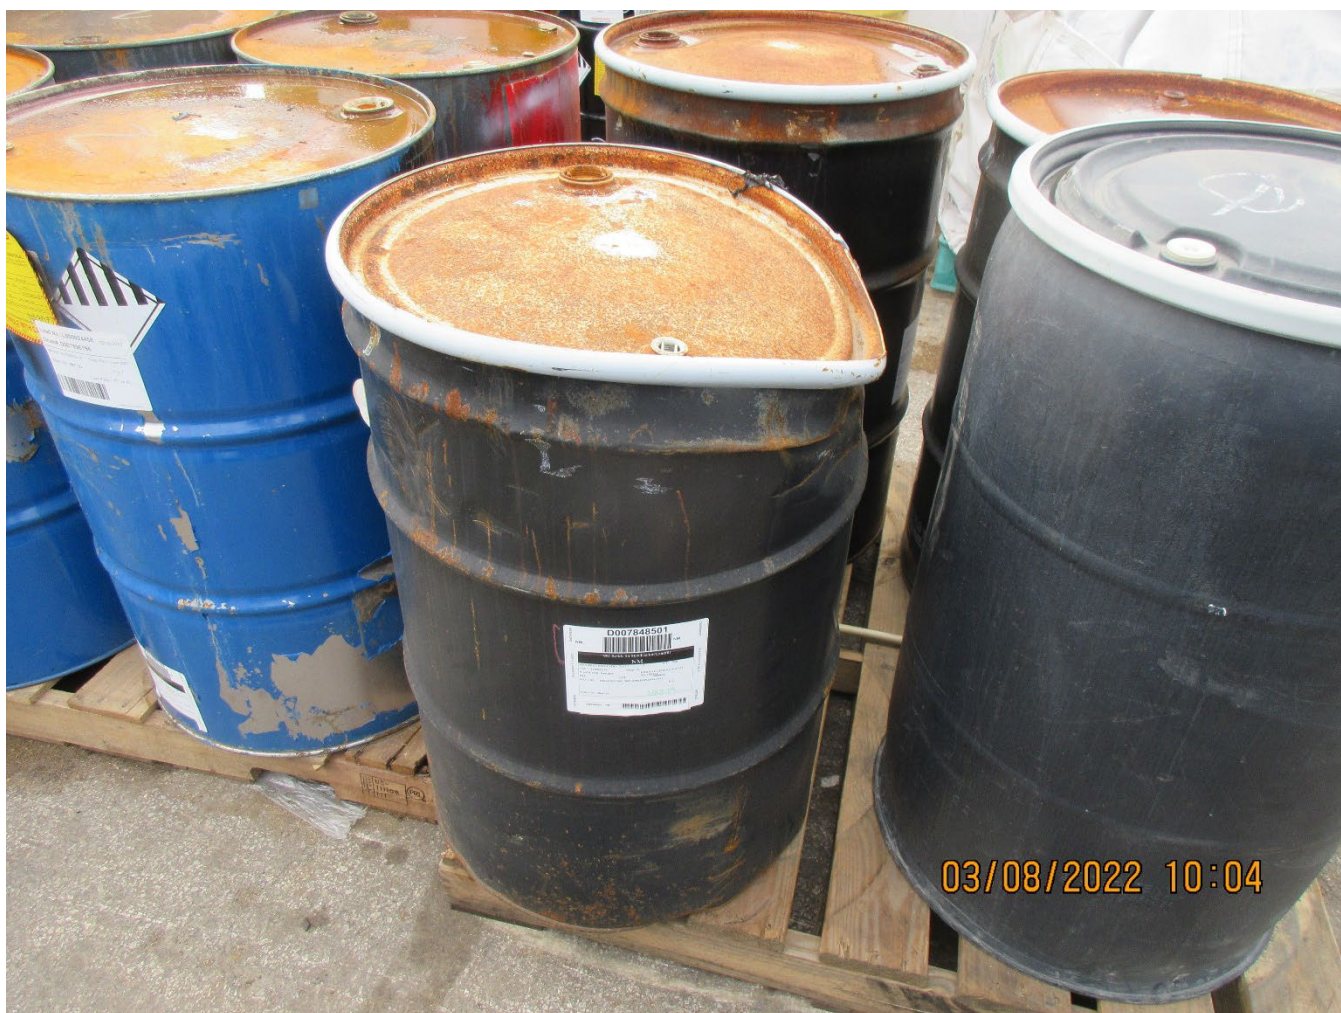
Photo 1 – Damaged Container in Row 15 of Unit 217

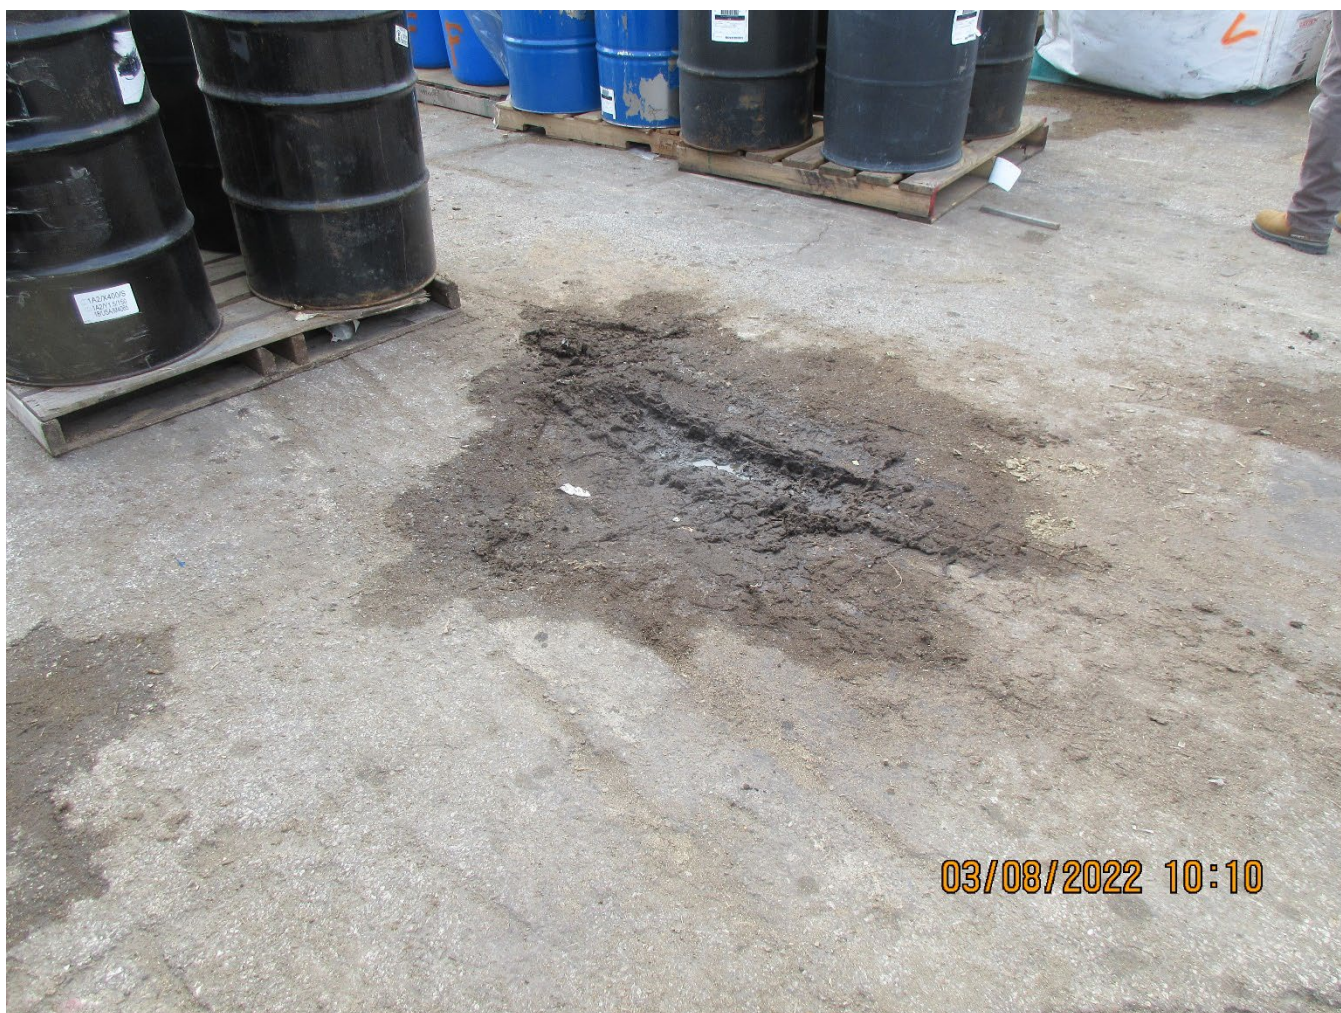
**In the area of Row 14, the surface of the asphalt was damaged by truck traffic (Photo 2). It is recommended that the facility take action to repair the asphalt in this area to avoid any possible disposal issues should a spill occur in this area.**

Photo 2 – Damage to Asphalt in Area of Row 14 of Unit 217

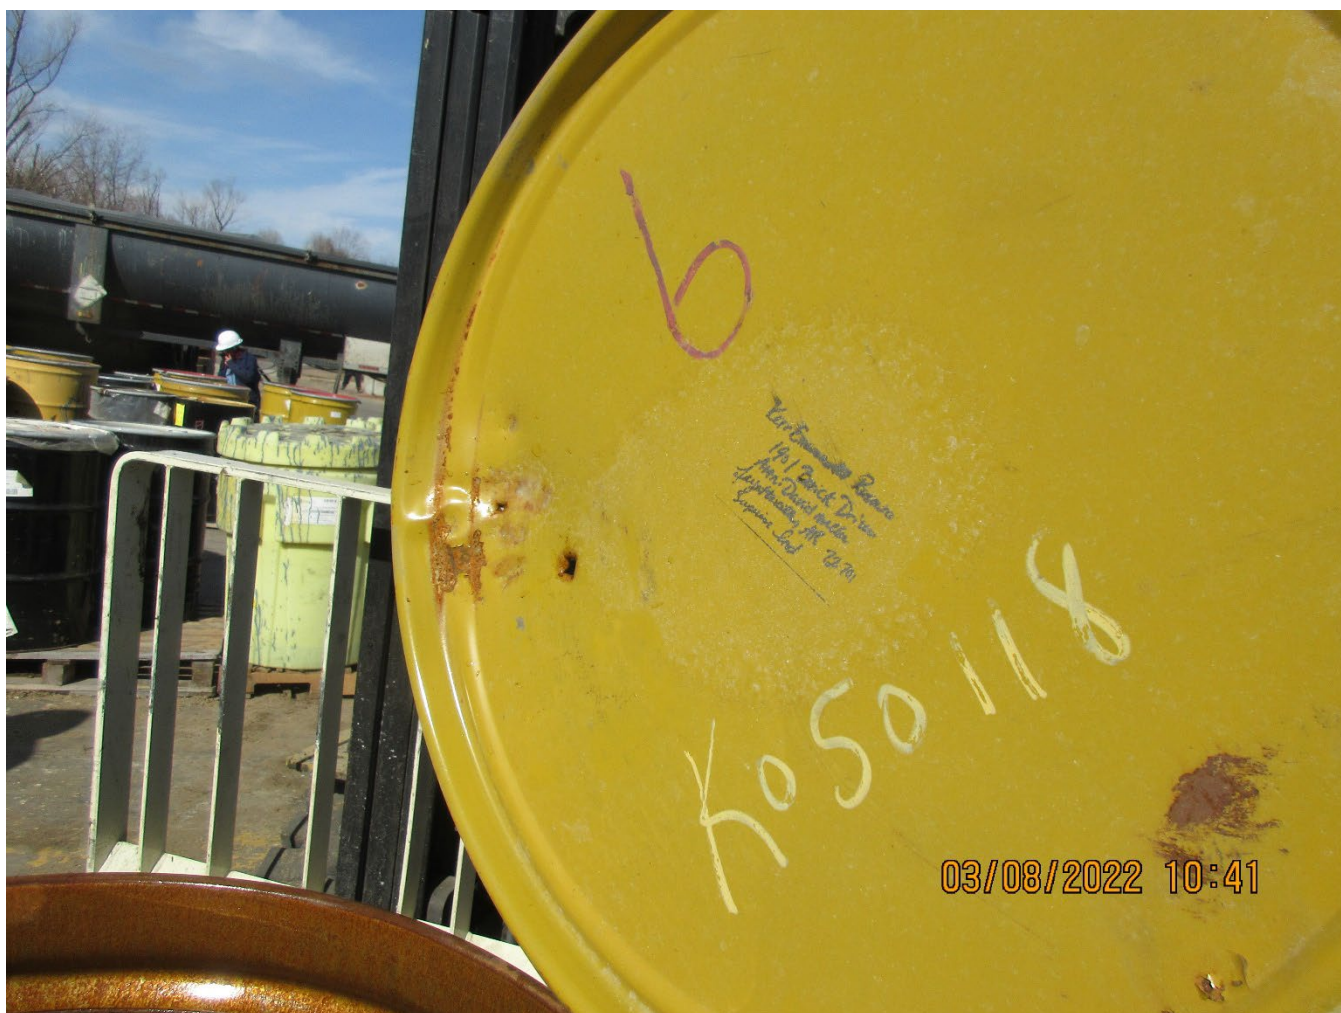
Photo 3 – Hole in lid of overpack container in Row 32 of Unit 217

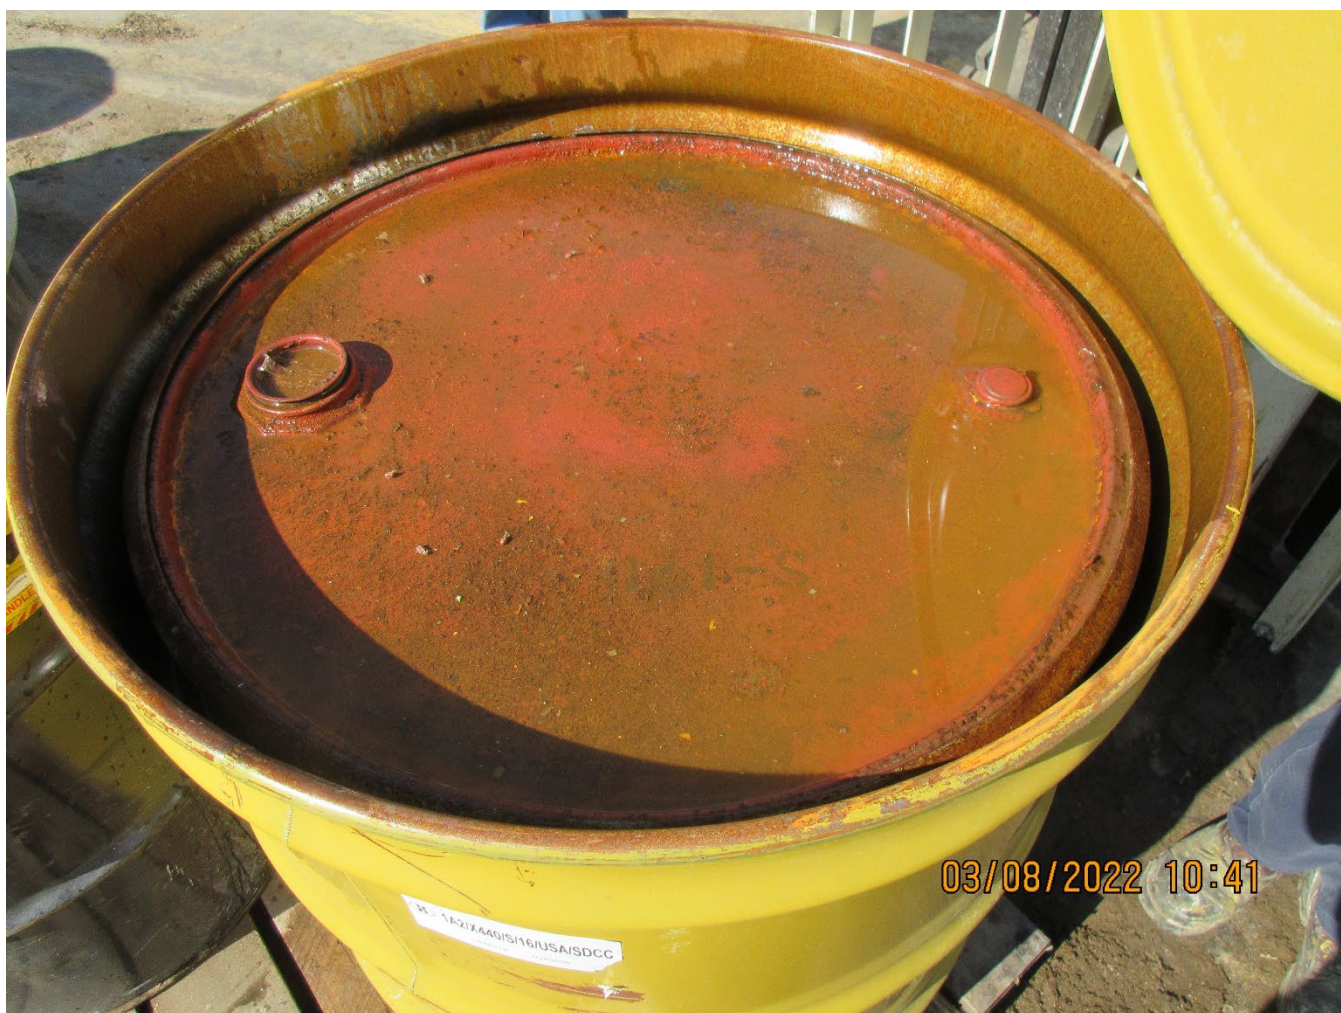
Photo 4 – Drum floating in water within overpack container in Row 32 of Unit 217 shown in Photo 3.

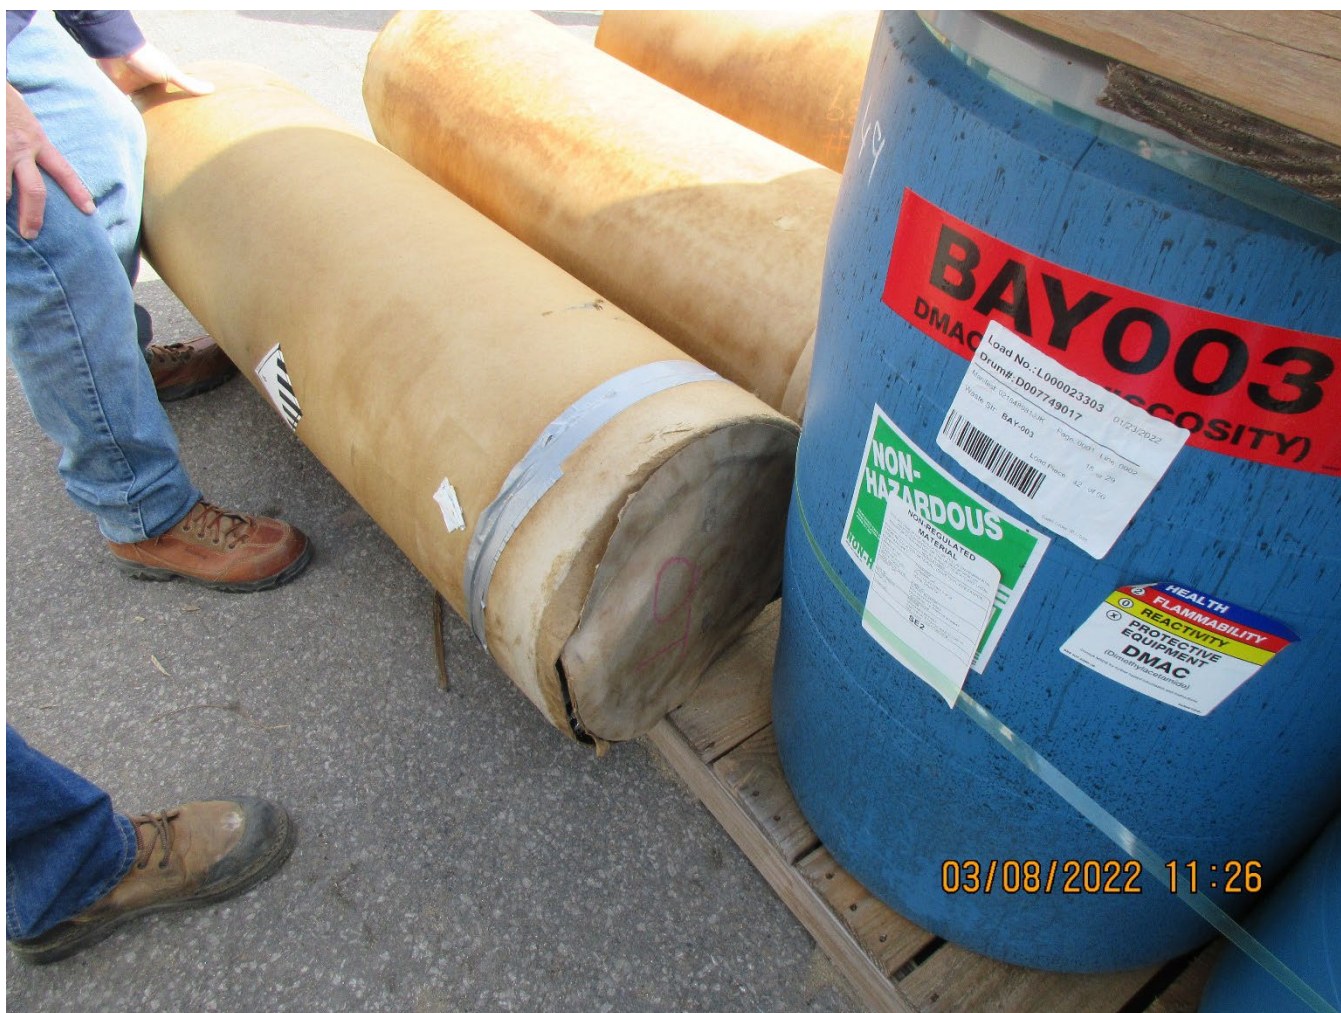
One 4-foot tube (Photo 5) and one cubic yard box containing universal waste bulbs were observed to be open at the time of the inspection. Three 55-gallon containers of universal waste batteries were also observed in this area.

Photo 5 – Four-foot tube of universal waste batteries in Area East of Unit 202

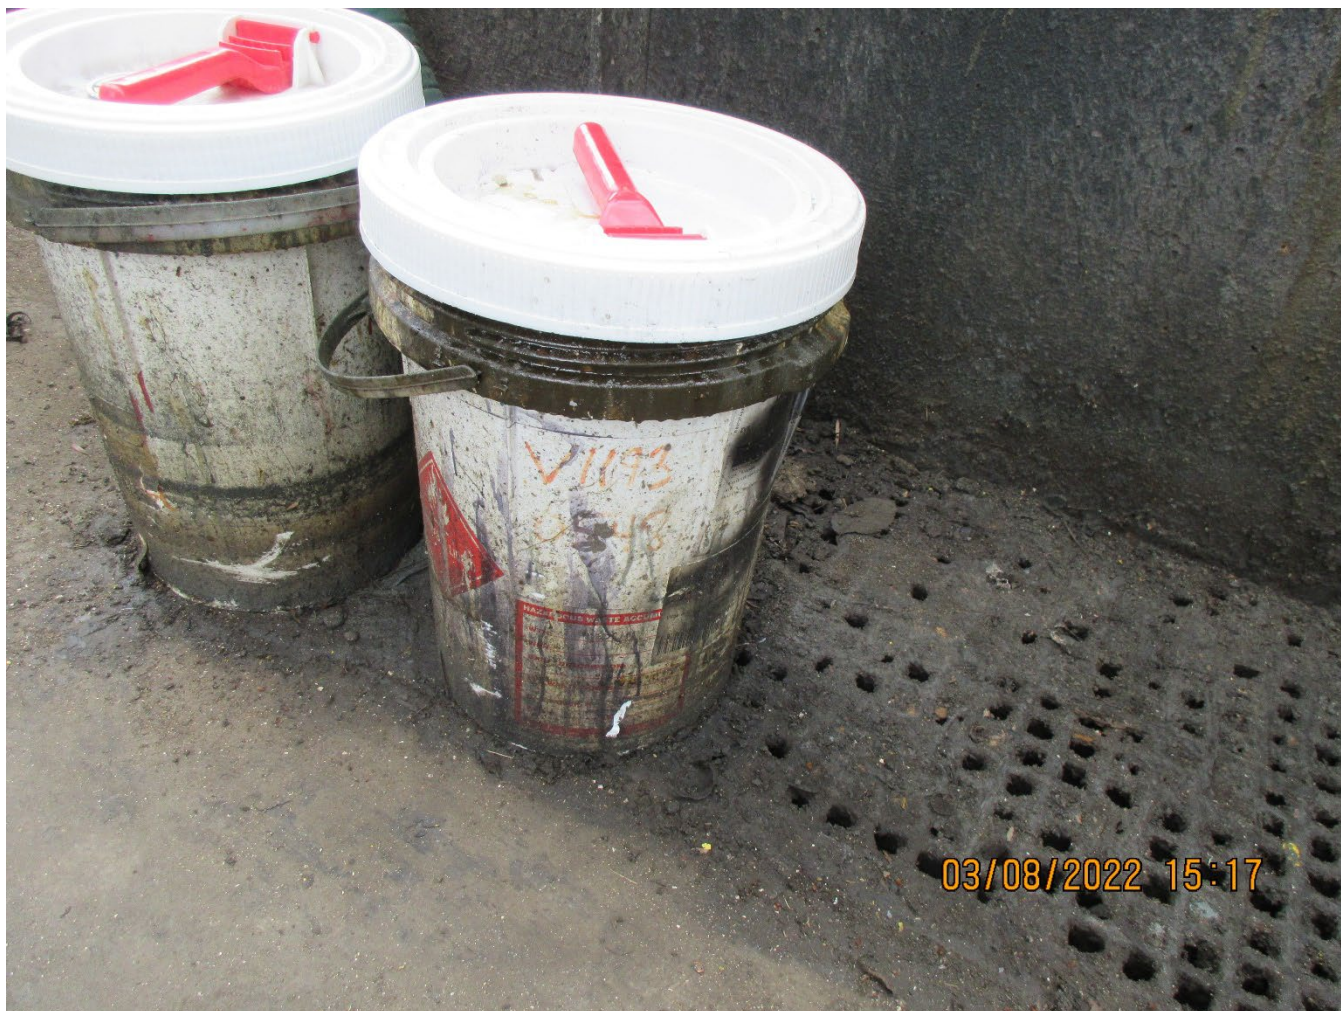
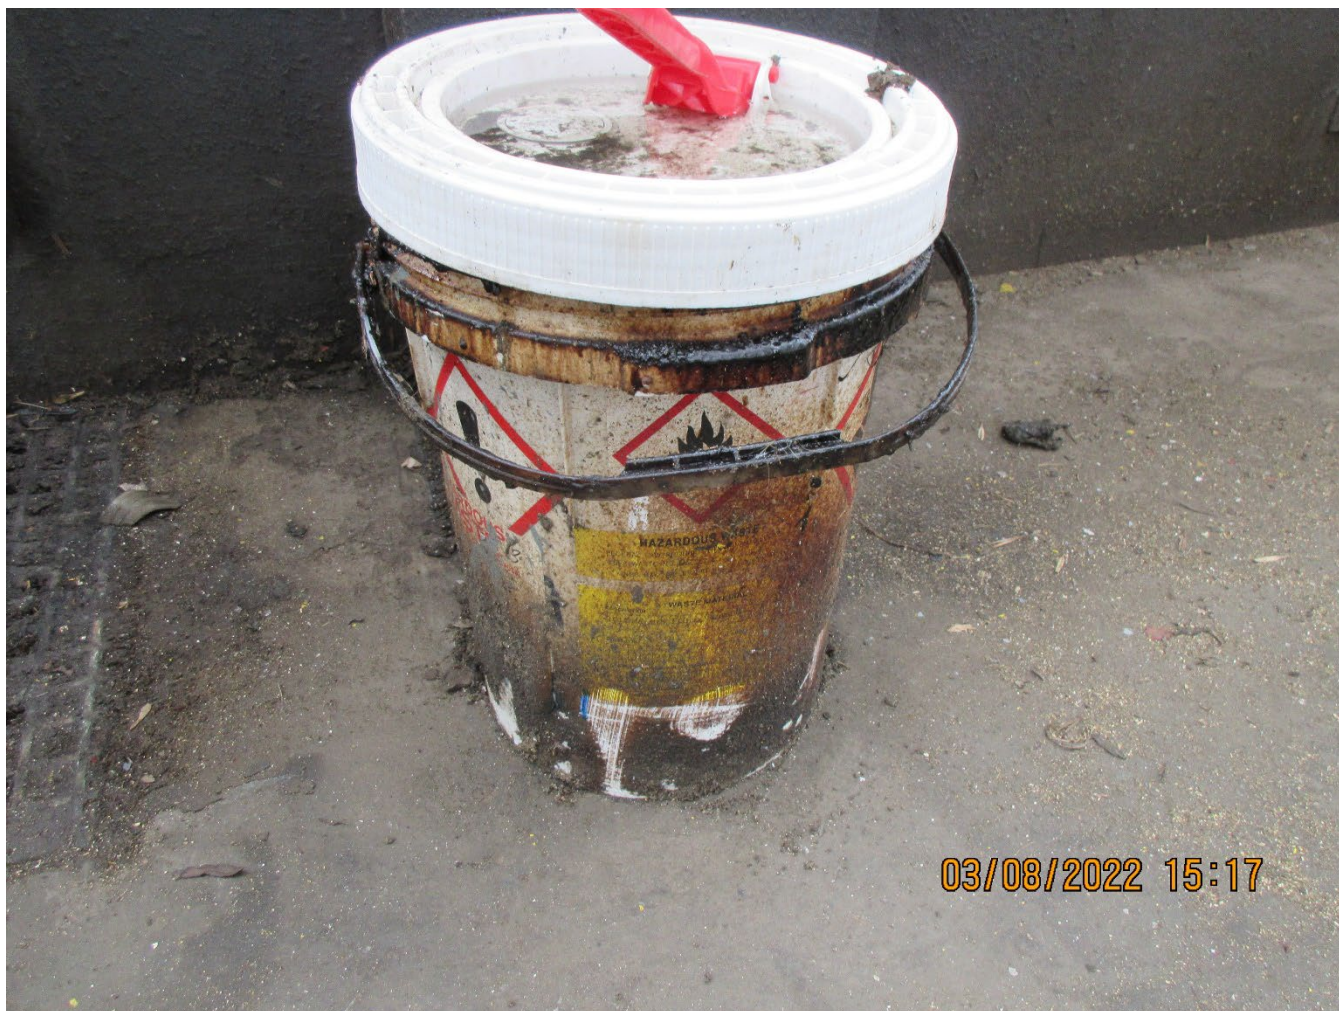
At Unit 208, the inspection team observed one SAA that contained three closed 5-gallon buckets for the accumulation of any drips from sampling ports. These containers were not marked legibly with the words “Hazardous Waste” or with indications of the hazards of the contents (Photos 6 & 7).

**Pursuant to Tenn. Comp. R. & Regs. 0400-12-01-.03(4)(e)5(i)(I & II) [40 C.F.R. § 262.34(c)(1)(ii)], which is a condition of the SAA Permit Exemption, a generator is required to mark satellite accumulation containers either with the words “Hazardous Waste” or with other words that identify the contents of the containers.**

Photo 6 – Five-gallon hazardous waste containers in SAA in the area of permitted tanks in Unit 208

Photo 7 – Five-gallon hazardous waste container in SAA in the area of permitted tanks in Unit 208

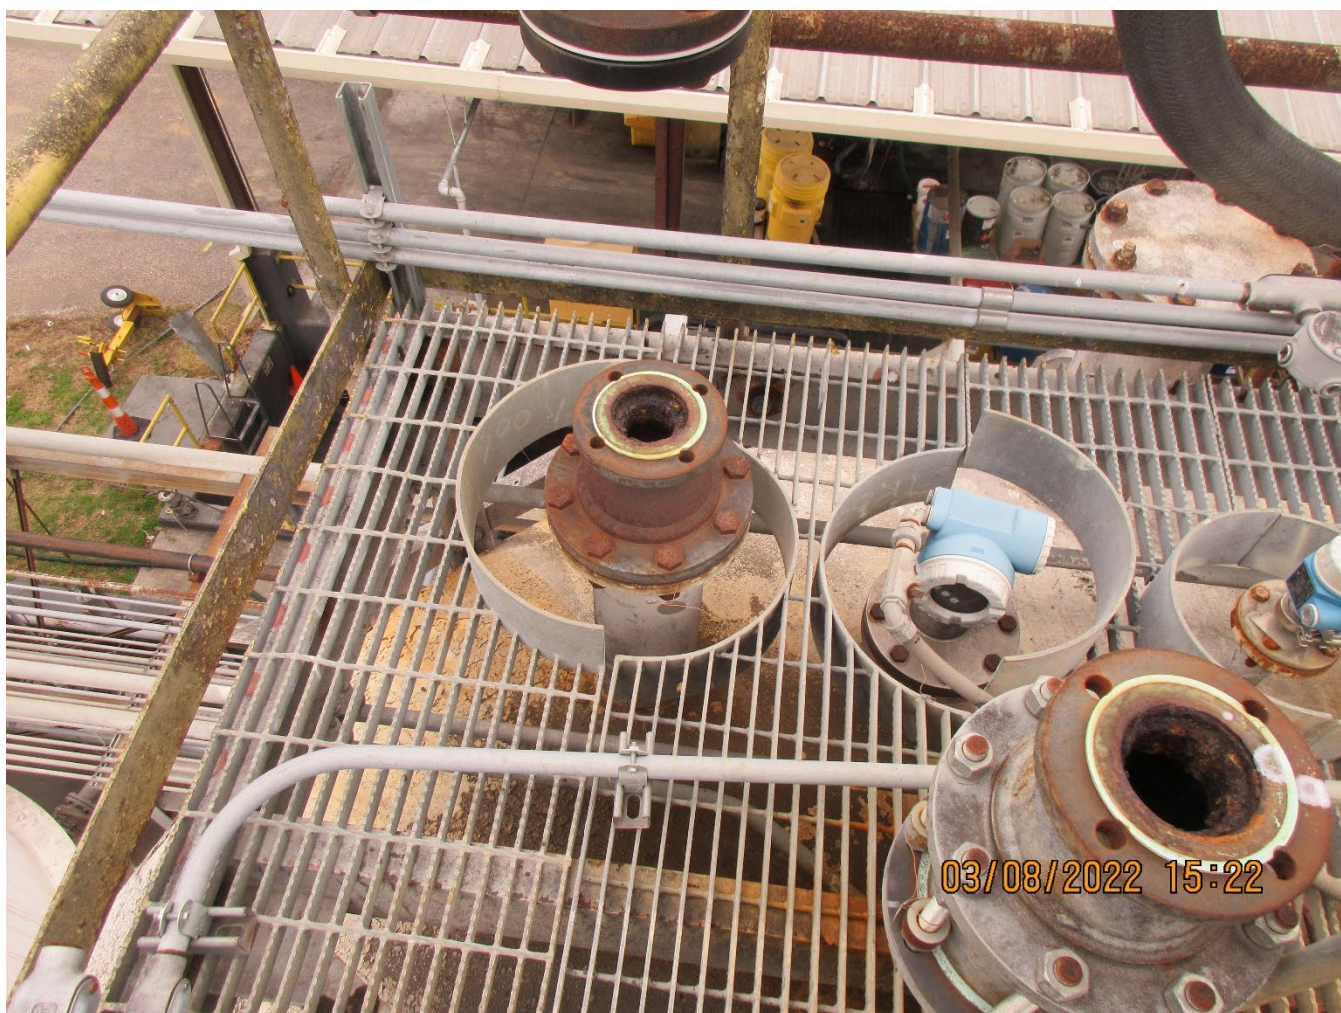
During the CEI, Daryl Himes and Laura Dahlgren of the inspection team and Michael Decker of Tradebe climbed the ladder to the platform at the top of the four tanks to observe their control devices. During the inspection on the platform, a closure device on Tank T-004 was observed to be open (Photo 8) at the time of the inspection. A work order dated March 10, 2022 was provided to the inspection team electronically a day after the inspection which indicated that an inlet ball valve was plugged and needed to be repaired.

Photo 8 – Top of Tank 4. Equipment removed during repair.

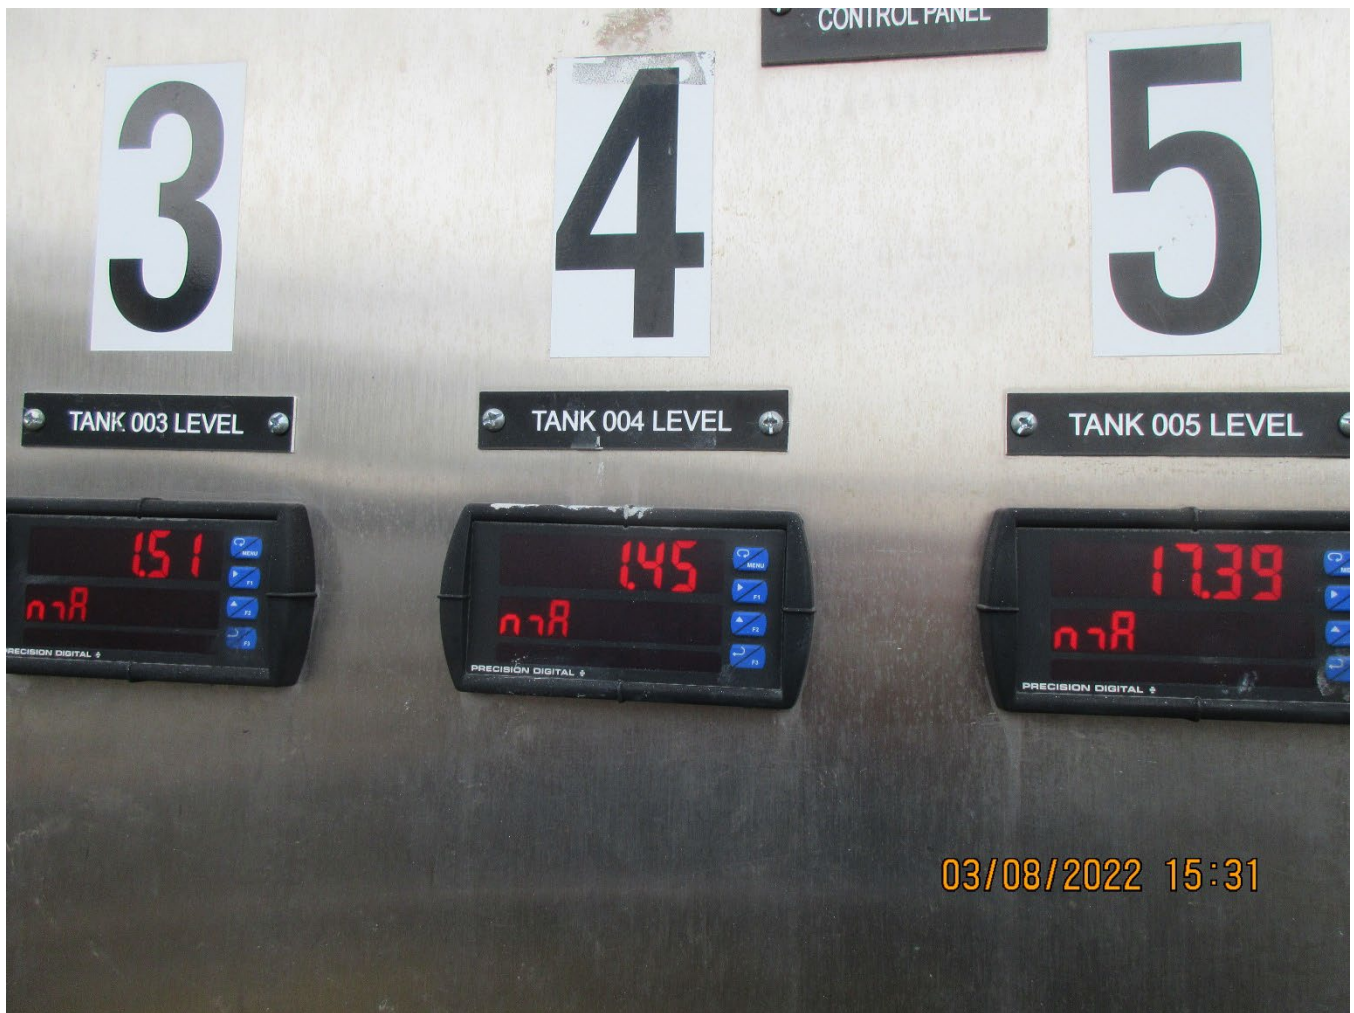
According to the level indicator panel, at the time of the CEI, Tanks 3-6 had readings of 1.51, 1.45, 17.39 and 14.49, respectively (Photo 9). Using a strapping conversion chart to calculate the quantity of hazardous waste in each of the tanks at the time of the inspection, Tank T-003 contained 3,075 gallons of hazardous waste, Tank T-004 contained 3,017 gallons of hazardous waste, Tank T-005 contained 16,389 gallons of hazardous waste, and Tank T-006 contained 13,957 gallons of hazardous waste. The inspection team observed that these permitted hazardous waste tanks were labeled with the words “Hazardous Waste.” Emission monitoring tags were observed on the ancillary equipment to each of the tanks. The secondary containment system for the tank system appeared to be in good condition at the time of the inspection.

Photo 9 – Level readings for Tanks 3, 4 & 5

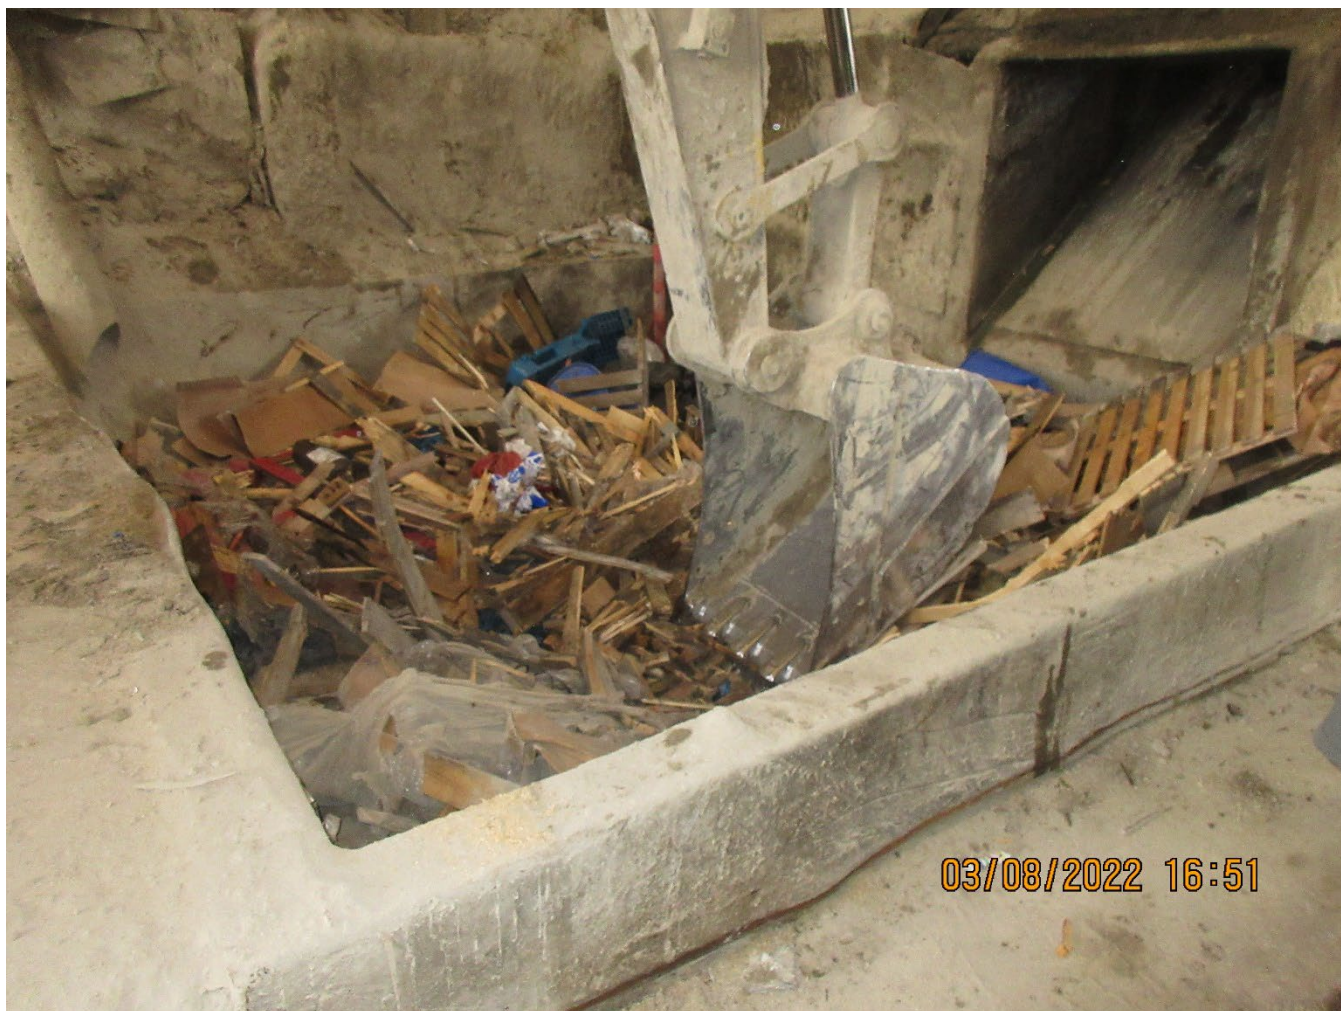
Area B of Unit 207 is utilized by the facility for treatment purposes (neutralization) (Photo 10) of hazardous wastes in a stainless steel lined concrete pit using cement kiln dust. No hazardous wastes were observed in this area at the time of the inspection.

Photo 10 – Treatment Unit within Area B of Unit 207
