## **RCRA Inspection Report**

SiVance, LLC  
5002 NE 54th Place  
Gainesville, FL 32609-1694  
EPA ID: FLD050768548

August 19, 2020 @ 8:40 A.M.

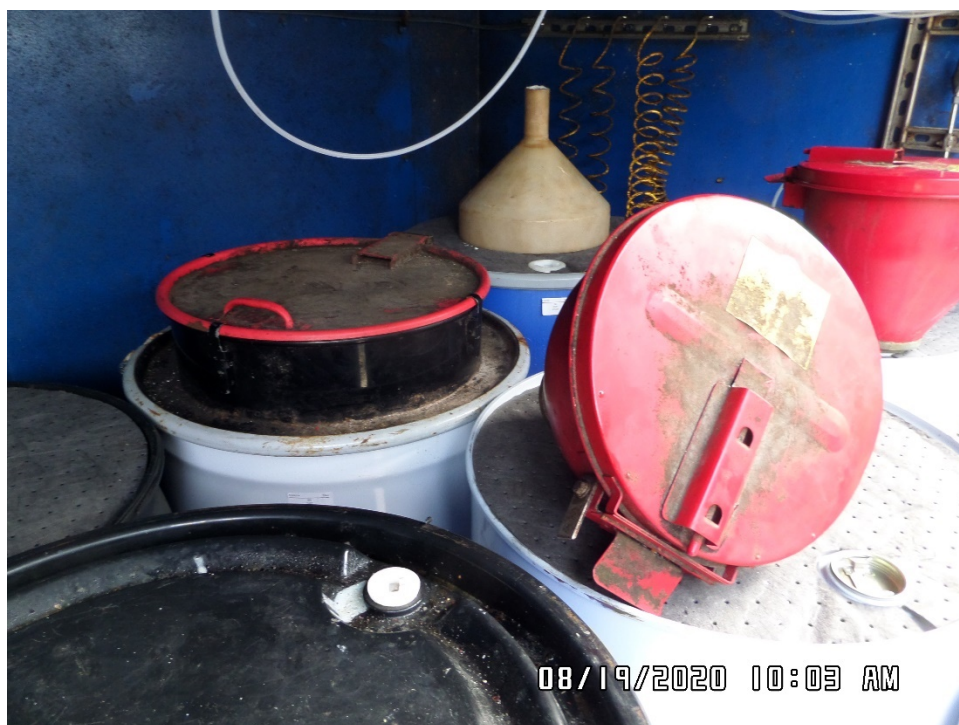
SiVance has a less than 90-day HWSA storing waste generated from the R&D Lab. The waste is stored in a metal cabin located outside the lab. At the time of the inspection, the area was storing four 55-gallon drums storing SiH waste (8/10/20), mixed solvent (8/17/20), waste contaminated towels (7/16/20), and hydrolyzed chlorine (7/24/20). The drums were closed and labeled. The inspection team noticed that some of the drums were hard to inspect due to lack of aisle space (See Figure 1) and the metal container didn't have a "No Smoking" sign. These deficiencies were addressed after the inspection.

Figure 1 - Drums storage at the R&D lab HWSA

**Pursuant to Fla. Admin. Code Ann. r. 62-730.160(1) [40 C.F.R. § 262.17(a)(6)], which incorporates Fla. Admin. Code Ann. r. 62-730.160(1) [40 C.F.R. § 262.255], and is a condition of the LQG Permit Exemption, a generator is required to maintain aisle space to allow the unobstructed movement of personnel, fire protection equipment, spill control equipment, and decontamination equipment to any area of facility operation in an emergency, unless aisle space is not needed for any of these purposes.**

**Pursuant to Fla. Admin. Code Ann. r. 62-730.160(1) [40 C.F.R. § 262.17(a)(1)(vi) (B)], requires LQGs must take precautions to prevent accidental ignition or reaction of ignitable or reactive waste. This waste must be separated and protected from sources of ignition or reaction including but not limited to the following: Open flames, smoking, cutting and welding, hot surfaces, frictional heat, sparks (static, electrical, or mechanical), spontaneous ignition (e.g., from heat-producing chemical reactions), and radiant heat. While ignitable or reactive waste is**

**being handled, the large quantity generator must confine smoking and open flame to specially designated locations. “No Smoking” signs must be conspicuously placed wherever there is a hazard from ignitable or reactive waste.**

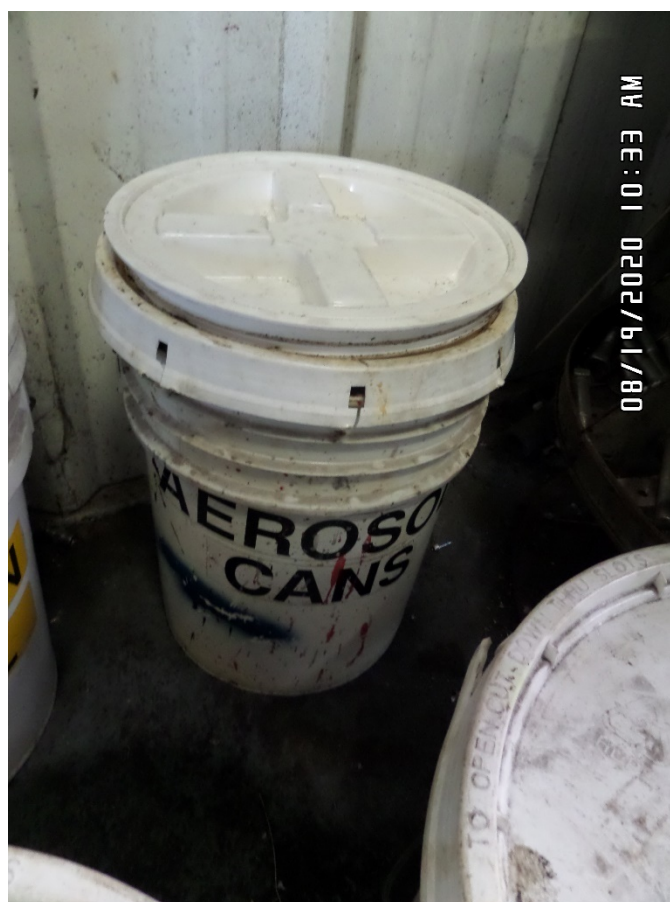
The Maintenance Shop provides maintenance of equipment around the facility. At the time of the inspection, there was a 5-gallon container of solvent wipes and a 5-gallon container of paint aerosol cans. The 5-gallon container of aerosol paint cans was not labeled and was open (See Figure 2). These deficiencies were addressed after the inspection.

Figure 2 - 5-gallon container storing aerosol cans

**Pursuant to Fla. Admin. Code Ann. r. 62-730.160(1) [40 C.F.R. § 262.15(a)(5)], which is a condition of the SAA Permit Exemption, a generator is required to mark or label its containers (i) with the words “Hazardous Waste” and (ii) with an indication of the hazards of the contents.**

**Pursuant to Fla. Admin. Code Ann. r. 62-730.160(1) [40 C.F.R. § 262.17(a)(1)(iv)], which is a condition of the LQG Permit Exemption, (A) a container holding hazardous waste must always be closed during accumulation, except when it is necessary to add or remove waste; and (B) A container holding hazardous waste must not be opened, handled, or stored in a manner that may rupture the container or cause it to leak.**

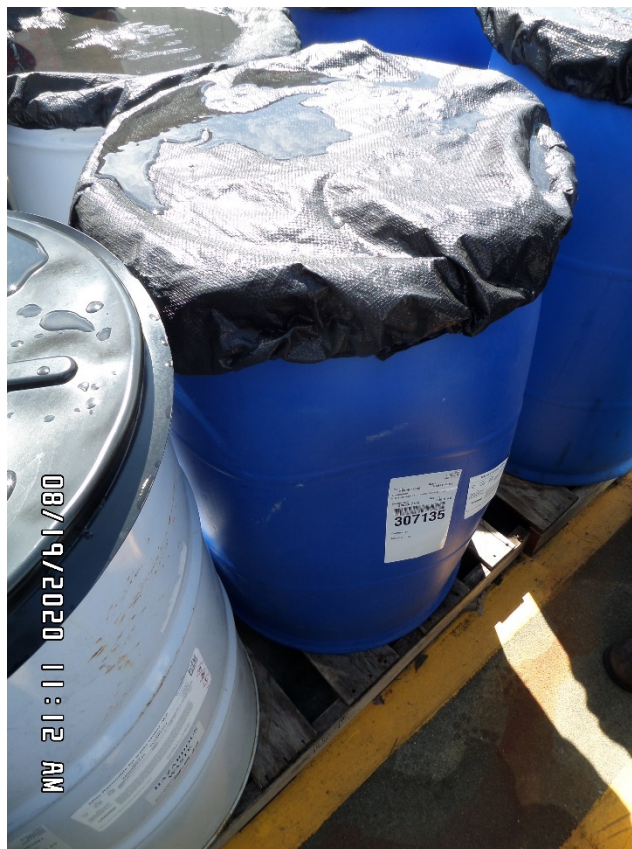
At the time of the inspection, the area was storing approximately 130 drums (oldest 7/7/20). The inspection team noticed three drums were missing their accumulation start date, a hazard indication, and one of those drums was deformed (See Figures 3-4). These deficiencies were addressed after the inspection.

Figure 3 - 55-gallon drum deformed, not labeled dated

**Pursuant to Fla. Admin. Code Ann. r. 62-730.160(1) [40 C.F.R. § 262.17(a)(5)(i)], which is a condition of the LQG Permit Exemption, a generator must mark or label its containers with the following: the words “Hazardous Waste”; an indication of the hazards of the contents; and the date upon which each period of accumulation begins clearly visible for inspection on each container.**

**Pursuant to Fla. Admin. Code Ann. r. 62-730.160(1) [40 C.F.R. § 262.17(a)(1)(ii)], which is a condition of the LQG Permit Exemption, if a container holding hazardous waste is not in good condition, or if it begins to leak, the generator must immediately transfer the hazardous waste from this container to a container that is in good condition, or immediately manage the waste in some other way that complies with the LQG Permit Exemption.**

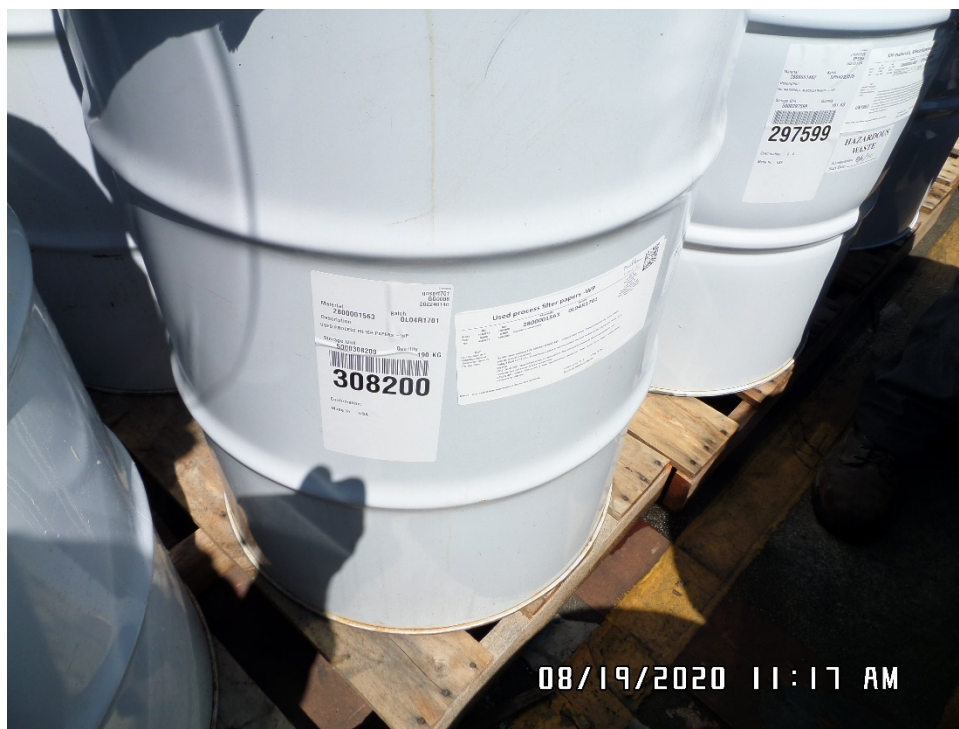
Figure 4 - 55-gallon drum not labeled, missing hazard identification
