Compliance Evaluation Inspection Report

| <b>Inspection Date(s):</b> | 08/02/2022 - 08/03/2022 | <b>Announced:</b> Yes | | | |
| <b>Permittee Name:</b> | GUN LAKE TRIBAL GAMING AUTHORITY WASTEWATER TREATMENT FACILITY | | | | |
| <b>Permit Number:</b> | MI0058661 | | | | |

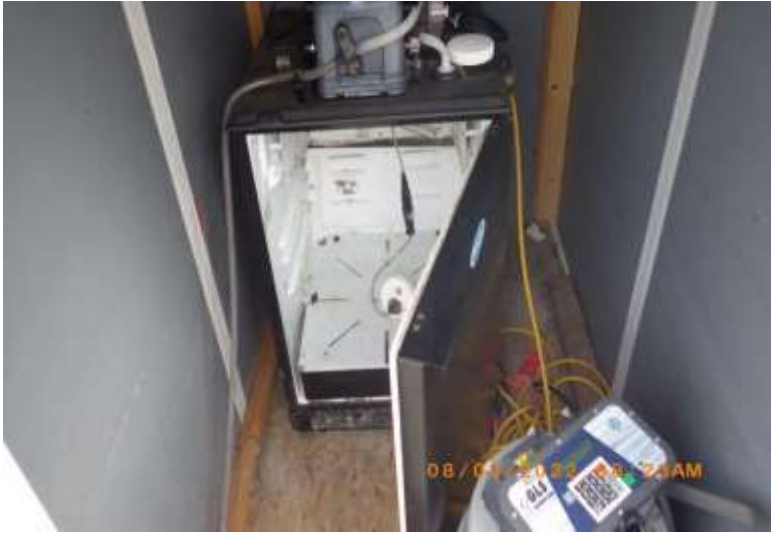
| GUNL0079.JPG | |

We began the physical inspection at the Equalization Tank ("EQ Tank") area. I observed the influent sampling house and the ISCO Influent Auto Sampler. The sampler was refrigerated and had a thermometer (see Photo Log image GUNL0079). However, Mr. Row said they do not maintain a temperature log.

| I observed the influent sampling house and the ISCO Influent Auto Sampler. The sampler was refrigerated and had a thermometer (see PhotoLog image GUNL0079). However, Mr. Row said they do not maintain a temperature log for the influent and effluent auto samplers. | <b>Citations:</b><br>40 CFR Part 136<br>NPDES Permit Part II.C.3<br>(Monitoring Procedures) |

| Influent Auto Sampler | |
| Note the thermometer inside the auto sampler. | |

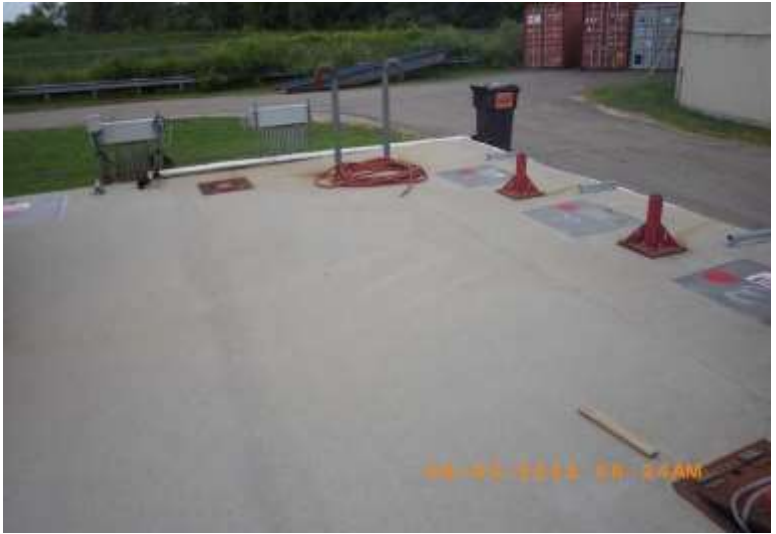
| GUNL0080.JPG | |

The EQ basin is covered under a concrete slab and could not be easily observed (see Photo Log image GUNL0080). There is a grinder in the EQ basin, prior to the Fine Screen.

| EQ Basin (under concrete slab) | |

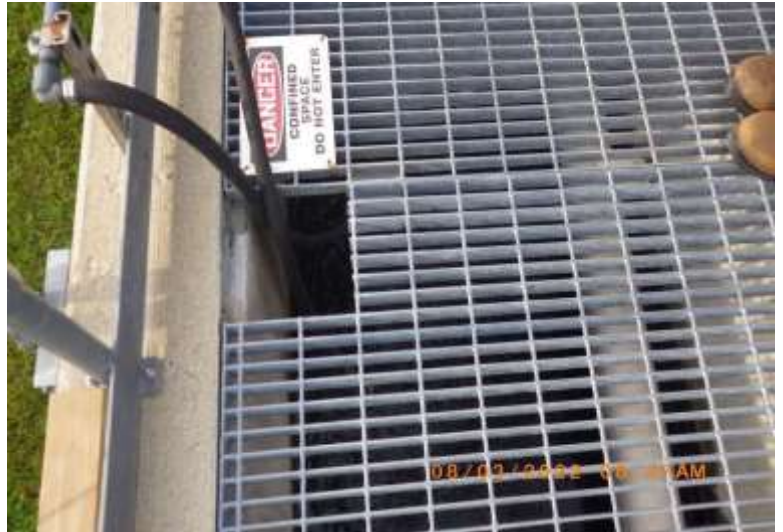
| GUNL0091.JPG |

| Final Outfall 001 |
| Effluent discharge and Buskirk Creek appeared clear. |

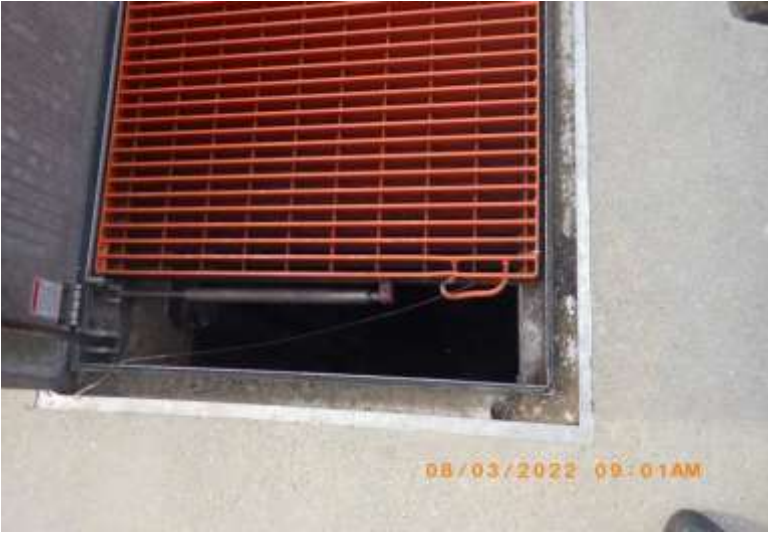
| GUNL0093.JPG | |

| View inside Lift Station wet well | |

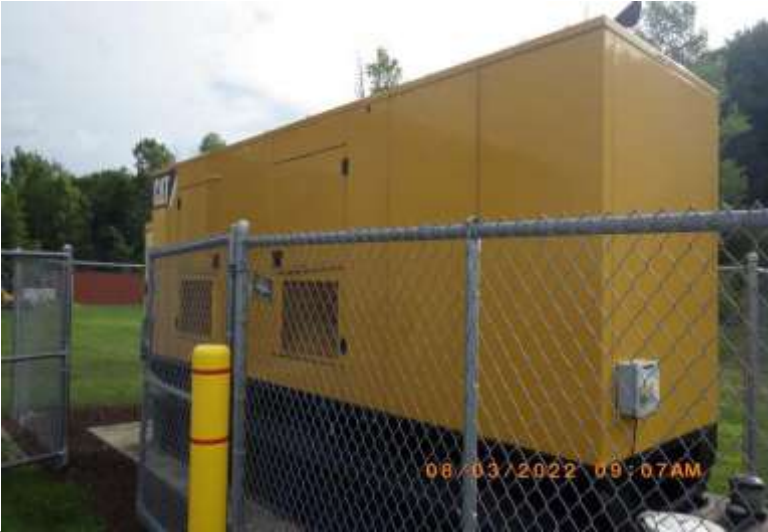
| GUNL0094.JPG | |

The last stop on the physical inspection of the wastewater plant was the backup generator (see Photo Log image GUNL0094). The diesel generator is automatically tested every Thursday.

| Wastewater Treatment Plant Backup Generator | |
| Diesel powered generator. | |
