**Inspection Report**  
**Mechanical Integrity Test**  
**Osage DNR / Environmental Protection Agency**  
**1201 Elm Street, Suite 500**  
**Dallas TX 75270**

| | | | | <b>Lease Name</b> Boulanger | | | | |
| | | | | <b>Well ID</b> 1A | | | | |
| <b>Type of MIT</b> Ada Pressure Test | | | | <b>Test Reason</b> Routine | | | | |

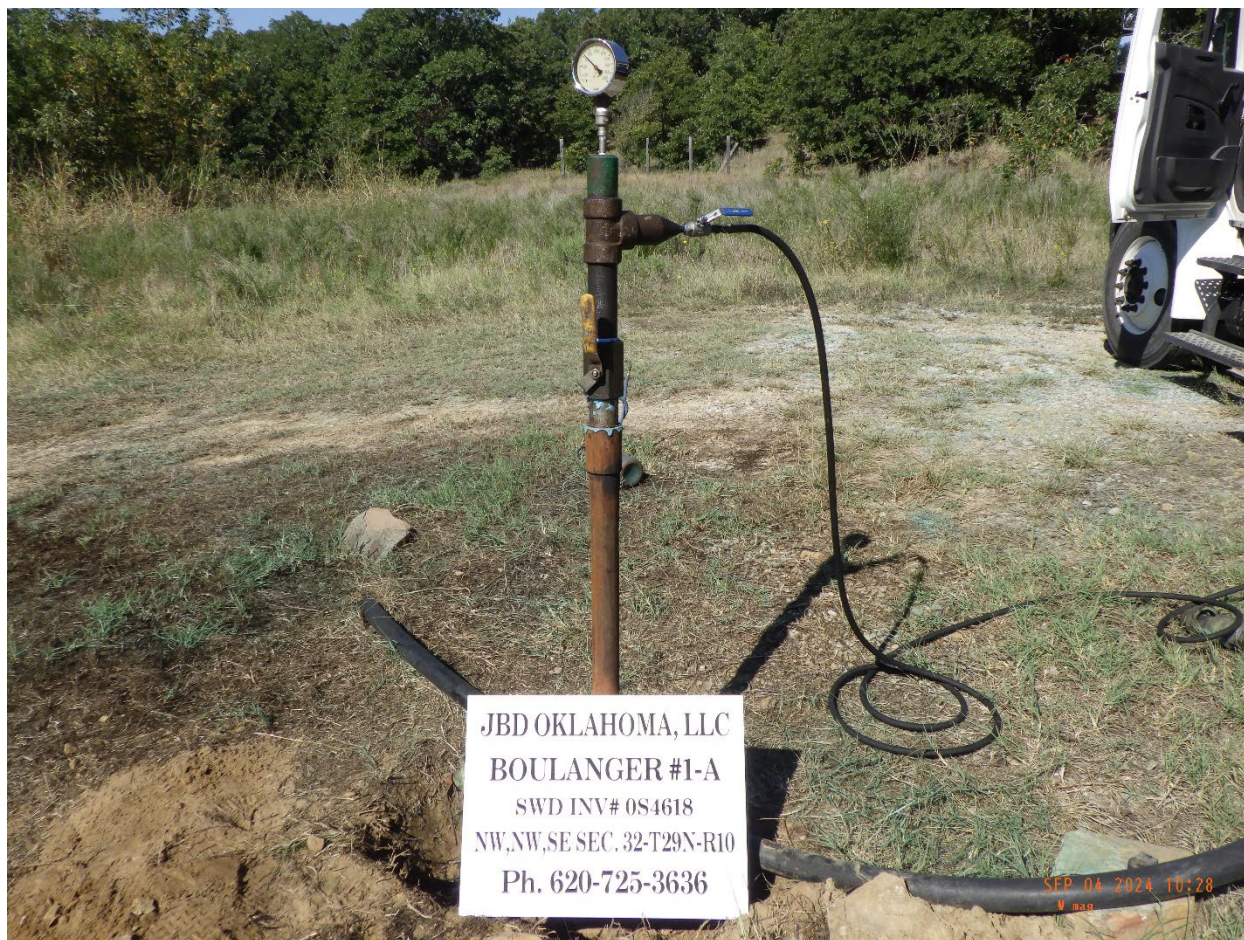
Photo No. 1

**Description:** This was well OS4618 connected and being pressured during the MIT. The change of ownership was not yet completed with the EPA UIC permitting group at the time of the inspection.
