EVALUATION OF EXPOSURE  
TO AIRBORNE FIBERS DURING  
REMOVAL OF RESILIENT FLOOR TILES  
USING RECOMMENDED WORK PRACTICES

Resilient Floor Covering Institute  
Rockville, MD

ENVIRON Corporation  
Washington, DC

April 3, 1989

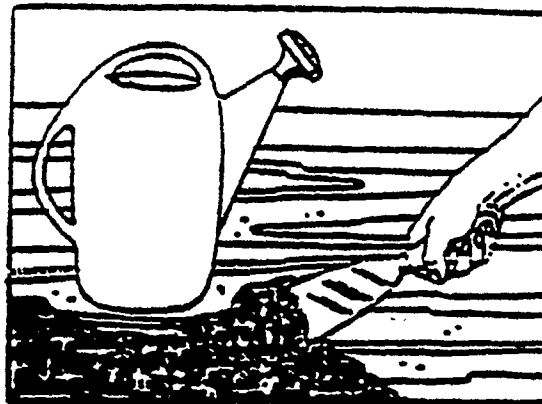
Sketch I. After wetting felt, an stiff-bladed scraper is used.

3. Use the stiff-bladed scraper to remove the excess felt (see Sketch I). If felt dries out, or dry felt is exposed during scraping, re-wet with more solution.
4. Pick up the larger pieces by hand and place in the trash bag immediately.

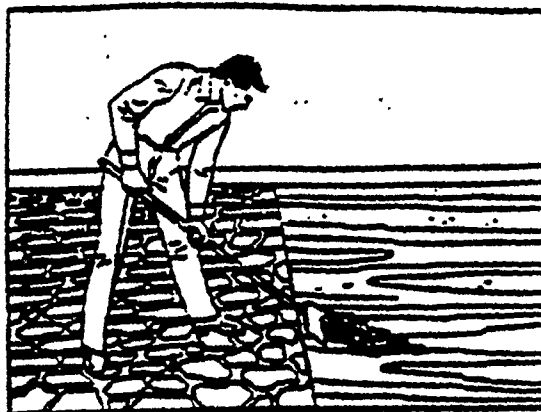
Sketch 13. Stand on the remaining floor covering, not the felt, during felt removal.

- Repeat the above on the next series of strips. Do only one three-strip area at a time. Stand on the remaining floor covering or clean floor (do not stand on the felt) to scrape up the felt.
- Repeat this operation until the felt has been removed from the whole floor. Close full bags tightly, and seal securely for disposal. Identify with a label stating, "Caution—Contains Asbestos. Dispose in an approved land fill only."
- When the whole floor has been cleaned free of felt, let it dry and vacuum up any dirt using the vacuum cleaner with the metal floor tool. Stand only in vacuumed areas as you proceed across the floor.
