**Well Inspection**  
**Osage DNR / Environmental Protection Agency**  
**1201 Elm Street, Suite 500**  
**Dallas, Texas 75270**

| <b>Operator Info</b> | Dexxon, Inc. | <b>Inventory ID</b> | OS1540000 | | |
| | Kiefer, OK 74041 | <b>Lease Name</b> | EDGINTON(BIG EAGLE) | | |
| <b>Inspection Reason</b> | Plugging Witnessed | <b>Responsible Company at Time of Inspection</b> | Dexxon, Inc. | | |

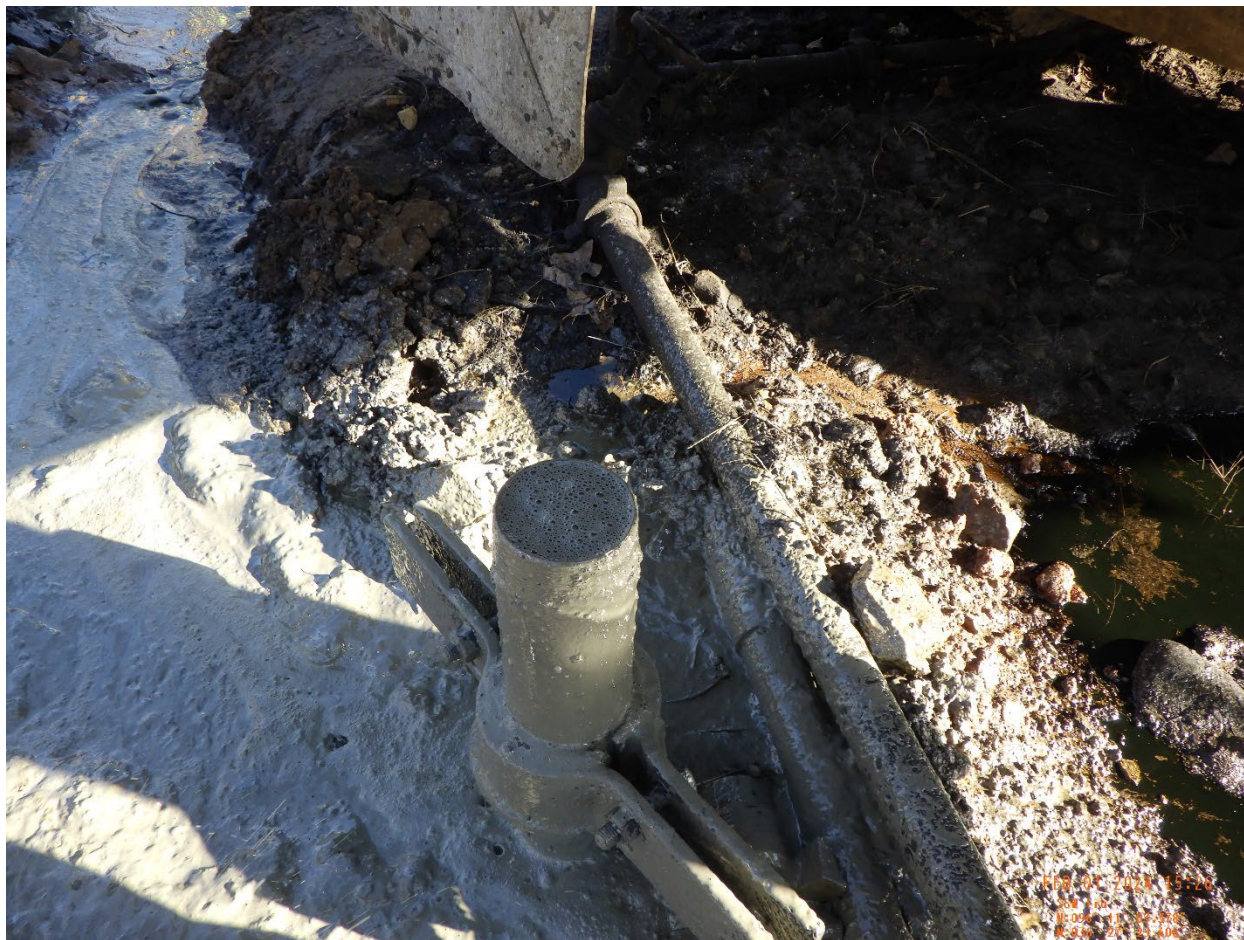
Photo No. 1

**Description:** This was well OS154000, standing full of cement with no fallback. Well apparently plugged.

| <b>Inspection Comments</b> | Inspector observed Speedy Well Service (SWS) run in hole to 1804 feet and circulate mud. SWS pumped 25 sacks of class A cement and pulled out of the hole. After 4 hours wait time, SWS ran in to top of cement at 1460 feet. SWS pulled up to 460 feet below land surface and circulated 35 sacks of class A cement to surface. Inspector observed cement standing at the surface with no fallback. Well apparently plugged. | | | | |
