## UNITED STATES ENVIRONMENTAL PROTECTION AGENCY

**Subject:** Sampling Summary Report - Arch Medical Solutions  
Compliance Sampling Inspection

- A. Facility Name: Arch Medical
- B. Facility Location: 35 Woodworkers Way, Seabrook, NH
- C. Facility Contact(s): Craig Michaud, Director of Engineering, (603)760 1532  
Eola Saucier, Downstream Process Manufacturing Engineer
- D. NPDES ID Number: NHPIU0022

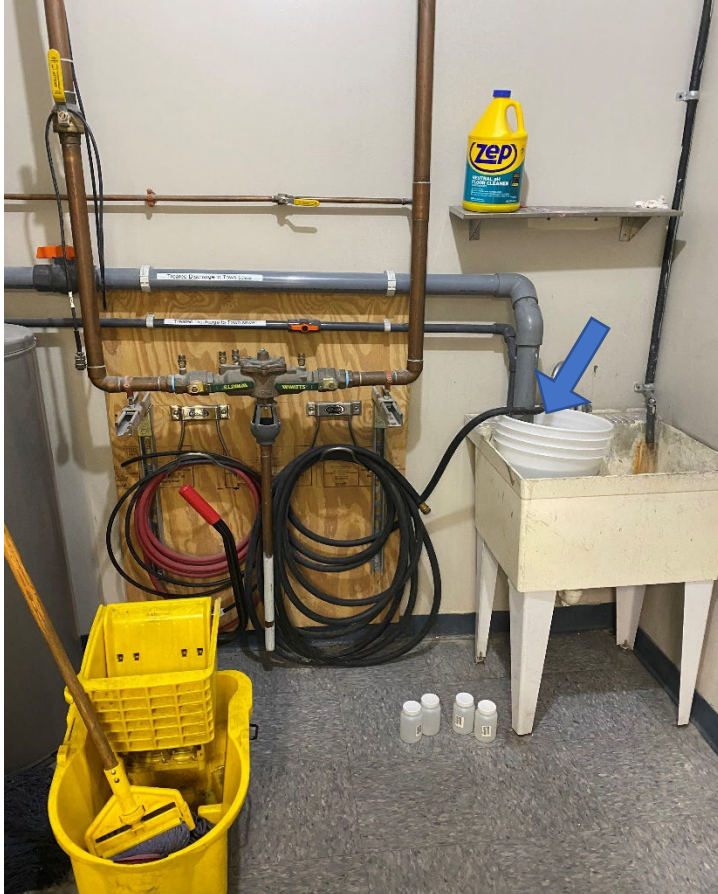
Mr. Leclerc, Mr. Michaud, and Ms. Saucier led the EPA inspection team on a tour of 35 Woodworkers Way beginning at 09:45. The tour began in the wastewater treatment room and an adjacent utility room. Piping from the neutralization system runs through the wall of the wastewater treatment room and drains into a sink located in the utility room. The piping consists of one 2-inch diameter plastic pipe and one 0.5-inch diameter plastic pipe, both labeled “treated discharge to town sewer” (photo 1).

Photo 1: Utility room adjacent to facilities wastewater treatment room. Sample collected from bucket collection system located at the end of grey pipes labeled “treated discharge to town sewer”.

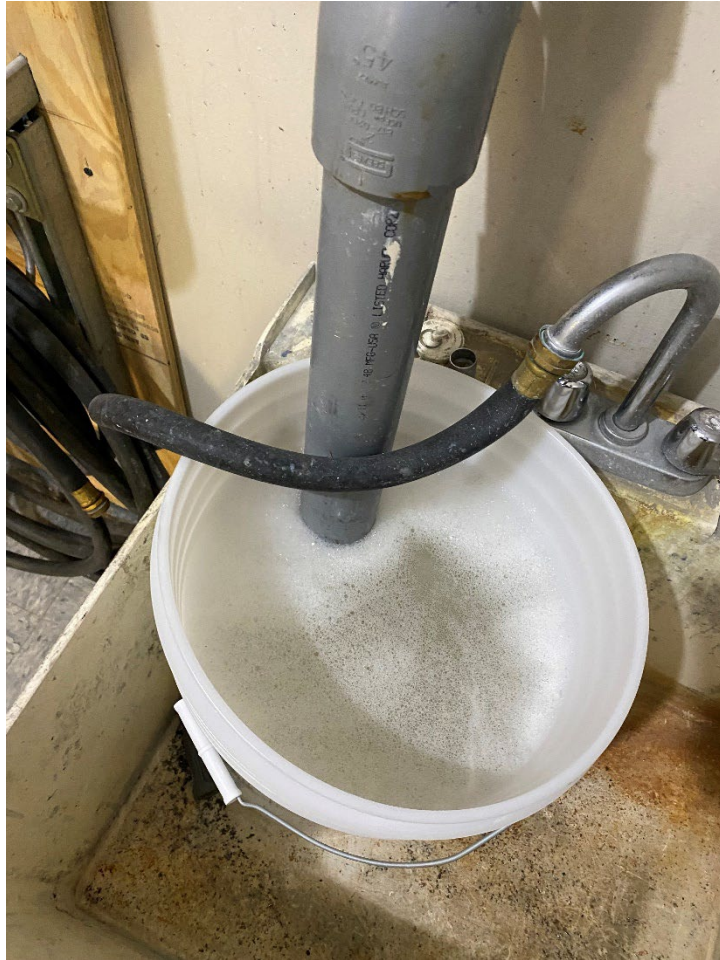
The EPA sampling team (Shannon Shea, and William Sommer) set up a bucket collection system at 09:55 to catch flow from the pipes labeled “treated discharge to town sewer” before draining into the sink due to low flow. Mr. Melcher and Mr. Bednarz continued the facility inspection with facility representatives while the EPA sampling team monitored flow to the collection system. Sample collection began at 10:28 and completed at approximately 10:50. Bubbles were present on the surface of the flow collected inside the bucket. Sample containers had a slippery film on the outside of the bottle from sample collection (photo 2).

Photo 2: Bucket collection system located inside sink of utility room. Note: presence of bubbles on surface.
