Williamsport Sanitary Authority (PA0027057 and PA0027049)  
Pretreatment Compliance Inspection

**Report Title:** Clean Water Act Compliance Inspection Report  
**Inspection Date(s):** March 18-20, 2024  
March 27, 2024 (Exit Interview)  
**Regulatory Program(s):** National Pollutant Discharge Elimination System (NPDES)  
**Type of Activity:** Pretreatment Compliance Inspection  
**Facility Name:** Williamsport Sanitary Authority  
**Facility Address:** 253 W 4<sup>th</sup> Street, Williamsport, PA 17701  
**Facility Latitude:** 41.239915  
**Facility Longitude:** -77.006408  
**County/Parish:** Lycoming County  
**Permit No:** PA0027057 (Central WWTP) and PA0027049 (West WWTP)  
**NAICS Code:** 221320  
**SIC:** 4952  
**Unique Project #:** ECAD-436 and ECAD-460

**Attachment B**

**Industrial User Site Visit Photo Log**

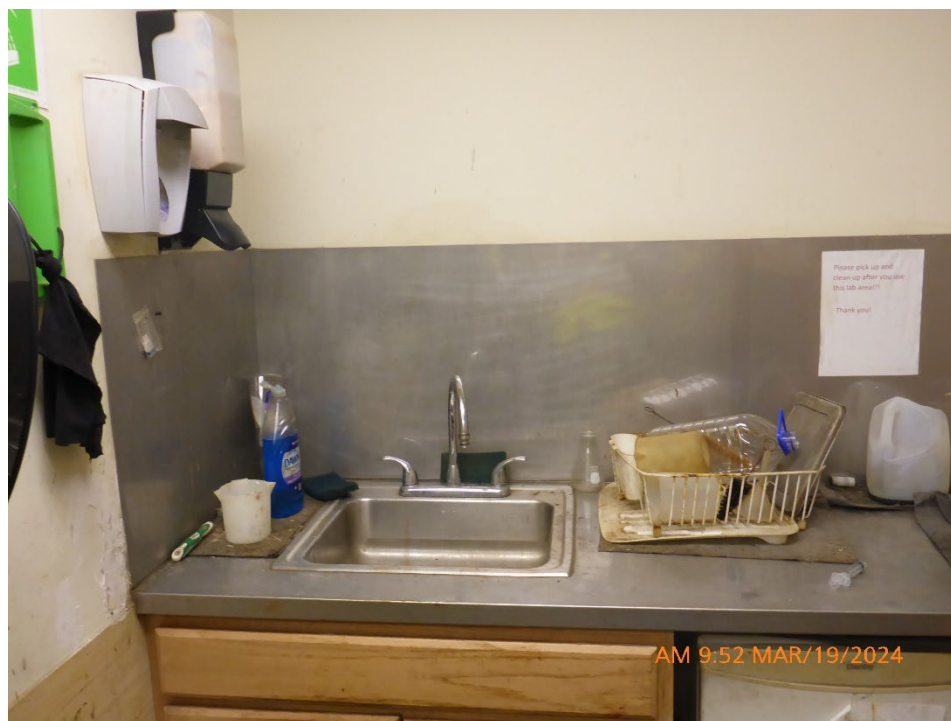
| <b>1. <u>Finding – The Inspection Team observed a sink without signage in the truck desk lab.</u></b><br><br>The Inspection Team observed a sink in the truck desk lab. According to the facility representative, the sink discharges to sewer through the SIU's sanitary connection, and the sink lab is used to for washing dishes and handwashing (see Photograph 1 in Attachment B). | | | |

**Photograph 1:** Sink without no chemical disposal sign in truck desk lab at Eureka Resources.

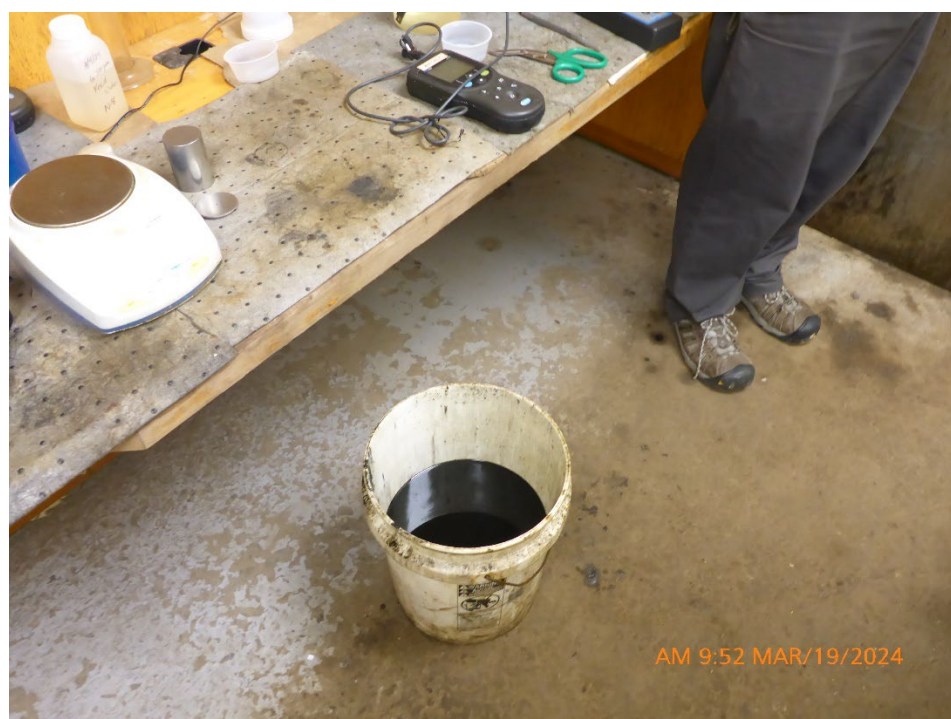
| <b>2. <u>Finding – The Inspection Team observed open buckets of waste oil without secondary containment.</u></b><br><br>The Inspection Team observed open buckets of waste oil without secondary containment in both the truck desk lab and near the sample retains storage area. According to the facility representative, the buckets are used to collect spent samples and emptied into the facility's treatment process when full (see Photograph 2 in Attachment B). | | | |

**Photograph 2:** Open bucket of waste oil samples in the lab area at Eureka Resources.

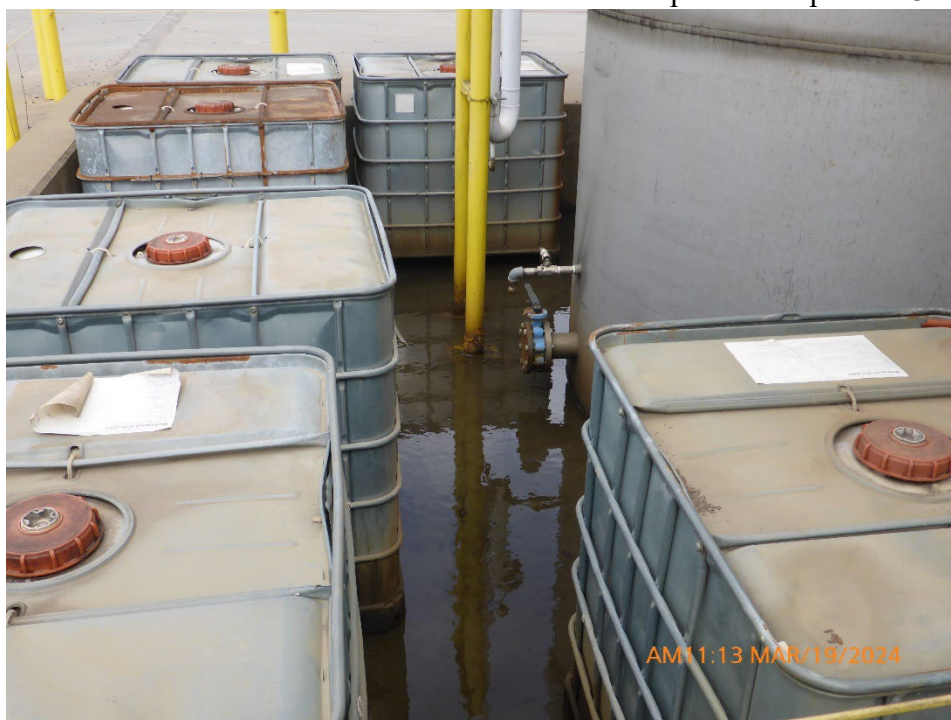
**Photograph 3:** Water inside containment area around methanol treatment column at Eureka Resources.

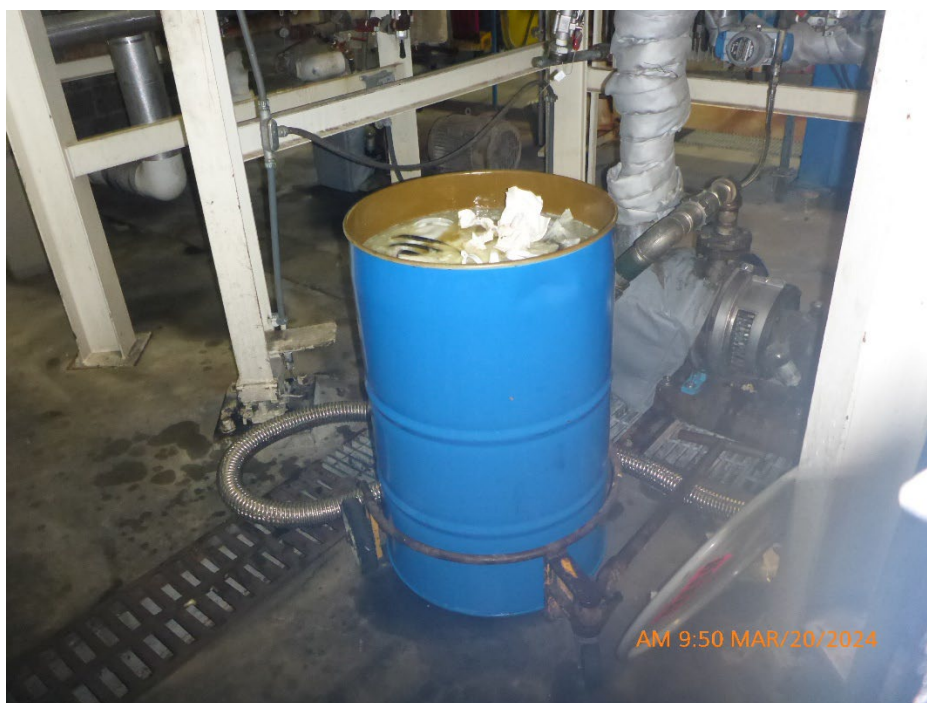
The Inspection Team observed a drum of various materials (a combination of liquid, fats, and solids) without secondary containment in the ethylene oxide production area (see Photograph 4 in Attachment B). The Inspection Team also observed drums of sodium hydroxide not fully on secondary containment in this same production building (see Photograph 5 in Attachment B). Additionally, the Inspection Team observed residual waste for incineration stored outside without secondary containment in an area that drains to a production trench drain.

**Photograph 4:** Drum of various materials (a combination of liquid, fats, and solids) without secondary containment in the ethylene oxide production area at Arxada.

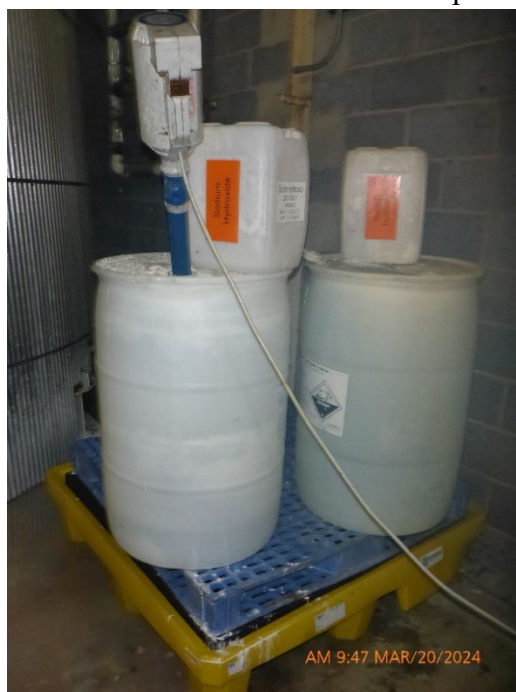
**Photograph 5:** Sodium hydroxide stored partially on secondary containment at Arxada.

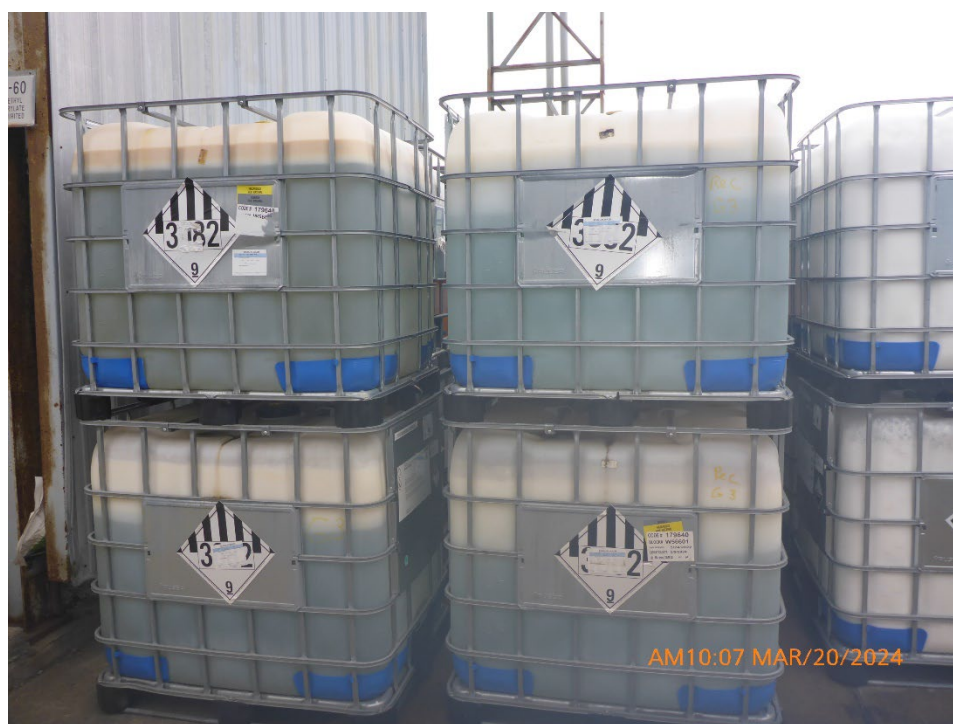
The Inspection Team observed approximately 45 totes with hazardous waste labels stored outside in an area that drains to the facility's trench drain system (see Photograph 6 in Attachment B). According to the facility representative, the totes did not contain hazardous waste and were improperly labeled.

**Photograph 6:** Totes with hazardous waste labels at Arxada.

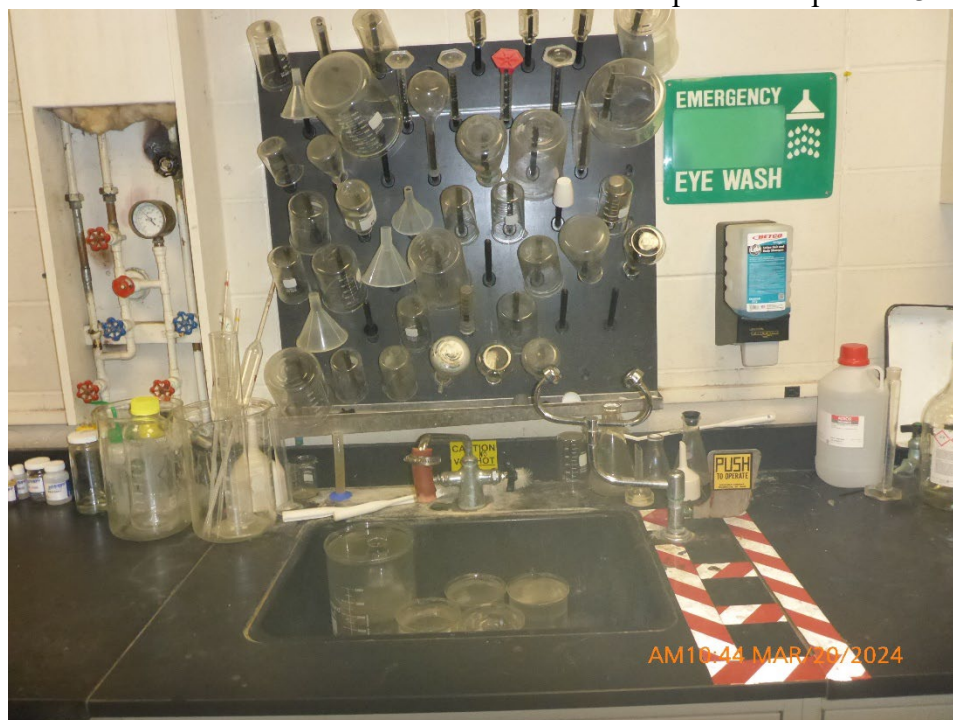
The Inspection Team observed a sink in the lab. According to the facility representatives, the sink discharges to sewer through the SIU's sanitary connection, and the sink lab is used to for washing dishes and handwashing. There was no signage above the sink stating that chemicals should not be disposed down the sink (see Photograph 7 in Attachment B).

**Photograph 7:** Sink without no chemicals down drain sign in lab at Arxada.
