## **RCRA Inspection Report**

AkzoNobel Specialty Plastics EPA ID# SCD000608331  
1872 Highway 9 Bypass West  
Lancaster, South Carolina 29720

January 13, 2022

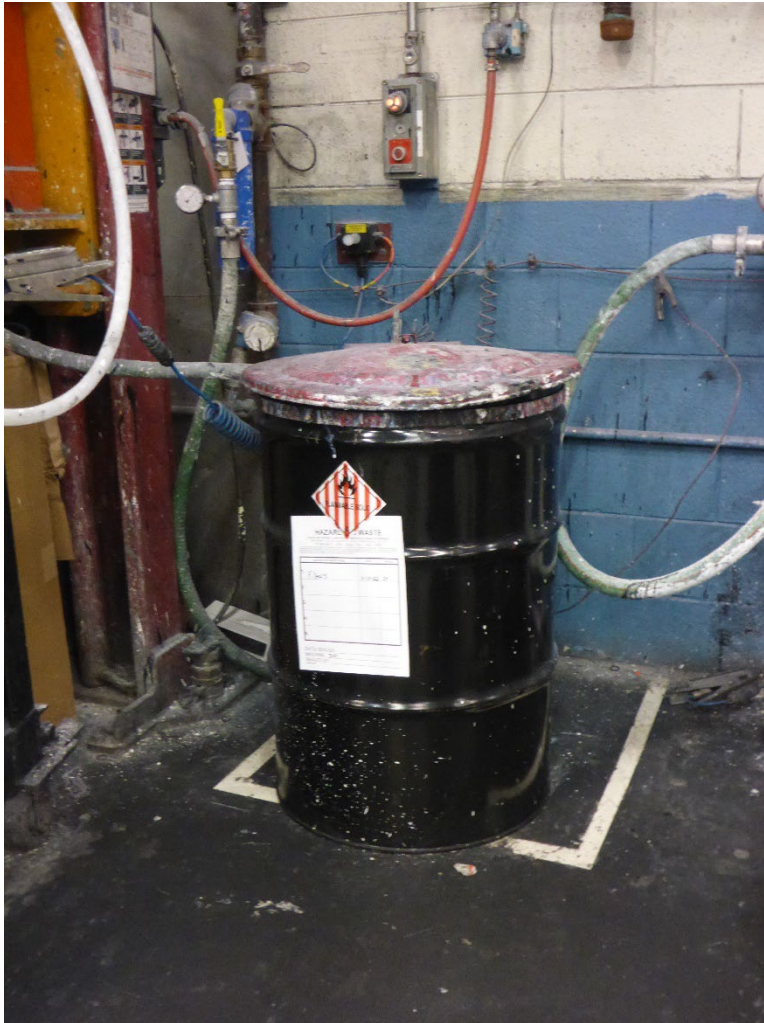
The inspectors observed three SAAs for accumulating Stream G hazardous waste solids in the Mix Room: one near the CMX-200 Tank Washer (Photo 1), one in the far corner of the room (Photo 2), and one in the middle of the room (Photo 3). One 55-gallon drum with a flip-top lid was observed in each SAA. The lid on the container near the middle of the room was damaged and left a partial gap between the lid and the top of the drum. The container in the CMX-200 Tank Washer SAA was labeled for accumulating hazardous waste solid filters; the container in the corner SAA was labeled for accumulating hazardous waste solid chips; and the container in the middle SAA was labeled for accumulating hazardous waste solids. All of the containers were marked with a flammable solid DOT hazard placard, but none were marked with an indication that the contents are toxic.

**Photo 1:** One of three SAAs in the Mix Room for accumulating Stream G hazardous waste solids. This SAA is located next to the CMX-200 Tank Washer. The 55-gallon drum in this SAA is labeled hazardous waste solid filters and it is marked with a flammable solids DOT hazard placard. It is not marked to indicate the contents are toxic.

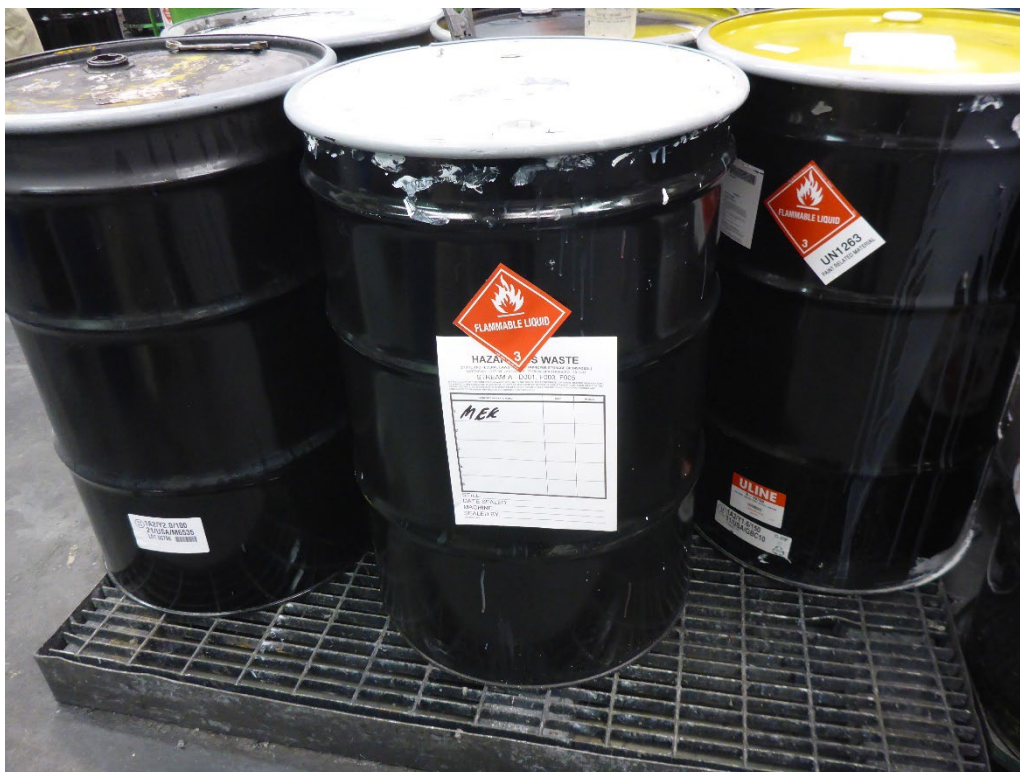
In addition to the containers observed in the SAAs noted above, the inspectors also observed approximately ten 55-gallon drums of hazardous waste on portable secondary containment pallets lined up near the Distillation Unit (Photos 5 and 6) and six 55-gallon drums of hazardous waste on portable secondary containment pallets near the middle of the room (Photos 7, 8, and 9).

Facility personnel stated that six additional 55-gallon drums, located on another set of portable secondary containment pallets, contained hazardous waste. One of these drums was labeled hazardous waste and marked with a flammable liquid DOT hazard placard (Photo 7). Another was not labeled as hazardous waste but was marked with a flammable liquid DOT hazard placard (Photo 7). Three of these drums were not labeled as hazardous waste or marked with an indication of the hazards of their contents (Photos 7 and 8). The final drum was not labeled as hazardous waste, but it was marked with an NFPA fire diamond (Photo 9). However, the ink had run on this label, causing the values marked on the NFPA fire diamond to be illegible. None of these containers were marked with an indication that the contents are toxic.

**Photo 7:** Three of six 55-gallon drums of hazardous waste observed on portable secondary containment pallets in the Mix Room near the center of the room. The drum on the left was not labeled as hazardous waste or marked with an indication of the hazards of its contents. The drum in the center was labeled as hazardous waste and marked with a flammable liquid DOT hazard placard. The drum on the right was not labeled as hazardous waste, but it was marked with a flammable liquid DOT hazard placard. None of the hazardous waste containers were marked to indicate their contents are toxic.

On 01/28/2022, Mr. LaBarge sent a letter to SCDHEC and the EPA in which he stated that the Mix Room has been reclassified as a hazardous waste CAA, and that containers in the Mix Room have been labeled as hazardous waste and with an indication that the contents are flammable.
