The lead lined steel boiling tank in the bead catalyst plant at the Socomey Vacuum Oil Co. plant at Paulsboro, N.J., is now giving good service after alterations which involved doubling the number of straps (now 24 in. apart), increasing the thickness of the lead from 1/4 in. to 1/2 in. and changing from chemical to tellurium lead. This flat bottomed tank has eliminated sagging encountered in hemispherical and "V" bottom installations. The time of service has not been sufficiently long to judge fully its merits but to date performance has been highly satisfactory.

### a. INTRODUCTORY HISTORY

A total of 125 tons of lead was installed to handle the corrosive acid alum solution in the bead catalyst plant of the Socomey Vacuum Oil Co., Inc., at Paulsboro, N.J. Nearly two billion beads or 50 tons of finished catalyst per day are produced in the lead lined forming towers from gel forming solutions consisting of sodium silicate and acid-alum (aluminum sulfate).

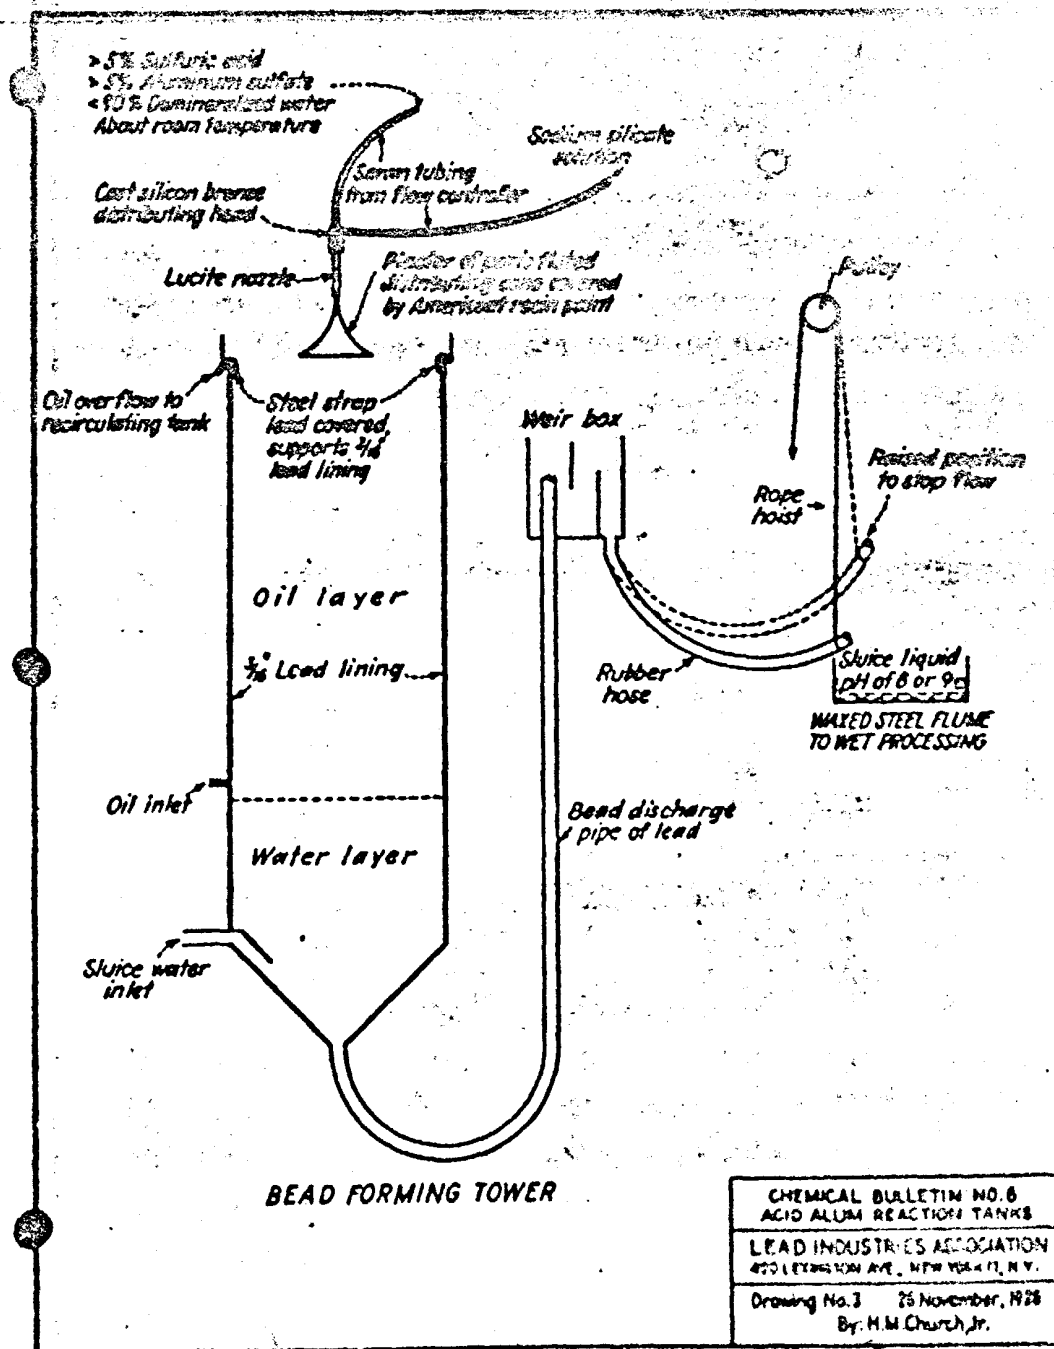
In addition, 3/16 in. lead lining is hung from a single horizontal steel strap near the top of the bead forming tower. This lead lining has served with no signs of failure since November, 1944, at room temperature and in the presence of dilute acid alum solution as shown in Drawing No. 3.

The 100-gal. lead lining of the bead forming tower is supported by a horizontal lead collar. In Drawing No. 3 the entire tower is shown with the lead lining. All lead lining is the old crucible material which contains the lead. A sluice water inlet and an oil inlet allow the liquid proportions to be maintained as shown.

1. The bead forming tower, lined with 3/16-in. chemical lead is unaffected by corrosion from the dilute acid and aluminum sulfate solutions.
