# **RCRA Compliance Evaluation Inspection Report**

Patrick Air Force Base  
1224 Jupiter Street 45 CES/CEIE  
Patrick Air Force Base (AFB), Florida 32925-3343  
County: Brevard  
EPA ID Number: FL2570024404

RCRA CEI Photographs for  
Patrick Air Force Base  
1224 Jupiter Street 45 CES/CEIE  
Patrick Air Force Base (AFB), Florida 32925-3343  
EPA ID Number: FL2570024404

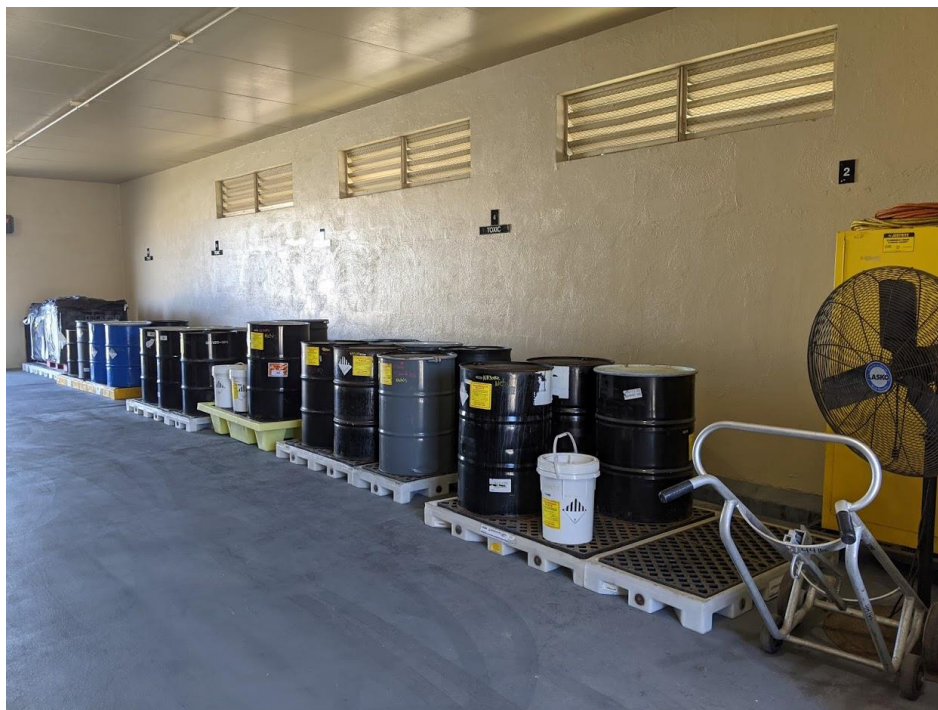
Photograph 1 of 4: Central Accumulation Area

At the time of the inspection, the AFB was storing hazardous waste inside Building 947. There was a landline phone located on the wall outside the building, a fire extinguisher on each end of the building and one inside. A hazardous waste and no smoking sign were posted, as well as, the emergency contact information. Eyewash station, spill kit, as well as other pertinent personal protective equipment (PPE) were available in Bay 1. Bay's 2-10 were designated for waste storage. Waste is separated according to its characteristic type and stationed on top of secondary containment. The bays with different waste characteristics were separated by a wall. At the time of the inspection there were approximately 34 containers. All waste containers were closed, labeled, and dated. No containers were dated beyond one year from the time of the inspection. One 250-gallon tote of non-regulated aqueous film-forming foam (AFFF) wastewater that is used to clean fire suppression foam was also stored in this building. EPA Hazardous Waste Codes identified on containers at the time of the inspection consisted of: D001, D005, D006, D007, D008, D018, D035, D039, F003, F005 and primarily consisted of waste from aerosols, the gun range, and paint-related waste generation from aircraft maintenance (Photographs 1, 2 of 4).

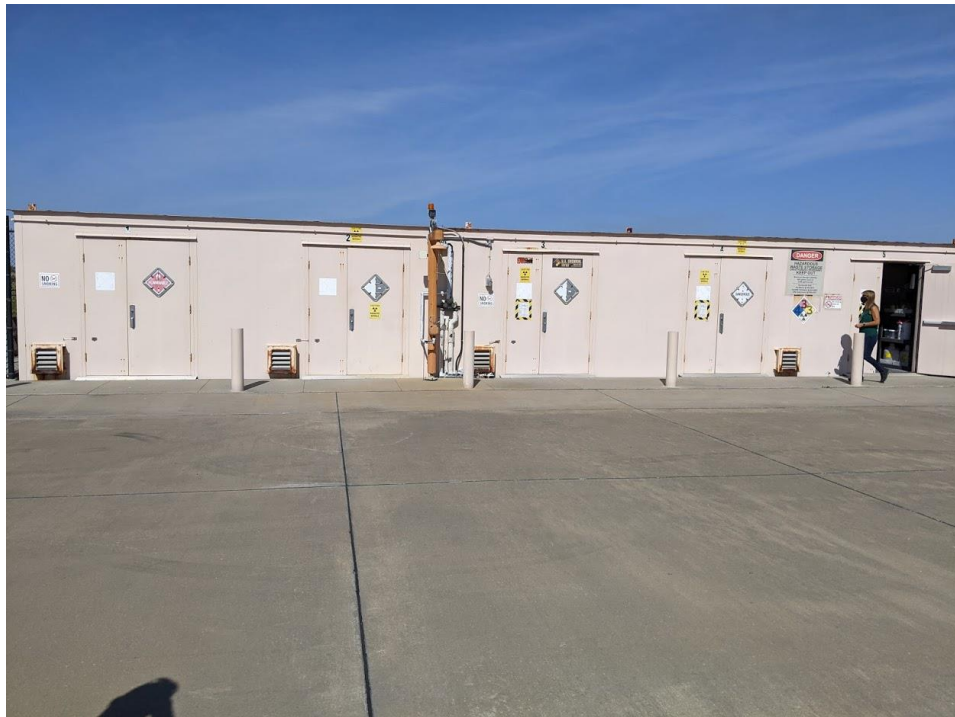
Photograph 3 of 4: Locker Storage

Stationed outside, the AF TAC consisted of 5 lockers separated based on hazard compatibility. Locker numbers 1 and 2 were designated for non-RCRA radioactive waste, locker numbers 3 and 5 were designated for hazardous waste, and locker number 4 was designated for mixed hazardous waste. At the time of the inspection, there were approximately 70-plus containers of varying sizes organized on shelves within the lockers. All containers were labeled, dated, and closed. Waste in this area is generated from lab samples collected from various military operation missions. EPA Waste Codes identified on containers in this area at the time of the inspection consisted of D001, D003, D002, D005, D006, D007, D008, D010, and D011. Oily rags and non-regulated material from resin cartridges were also stored at this location at the time of the inspection (Photographs 3, 4 of 4).
