To P. L. Fetzner  
From H. L. Hackett  
Date November 20, 1974  
Subject Leaks causing high readings at points 1 and 2 on the continuous monitor.

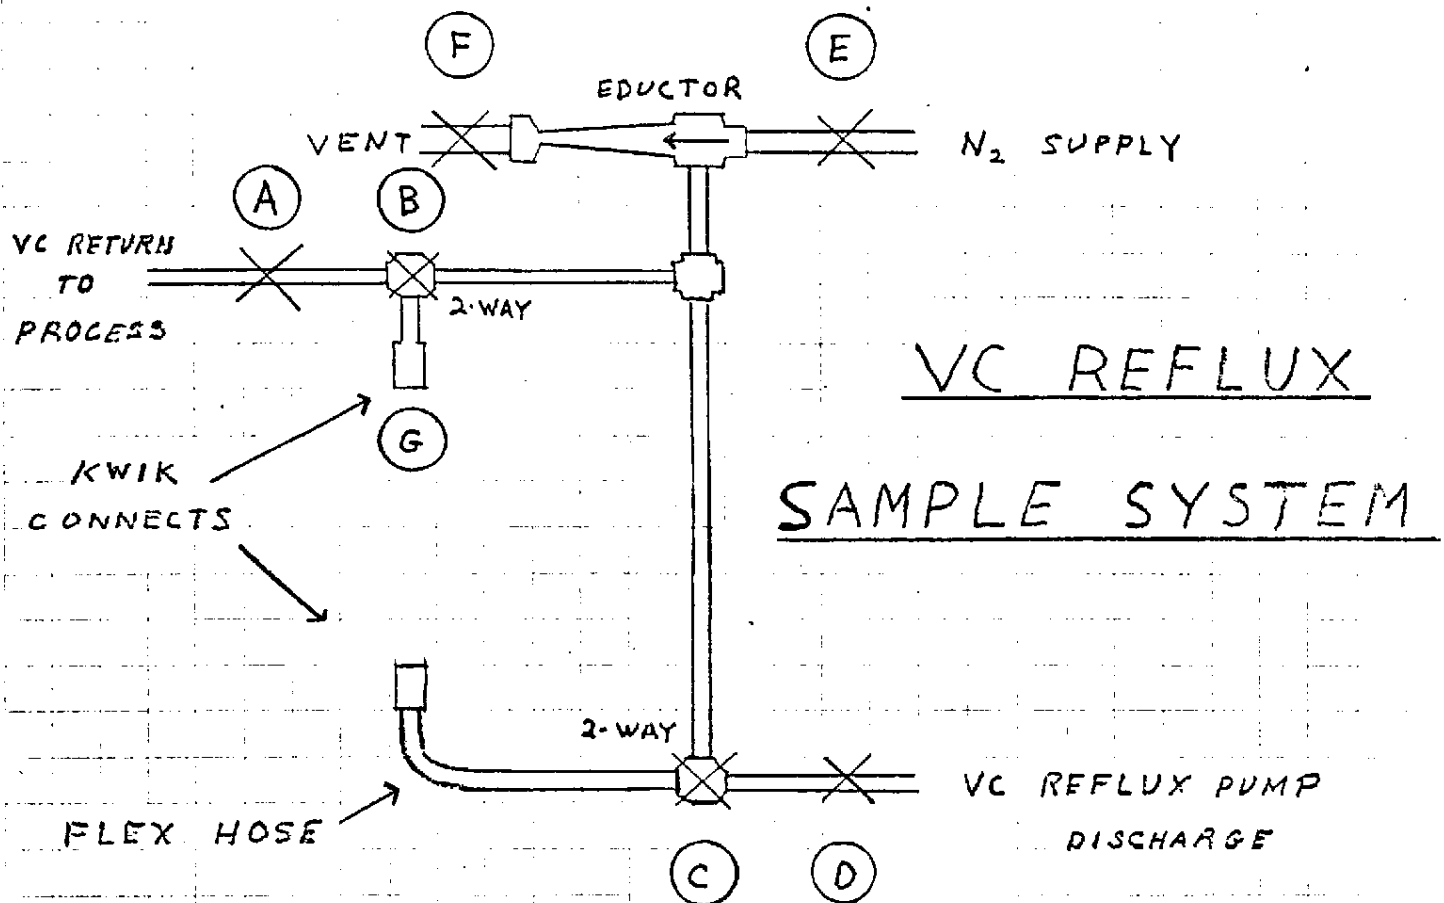
# FIGURE I

At point 1, where the vinyl reflux sample is taken, VCM was leaking through the upper kwik-connect. (Shown on the attached crude drawing at G). This was 3' foot up wind from where the air sample is taken. Opening valve E to make the nitrogen eductor operational soon lowered VC readings to less than 0.5 ppm. Rather than replacing the kwik-connect, the solution appears to be to leave all valves in closed positions after finishing the sampling procedure. Closing valves A,B,C, and D stopped the leaks.

Recommendation: Make sure the valves in all vinyl sampling systems in the plant which correspond to valves A,B,C,D, and possibly also F, are left in the closed position after sampling. The two way valves B and C are closed to the kwik-connects when they are at the midpoint of their rotation. This will provide two closed valves in series from all sources of vinyl leading to the kwik-connects.
