**Region 6 - Enforcement & Compliance Assurance Division**  
**INSPECTION REPORT**

| Regulatory Program(s) | Water (CWA) NPDES Industrial Stormwater (MSGP) Program | |
| Company Name: | <b>Capstone Oilfield Disposal of Arkansas, LLC</b> | |
| Facility Name: | <b>Flanagan, Tom 1 SWD Tank Battery</b> | |

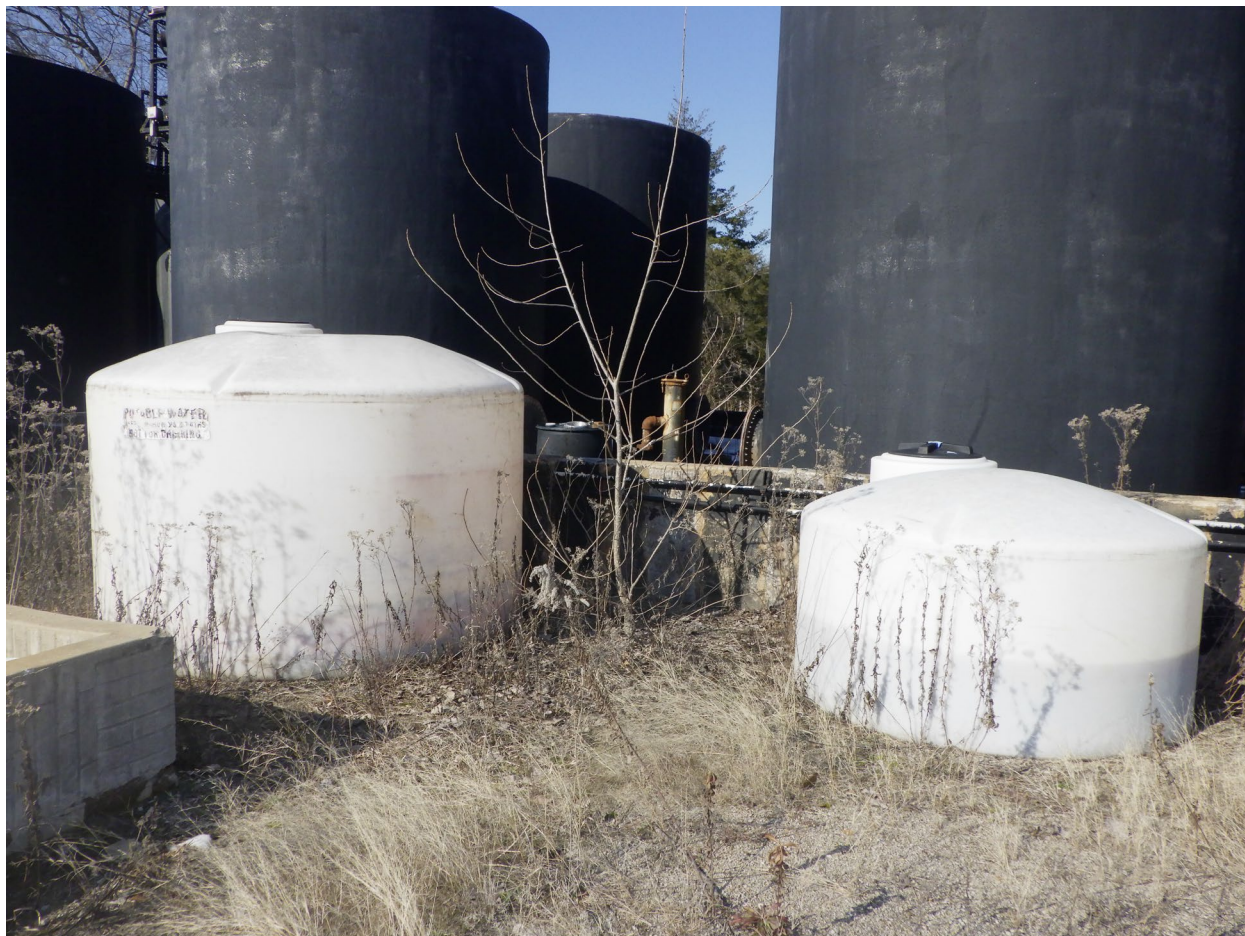
Photo No. 1

I observed two (2) tanks outside secondary containment, and one (1) tank is missing a lid; see Appendix 1 (Photograph Log), Photos No. 1 and No. 2. For additional GPS location and photo metadata, see Appendix 1.

**Description:** Looking NNE, this photo shows two storage tanks outside containment; one tank is open.

- One (1) tank outside secondary containment with a missing lid, see Part 1, 1.7 of the general permit.

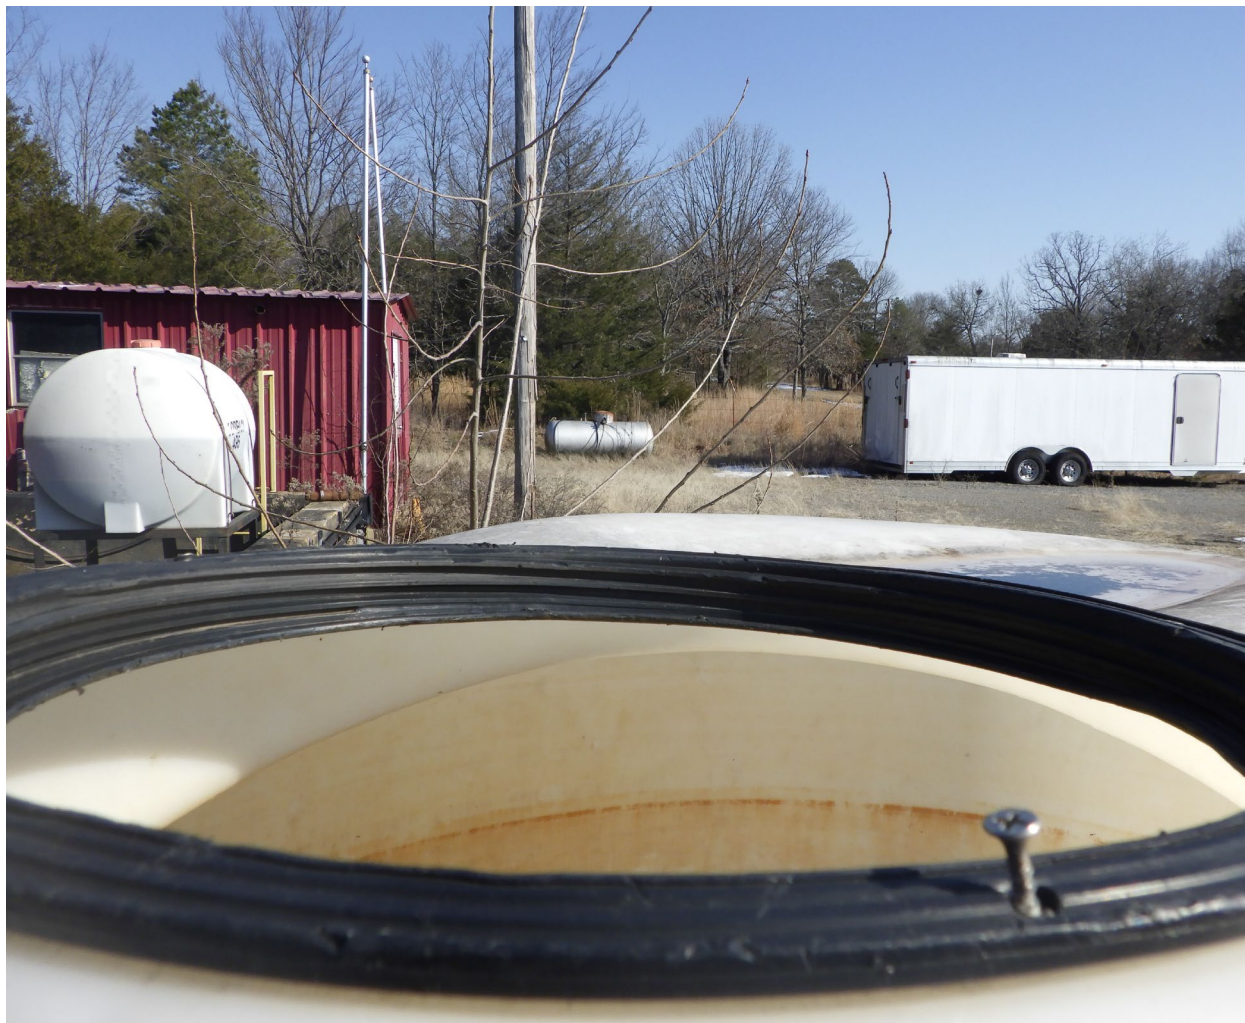
Photo No. 2

**Description:** Looking E, this photo shows one tank from Photo No. 1 with an open top.
