**Well Inspection**  
**Osage DNR / Environmental Protection Agency**  
**1201 Elm Street, Suite 500**  
**Dallas, Texas 75270**

| <b>Operator Info</b> | CapturePoint, LLC (formerly Perdure Petroleum, LLC)<br>1101 Central Expwy S., Suite 150<br>Allen, TX 75013<br>Phone: 832-300-8221 | <b>Inventory ID</b> | OS0406000 | | |
| | | <b>Well ID</b> | 60-W25 | | |
| <b>Inspection Reason</b> | Fluid Level Monitoring | <b>Responsible Company at Time of Inspection</b> | CapturePoint, LLC | | |

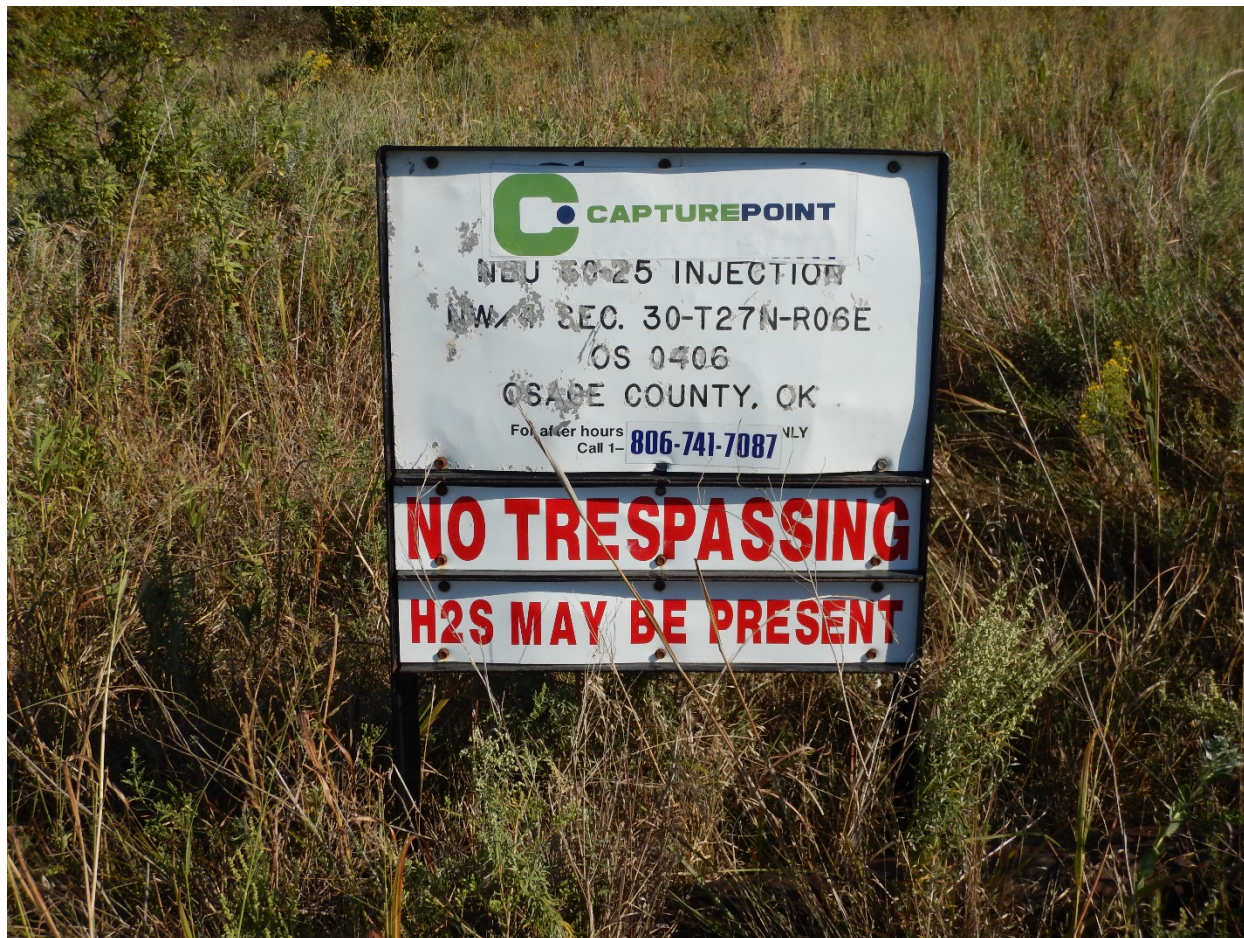
Photo No. 1

**Description:** This was the well sign for well OS0406000 (NBU 60-W25).

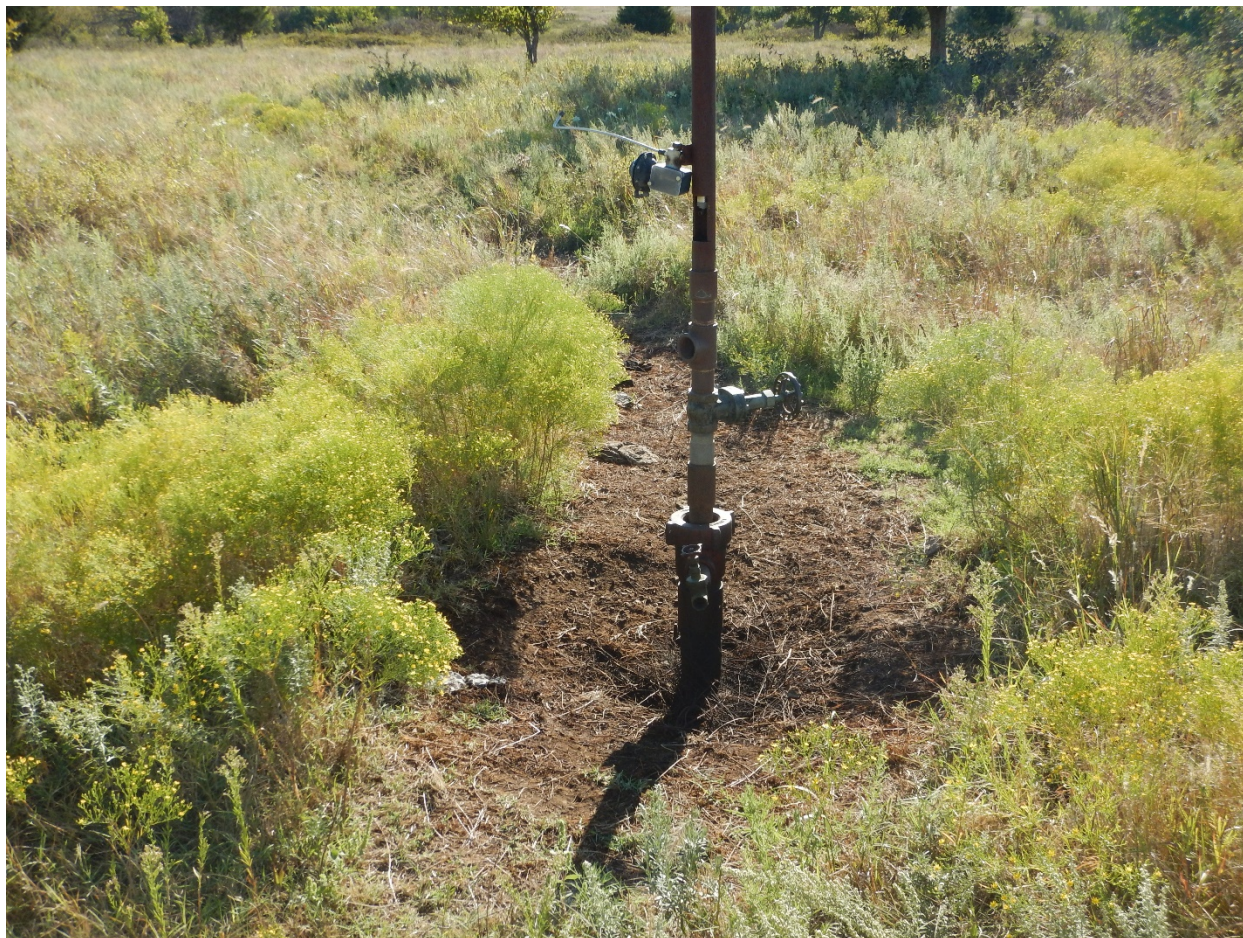
Photo No. 2

| <b>Inspection Comments</b> | At the time of the inspection, the operator reported the casing of well OS0406000 was parted approximately 90 feet below the surface. At the time of the inspection, I observed the fluid level down the tubing and the casing to be at 98.70 feet with the EPA Echometer. At the time of the inspection, I observed 0 psi pressure on the casing and tubing of the well. | | | | |

**Description:** This was well OS0406000.
