## **RCRA Inspection Report**

United States Air Force - Moody Air Force Base (Moody AFB)  
23 CES/CEIEC  
23 Flying Tiger Way  
Moody AFB, GA 31699  
EPA ID: GA0570024109

September 27, 2022; 1:00 pm to 5:45 pm through September 28, 2022; 7:30 am to 4:00 pm.

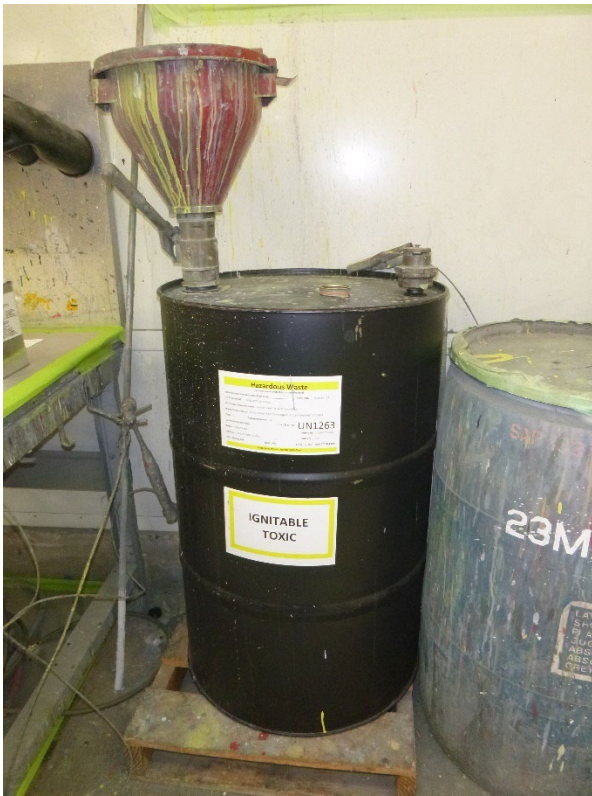
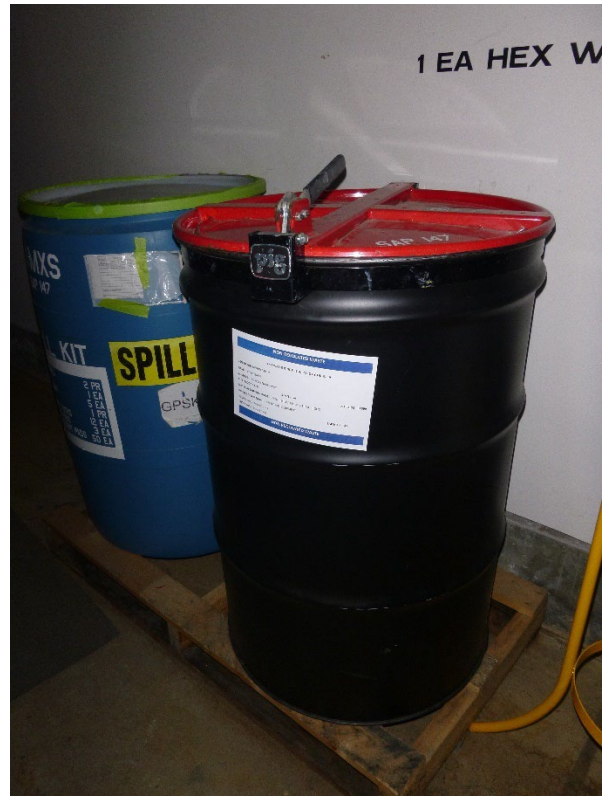
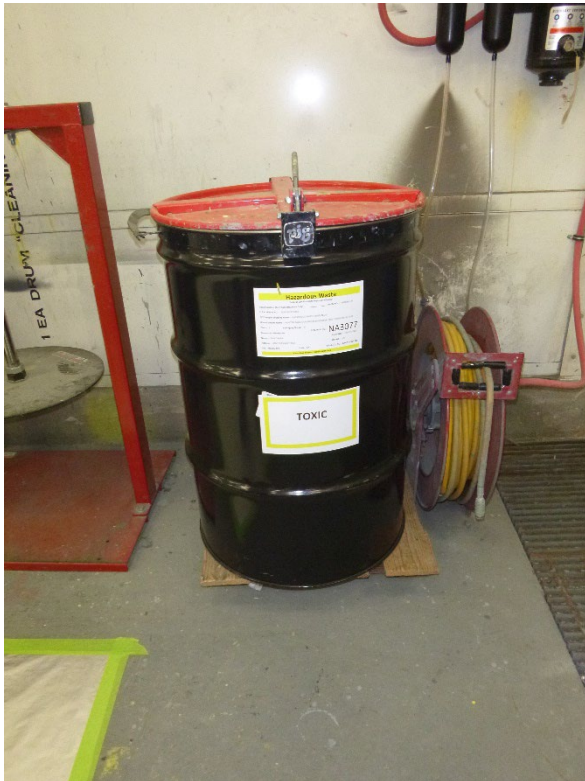
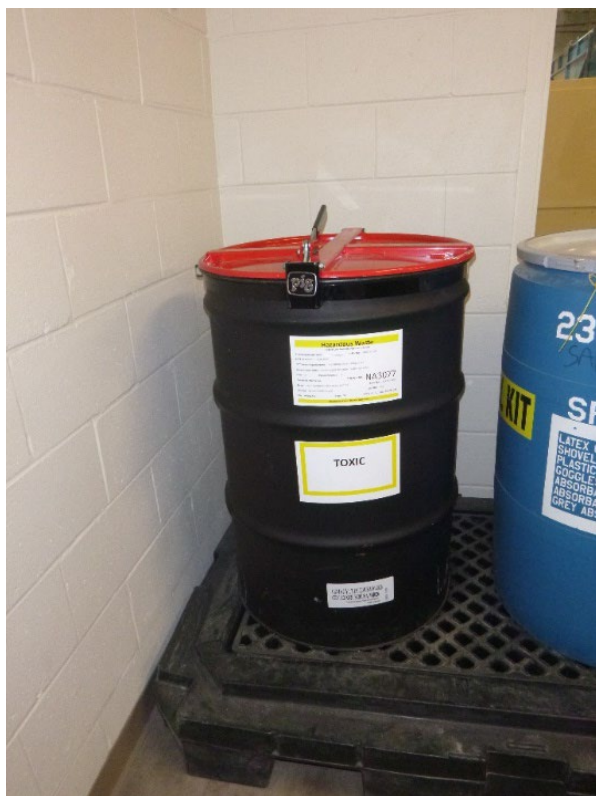
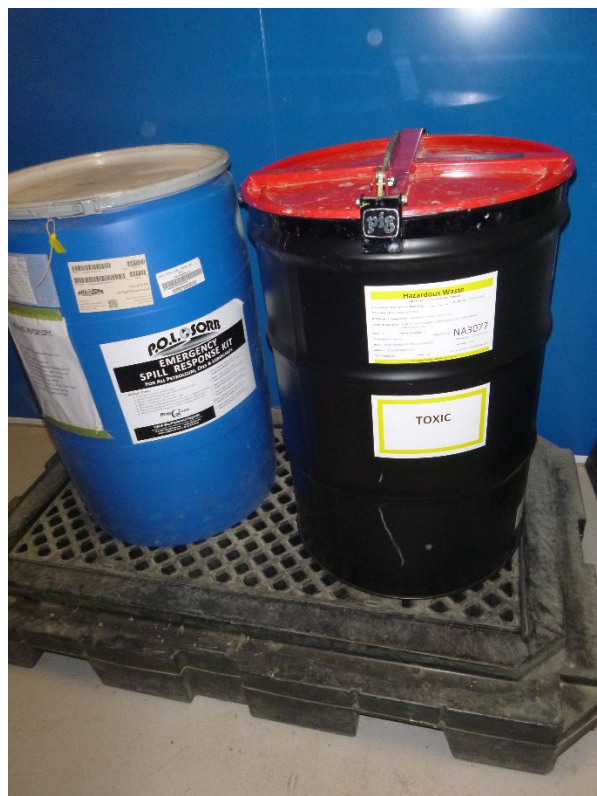
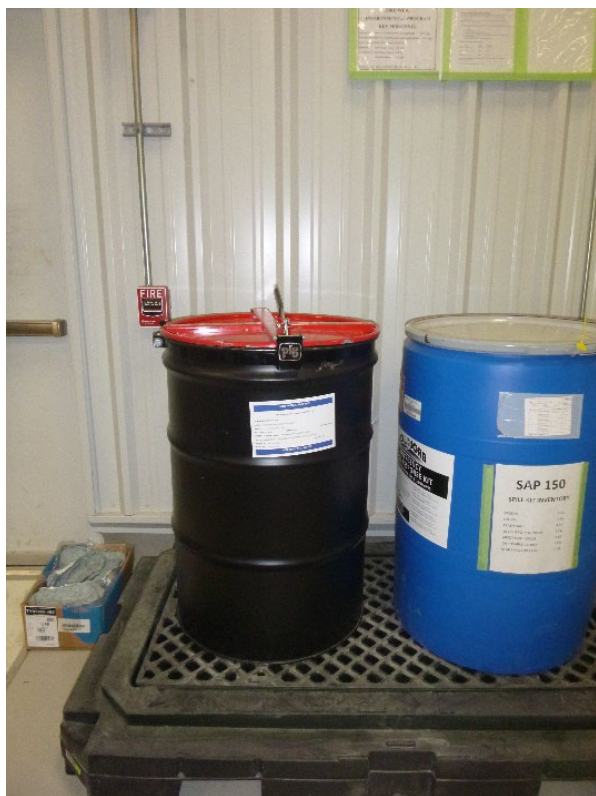
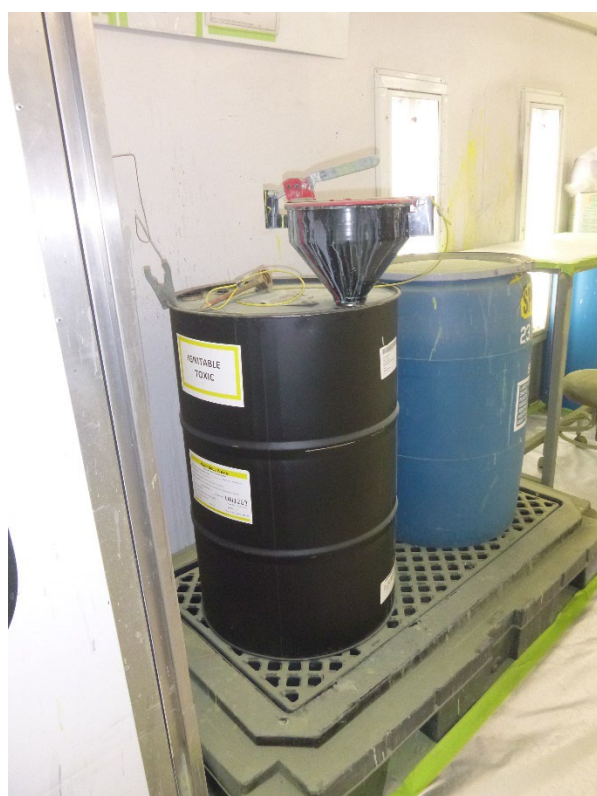
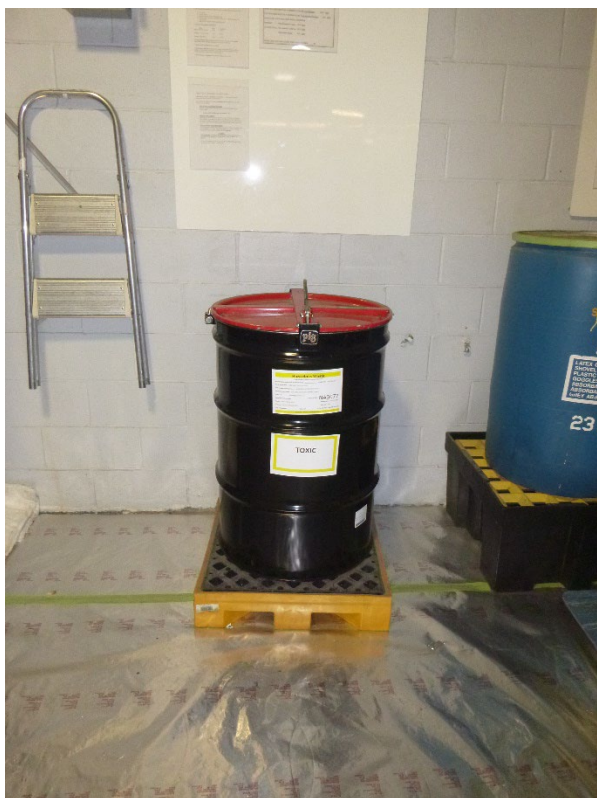
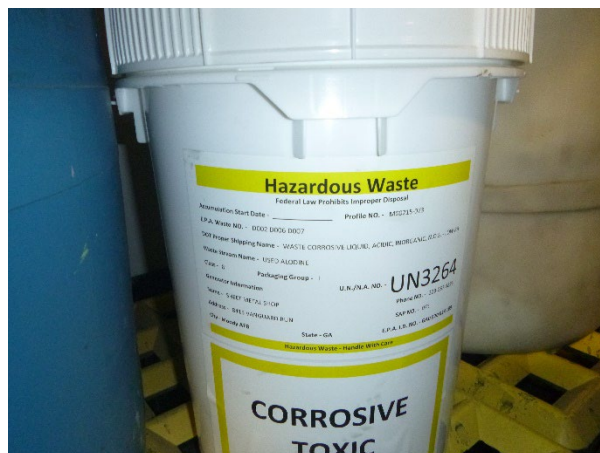
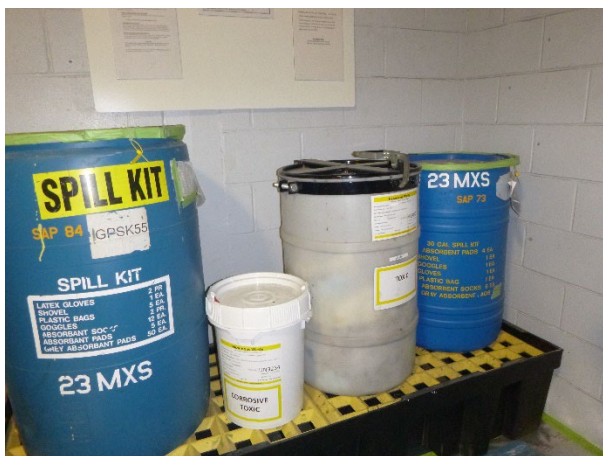
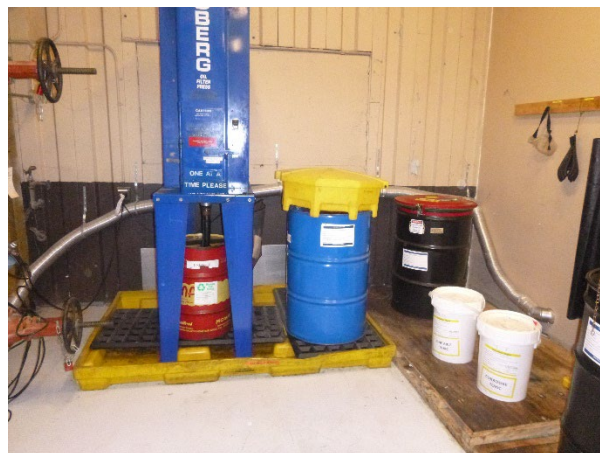
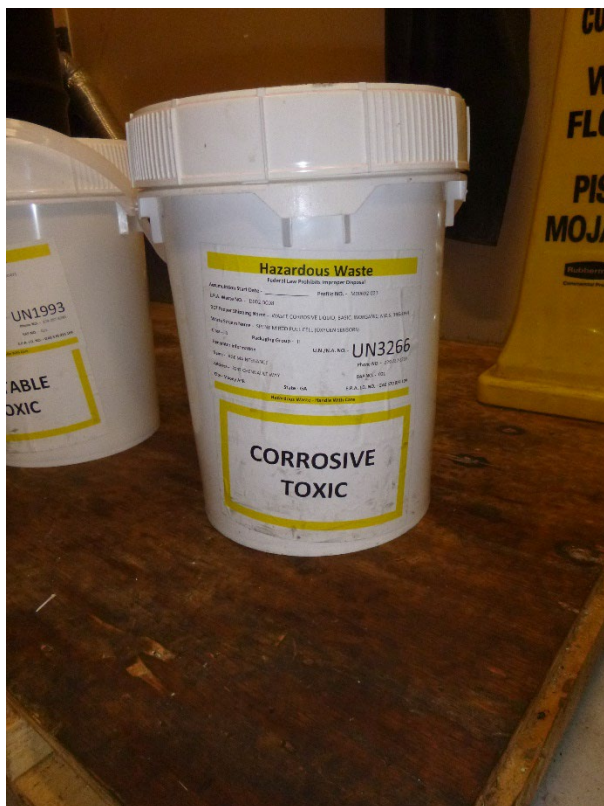
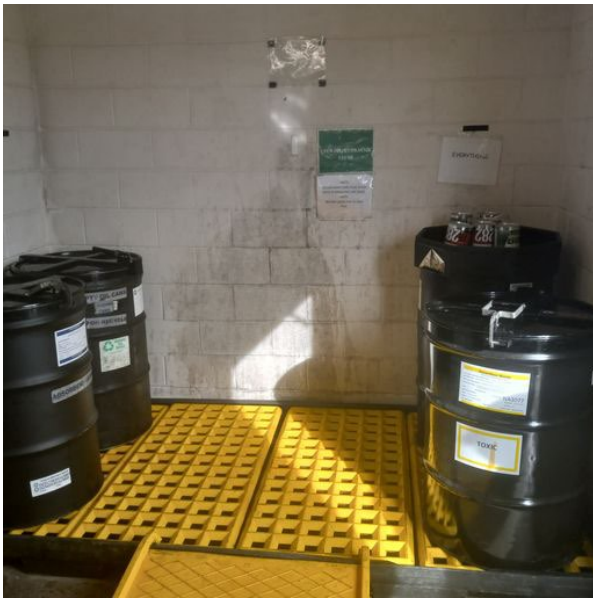
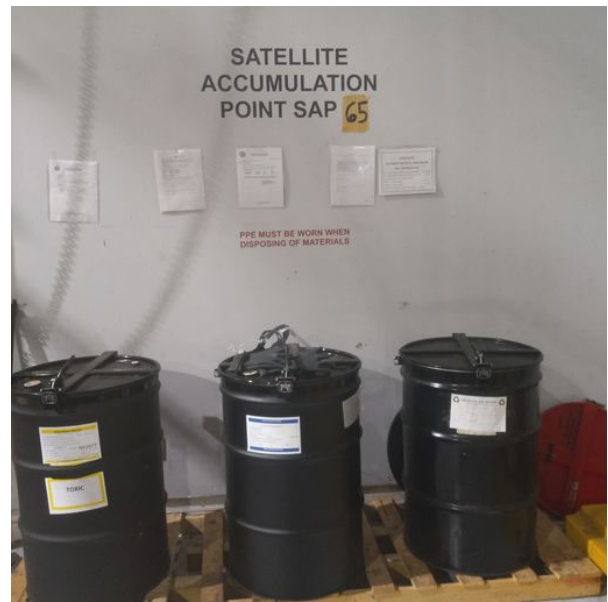
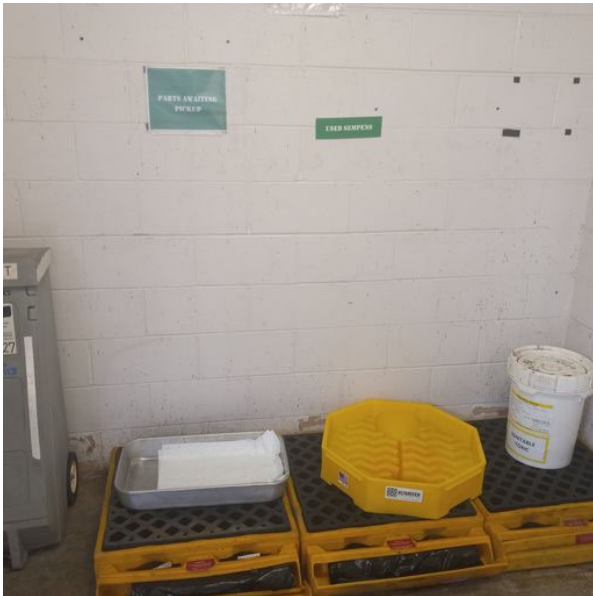
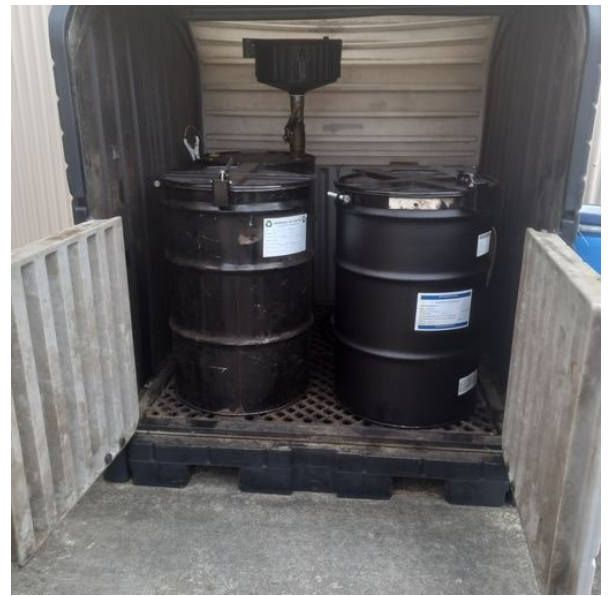
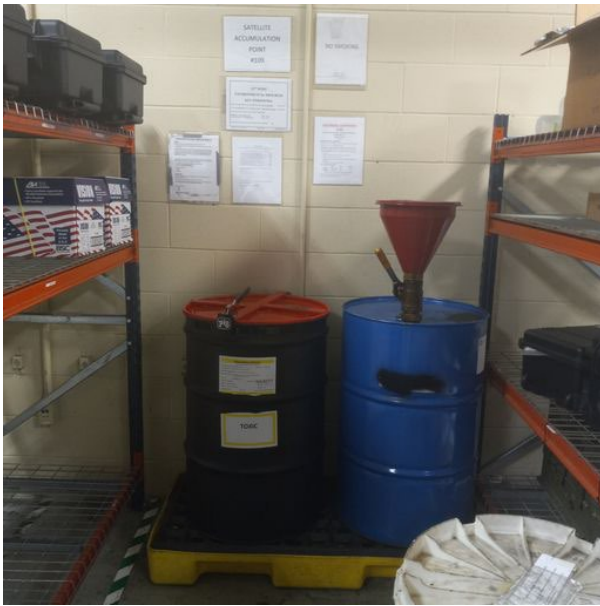
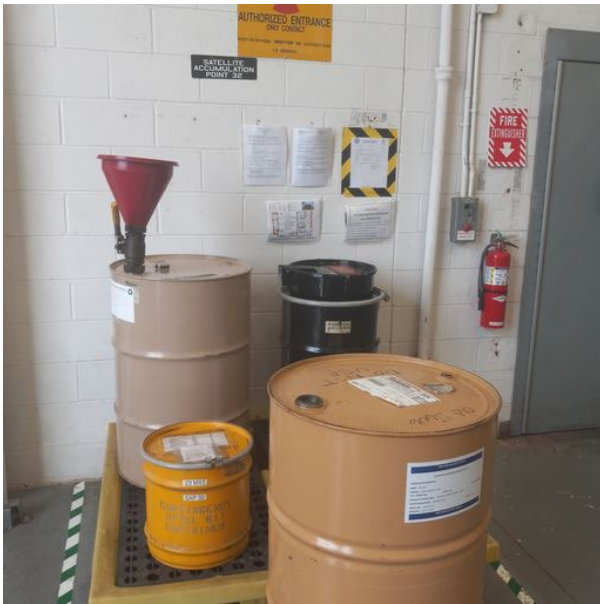
Each designated satellite accumulation container at each SAP was labeled, closed, and in good condition (Photos 1-23).

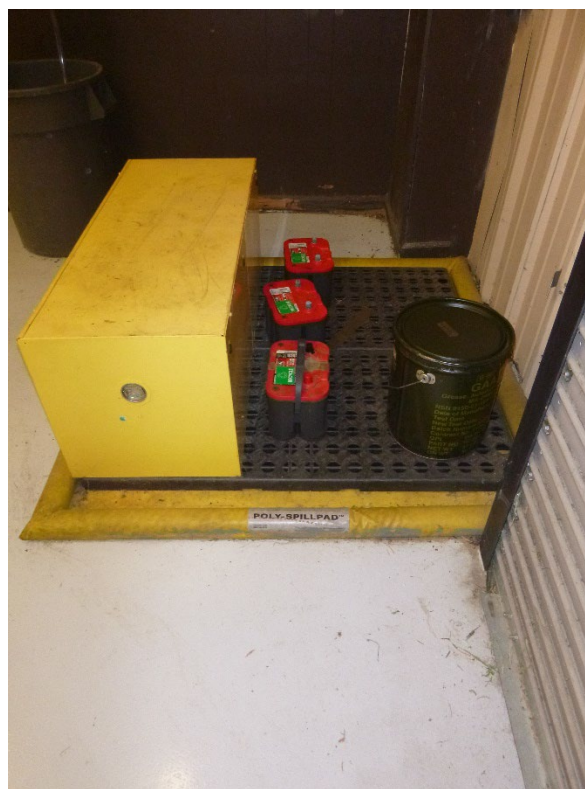
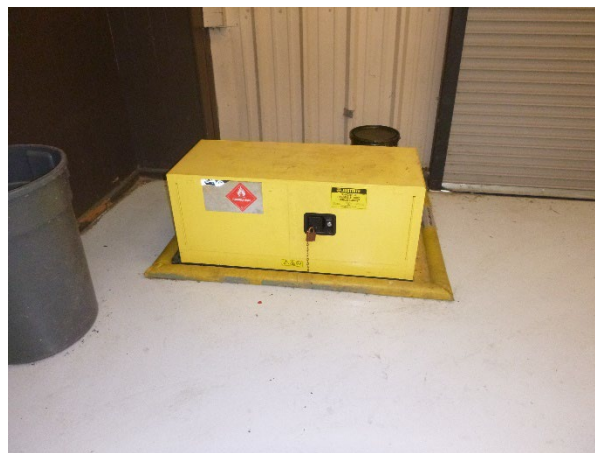
Photograph 16: Building 755 - Batteries.

Photograph 17: Building 755 - Batteries.

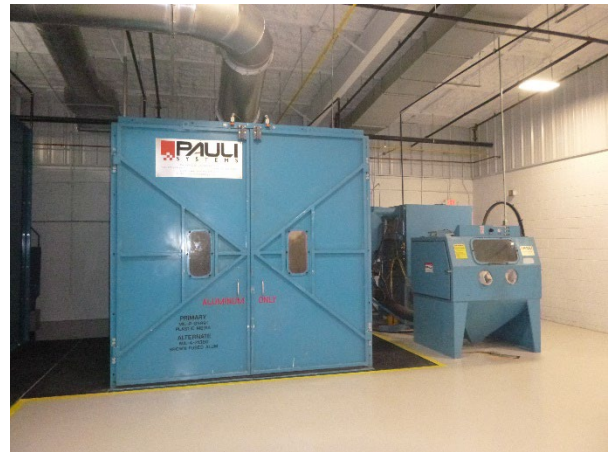
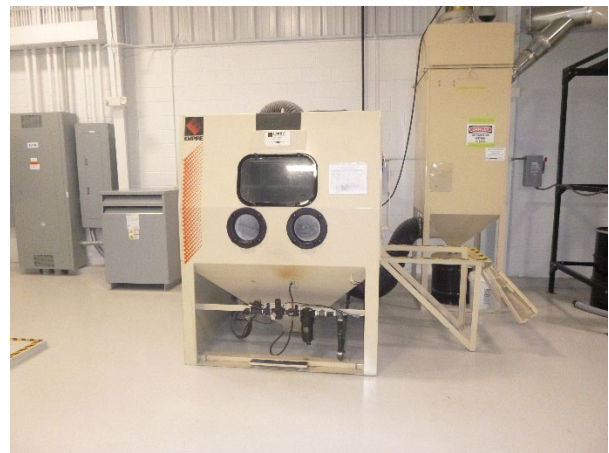
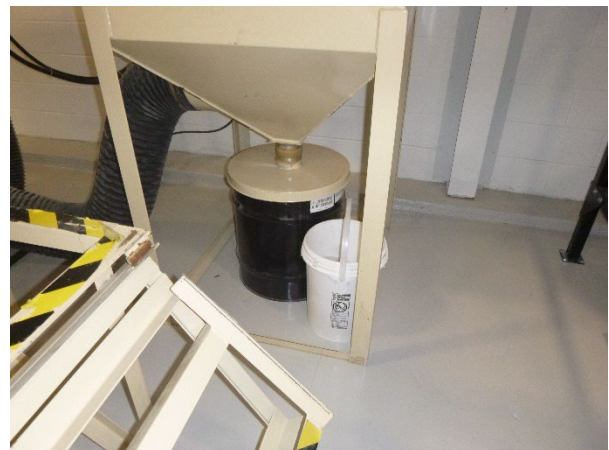
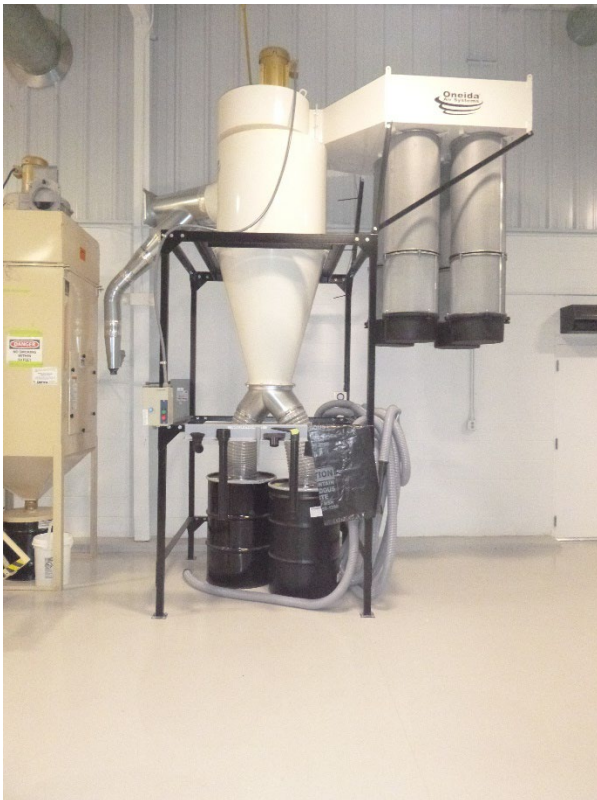
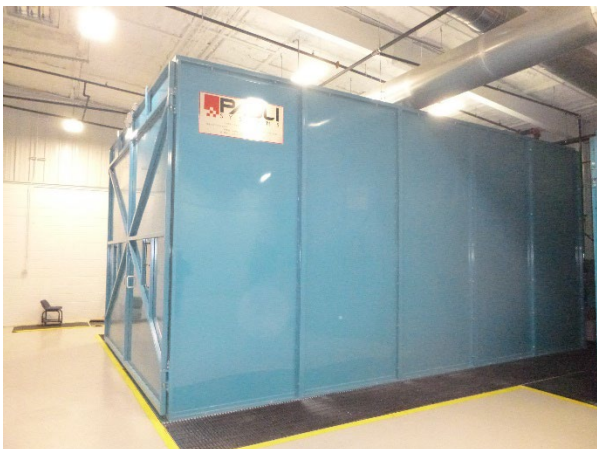
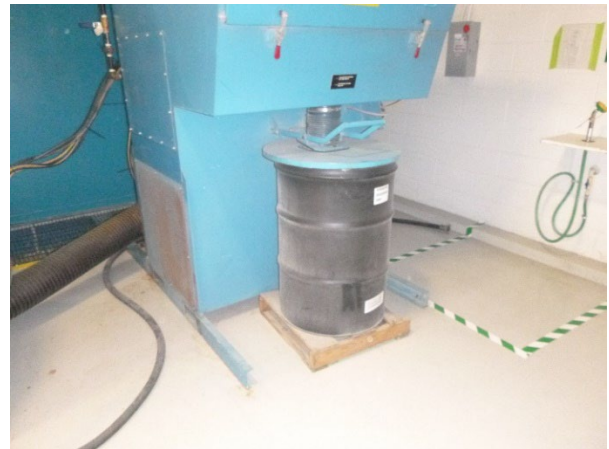
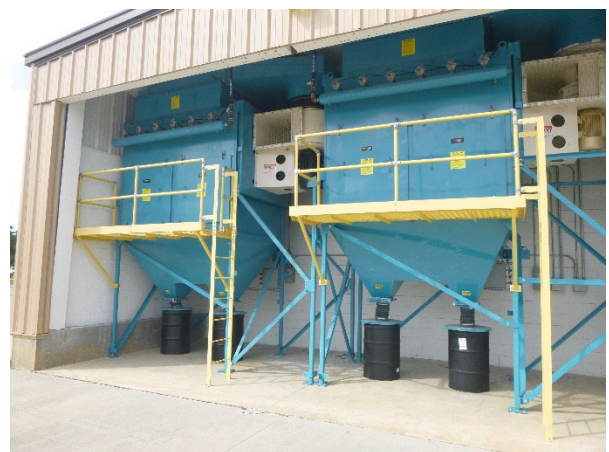
The inspection team noted multiple blast media booths in Building 717. Each booth was connected to a waste collection container. There were seven 55-gallon metal containers and one 25-gallon metal container used to accumulate spent blast media (Photos 24-30). Facility personnel stated that these wastes are managed as a hazardous waste. These containers were not labeled with the words hazardous waste or with an indication of the hazard. Four of these containers were located underneath the baghouses on the exterior of Building 717. These containers did not appear to be under control of the operator of the process generating the waste. The filters used in blast media booths are managed as hazardous waste when spent. Moody AFB documented compliance in this area in an email on October 21, 2022.

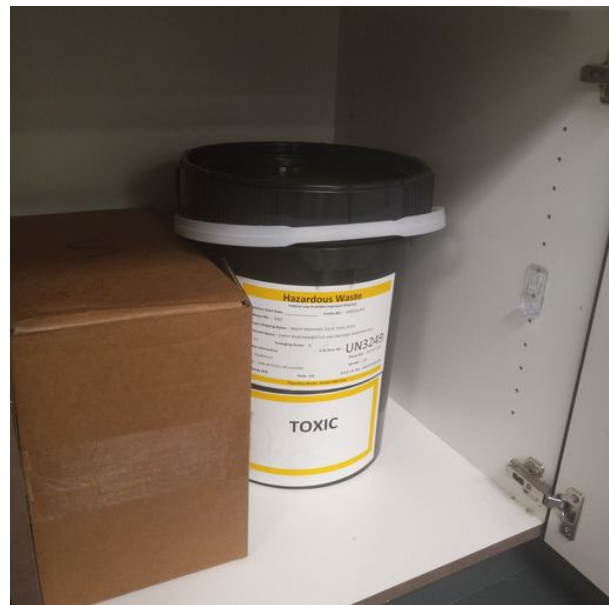
Photograph 31: Building 900 – SAP 34.

In the pharmacy, Moody AFB was accumulating empty warfarin containers and expired warfarin pills in SAP 34 as mentioned above; this container was empty on the day of the inspection (Photo 31). Additionally, Moody AFB was accumulating expired or waste pills in two 5-gallon containers filled with activated carbon to treat the pills to render them unrecoverable and unusable (Photo 32). These containers were provided by Rx Destroyer for Drug Disposal. These two containers were not labeled, had some waste on the top of the containers, and were not documented of how long they had been accumulating non-credible hazardous waste pharmaceuticals. The HAZ MART personnel were unaware of this waste stream at the time of the inspection. Pharmacy personnel stated that the Logistics group was the one that provided and removed these containers. According to personnel in Logistics, these containers were disposed of in a non-hazardous waste dumpster and hauled to a municipal landfill with the base trash. All personnel were instructed to no longer dispose of the buckets in this manner and store them. After the inspection team left the Logistics, EPA headquarters was contacted and consulted about this situation. It was determined that the pill disposal buckets should be labeled as hazardous waste and when full should be sent to a hazardous waste incinerator to meet the new RCRA Subpart P requirements. Moody AFB documented compliance in this area in an email on October 21, 2022.

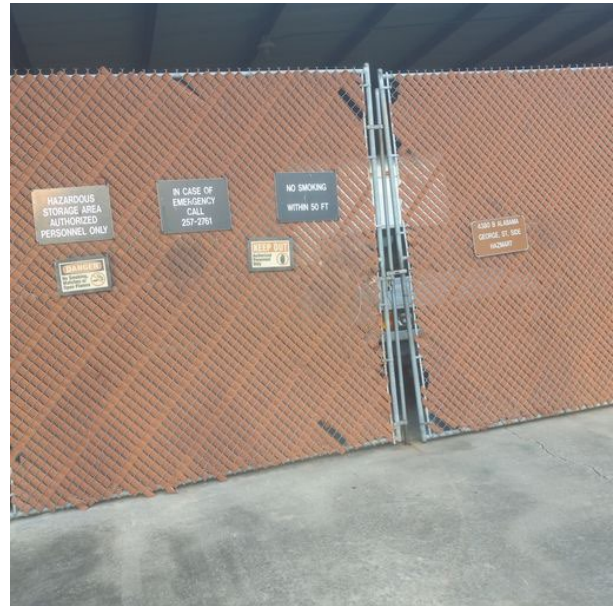
Photograph 34: Building 932-B - Central Accumulation Point.

Moody AFB manages hazardous waste in a CAA and an SAA in Building 932-B, the HAZ MART. This area is a secured, fenced-in area with a roof (Photo 34). Signs were posted on the HAZ MART's fenced gate which read “Hazardous Waste Storage Area Authorized Personnel Only”, “Danger, No Smoking, Matches or Open Flames”, and “KEEP OUT Authorized Personnel Only”. Moody AFB manages ignitable, reactive, and universal waste in this CAA. The inspection team compared the printed inventory of 117 containers with the actual containers in storage with no discrepancies (Photos 35-42).

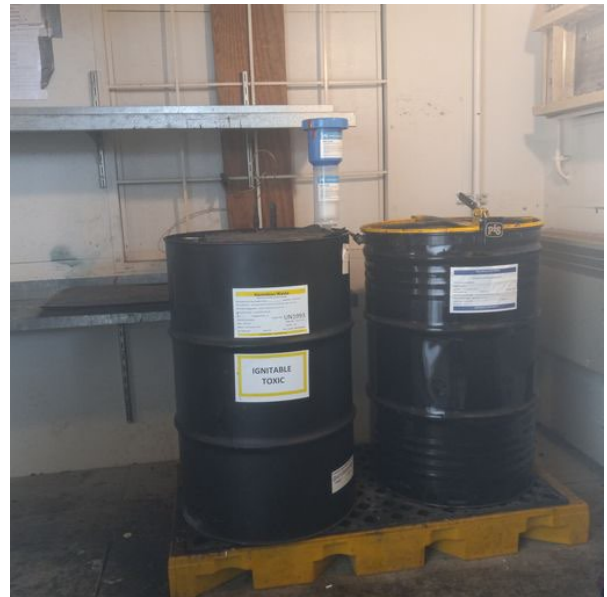
Photograph 43: Building 932-B – SAP 59.

There were multiple containers of universal waste lamps and batteries stored in the HAZ MART on the day of the inspection which were closed and marked with an accumulation start date and were labeled as to their contents. The oldest date observed on any container of universal waste was March 30, 2022, of spent broken fluorescent lamps (Photos 39-41). SAP 59 was in the HAZ MART (Photo 43). Each container was labeled, in good condition, closed, and provided with adequate aisle space.
